Intended for  
**Viking Energy Wind Farm LLP**

Project Number  
**1620009158**

# **VIKING ENERGY WIND FARM PLANNING MONITORING OFFICER AUDIT REPORT 025: 24<sup>TH</sup> OCTOBER TO 20<sup>TH</sup> NOVEMBER 2022**

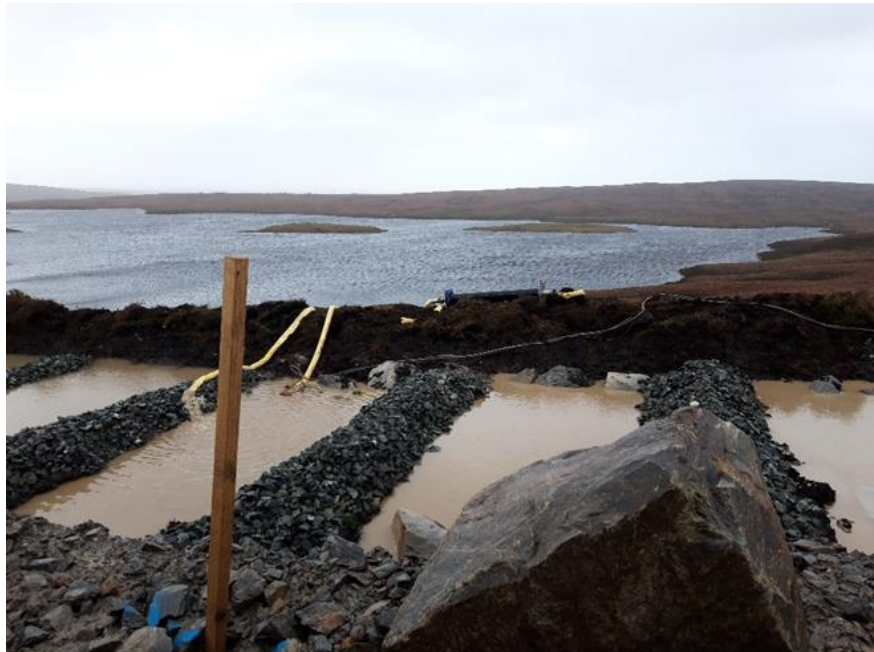
In response to periods of heavy rainfall and prevention of silty water events, a water pump with reactor is being used between K61 and K62 on settlement ponds by Maa Water (Photo 1). The reactor accelerates sediment separation and usage has been approved by SEPA. Water from the water pump reactor is then released into another settlement pond and then multiple layers of silt fencing (Photo 2).

**Photo 1.** View of settlement ponds and water pump with reactor near Maa Water

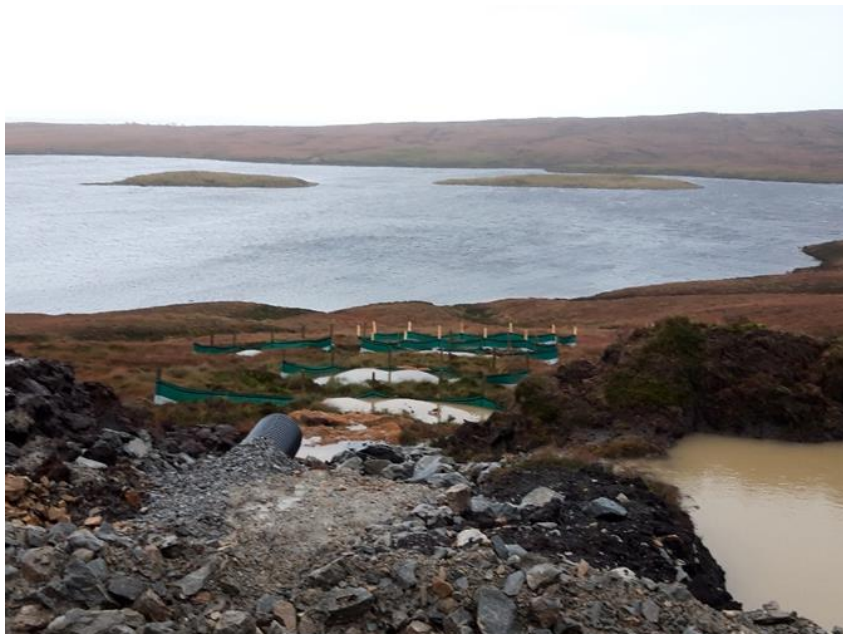
**Photo 2.** View of drainage system near Maa Water: Settlement pond, culvert and silt traps

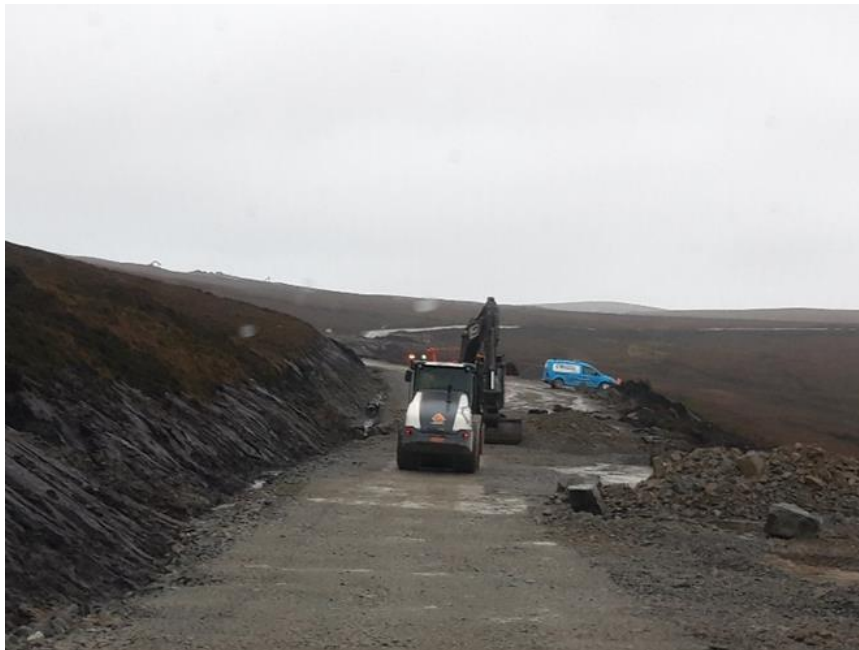
During the visit, tracks between K61 and K62 are being widened in preparation for turbine delivery (Photo 3). Following widening of tracks, culverts in this section will also be extended.

**Photo 3.** Widening track between K61 and K62

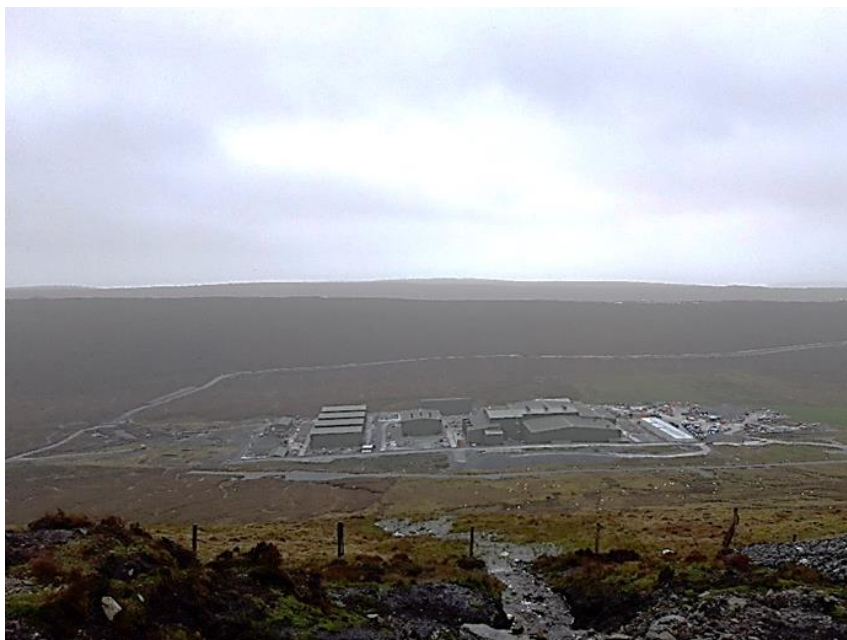
The excavation of the cross-country cable route from K88 to the substation, including the crossing of the Burn of Weisdale has been completed (Photo 4). Following the heavy rainfall events reported in PMO024, further mitigation has been installed. Mitigation includes drainage grips, settlement sumps/ ponds, installation of additional silt fences and clean water cut off ditches (Photo 5). There has been no repeat of this incident.

**Photo 4.** View towards cross-country cable route between K88 and substation

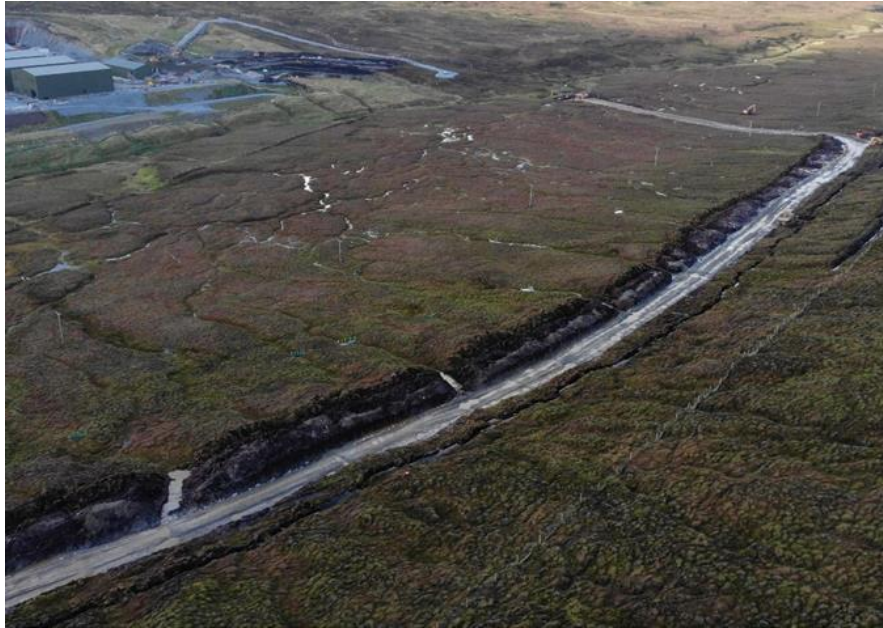
**Photo 5.** Aerial view of cross-country cable route into substation with drainage and other mitigation (Photo from RJ McLEOD)

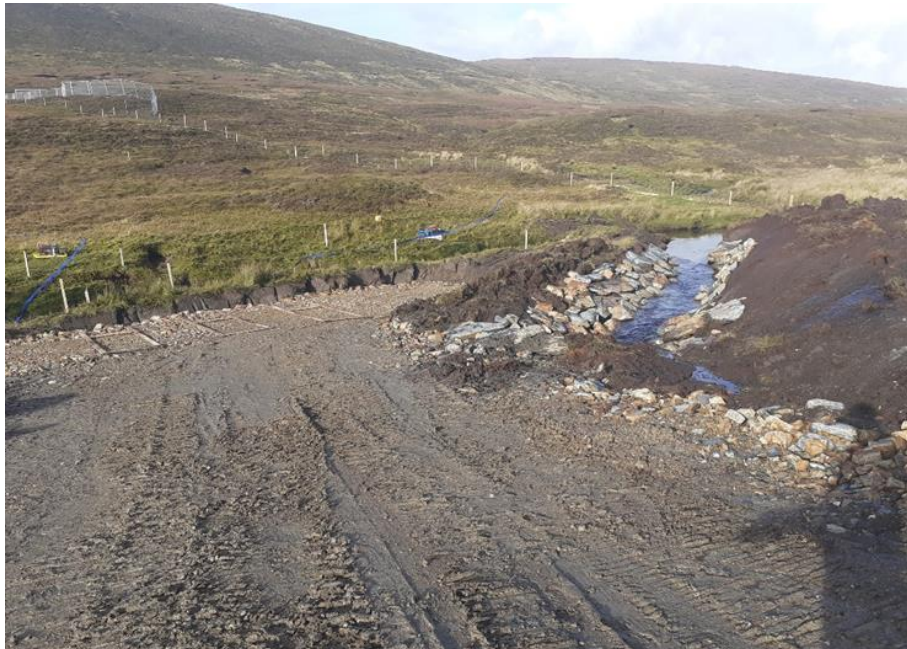
The Burn of Weisdale diversion is ongoing and should be completed before next visit (Photo 6). An additional duct is to be installed for cabling which will avoid future disturbance of ground and additional overhead lines. The final drainage on Sandwater track has been installed according to the final design specifications (Photo 7).

**Photo 6.** Ongoing Burn of Weisdale diversion (Photo from RJ McLEOD)

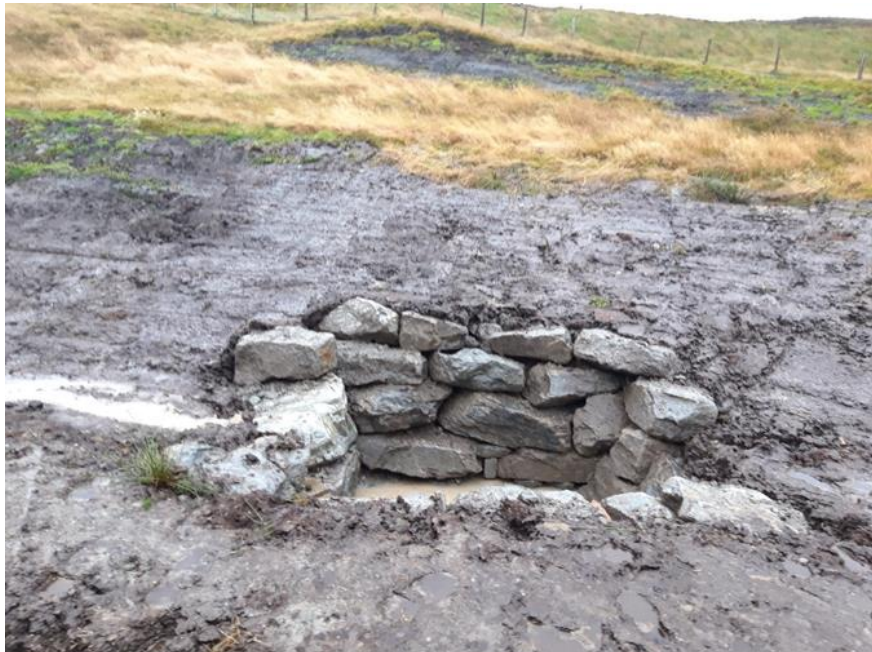
**Photo 7.** Final planned drainage installed by Sandwater track

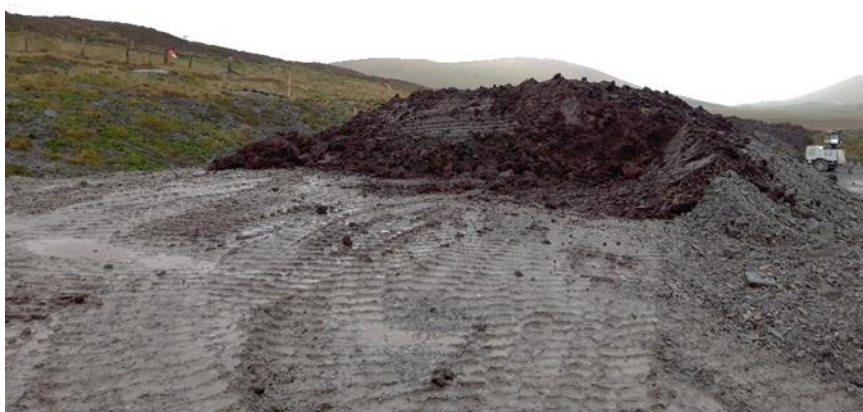
A temporary peat storage has been established on the Sandwater track and has been bunded appropriately (Photo 8).

**Photo 8.** View of temporary peat storage by Sandwater track

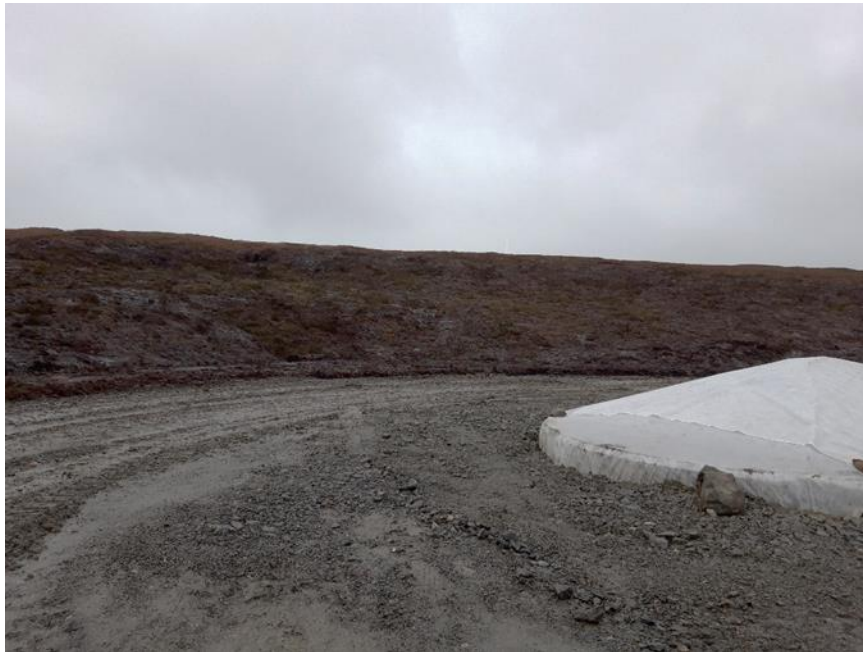
N99 turbine base has been backfilled. Backfilled turbine bases are being prepared for turbine erection activities and drainage amended, where required, to the permanent design requirements (example Photo 9). Backfilling of cable trenches is being carried out in some areas where this is possible and has been observed during visit (Photo 10).

**Photo 9.** N96 turbine base backfilled, drainage amended and prepared for turbine erection activities

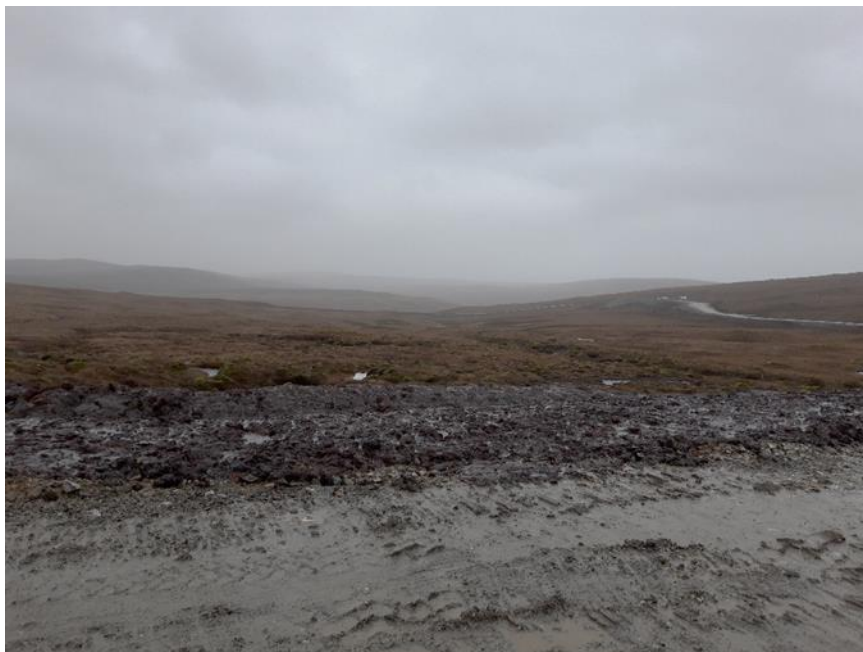
**Photo 10.** View of backfilled cable trench near N97

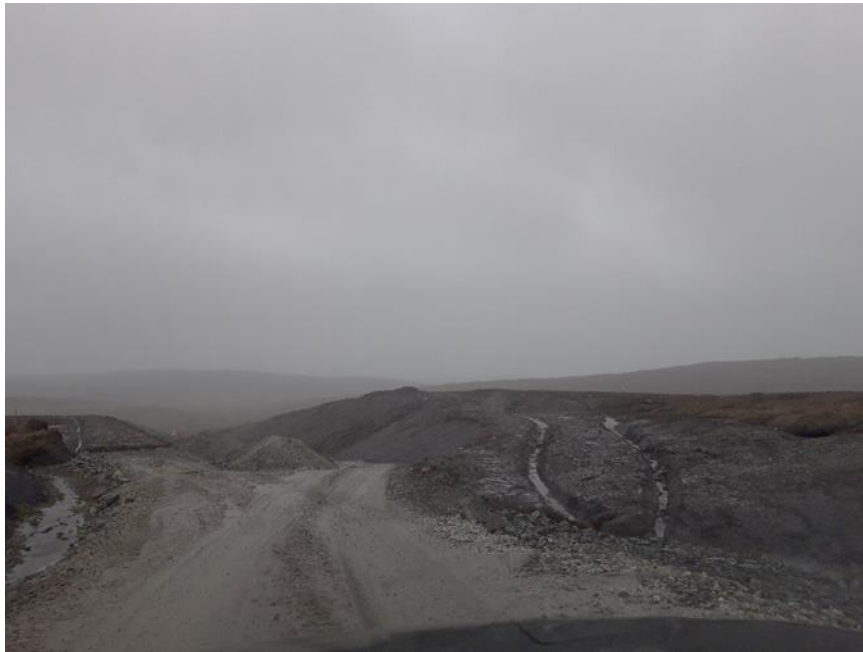
Following the report on Spur 52 in PMO024, additional drainage has been installed (Photo 11).

**Photo 11.** Additional drainage installed on top of Spur 52

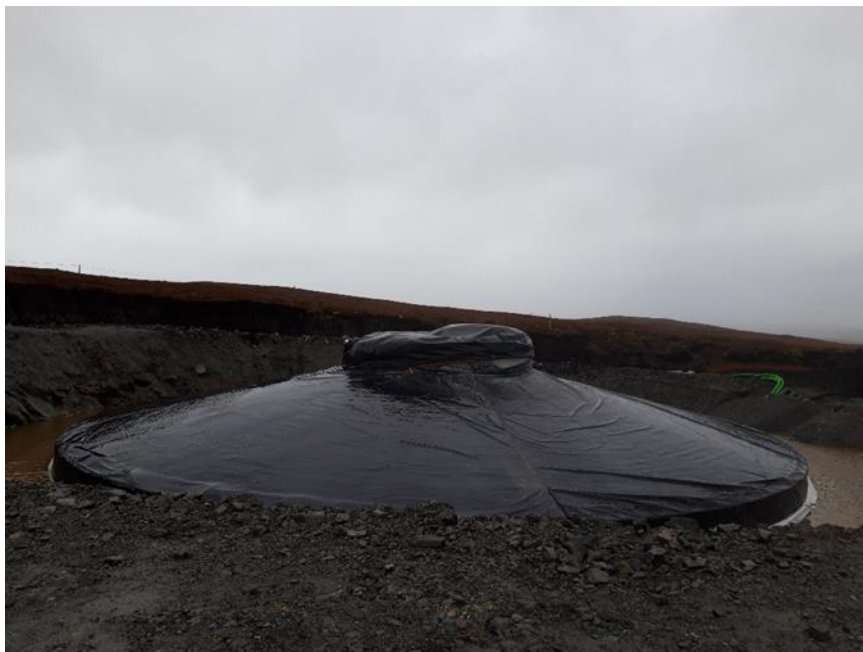
The last of the turbine bases have been poured at N150 (Photo 12). Turbine bases at N110, N112, N118, N121, N123-127, N129 and N142 have been backfilled and geotechnical testing completed.

**Photo 12.** Final poured turbine base at N150

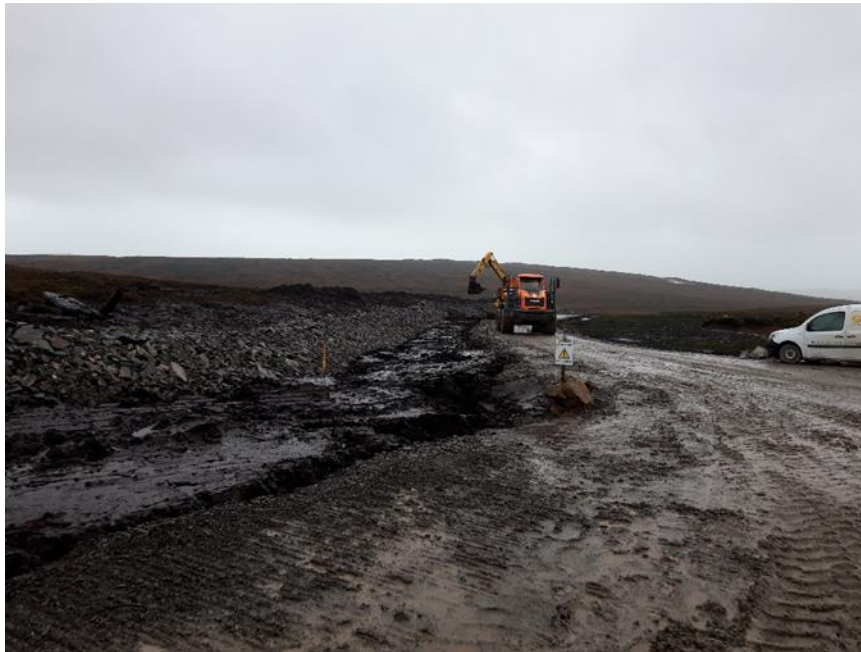
Previously reported cable issues continue to delay the backfilling of some cable trenches. Backfilling of cable trenches, where the cables are not being affected by delays, has commenced and work is continuing. The backfilling of cable trenches by N118 was observed during the site visit (Photo 13). Following hydroseeding activities, early growth can be seen along the cuttings adjacent to the access tracks.

**Photo 13.** Cable trench near N118 being backfilled

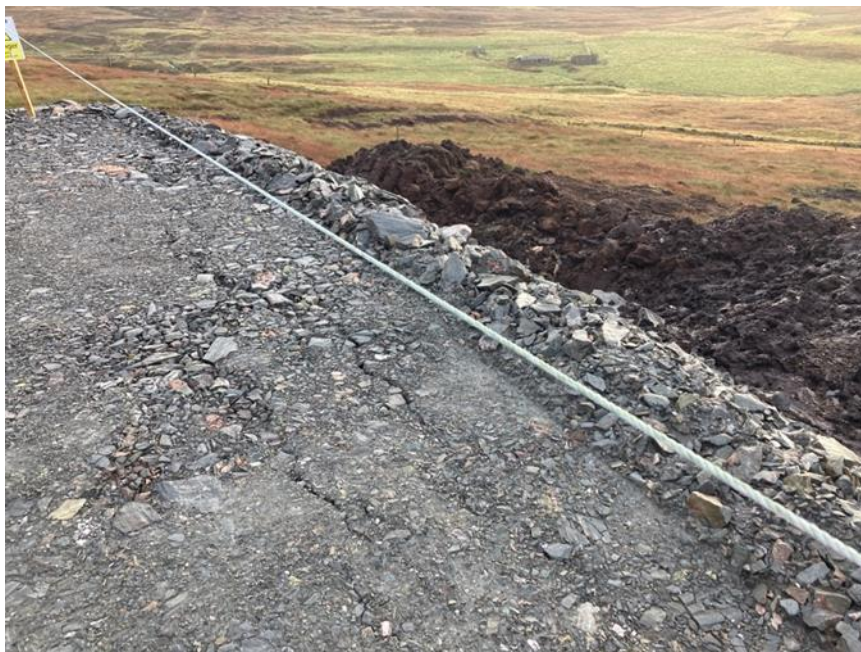
Cracking of the edge of the hardstanding surface at N114 noted (Photo 14). This is included in the project geotechnical risk register and is being monitored while the cause is being investigated.

As reported in Section 3.6.2, the GCoW is monitoring the crack at the edge of the hardstanding surface at N114 and .

**Photo 14.** Noted cracks at Turbine Hardstanding N114 currently under investigation (Photo from GCoW)

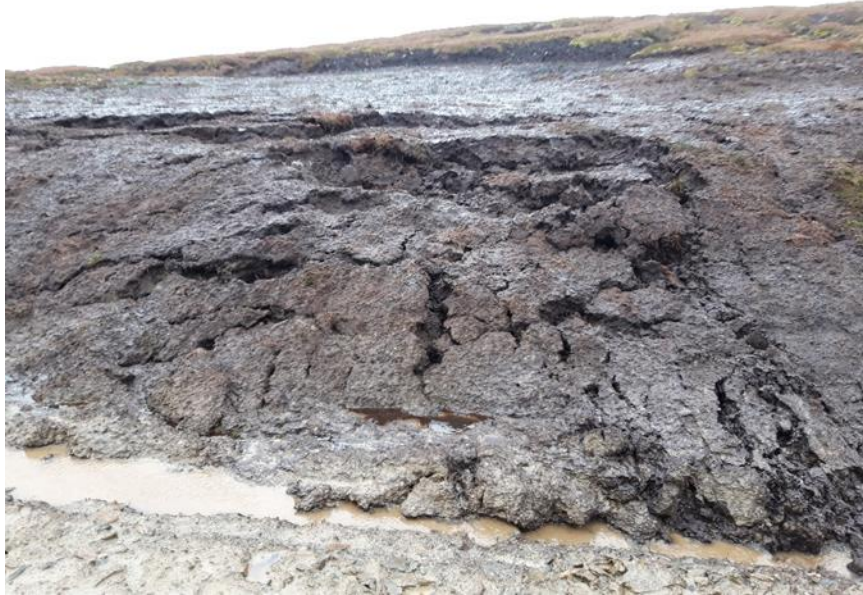
It was noted by the GCoW prior to the site visit that there had been slumping peat in the area following a period of heavy rainfall (example Photo 15). Occurrence of slumping peat has been restricted to sloped reinstatement areas. There are no significant environmental impacts as a result of the peat slumps. The Design Engineer noted that drainage surrounding areas of peat slumps will be assessed and added where required.

The GCoW mentioned observations of peat slumps and required clarification on the plans for the reinstatement of these areas. The Design Engineer clarified that the areas would be reinstated and drainage would be modified to divert surface water flow. The peat slumps did not have any significant environmental impacts. These areas are mentioned in Section 3 above.

**Photo 15.** Example of peat slump at N147

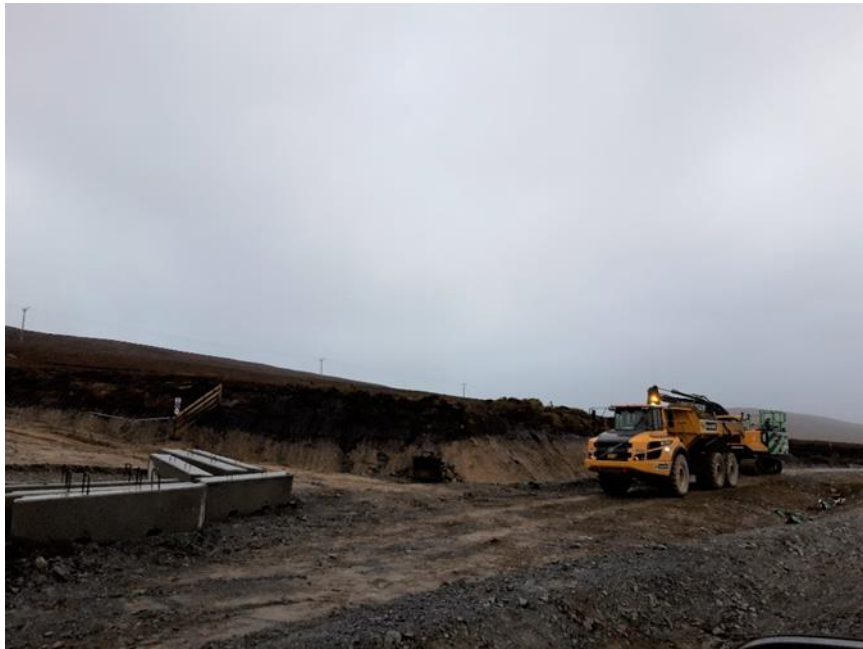
The laying of cable ducts under the A970 as reported in PMO023 and PMO024 has been completed and the road has been reinstated. The restoration of temporary road used during construction was observed during the visit (Photo 16).

**Photo 16.** Temporary road by A970 being reinstated
