**Shetland OBC  
Options Development  
Fair Isle  
Ro-Ro Linkspan**

**Shetland OBC  
Options Development  
Grutness  
Ro-Ro Linkspan**

Appendix 5 - Images

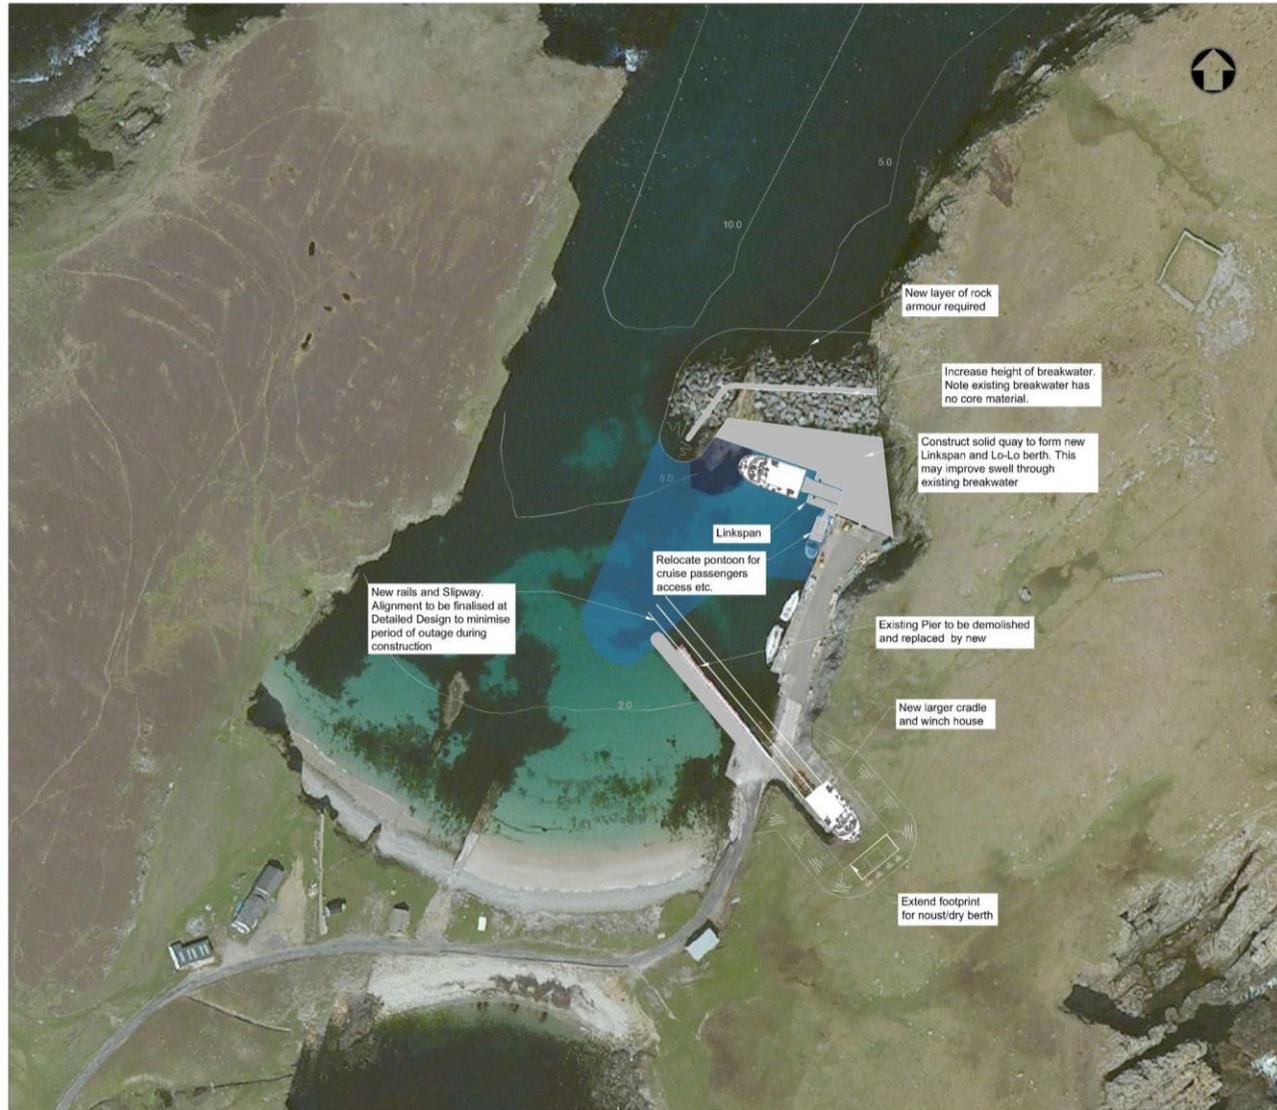
- All levels are to Chart Datum
- Bathymetric information sourced from Beckett Rankine drawing no. 1537-01-201
- Tide Levels:
  - MHWS = 2.2m
  - MLWS = 0.6m
- LAT has been taken as Chart Datum
- Assumed vessel MD240 or similar with:
  - LOA = 23.98m
  - Beam = 11.20m
  - Service Draught = 2.8m
- Dredge level allows for 1m UKC

- Rock dredging to -4.0mCD
- Maintenance dredging to -4.0mCD

Image 1 – Fair Isle: General Arrangement of Proposals

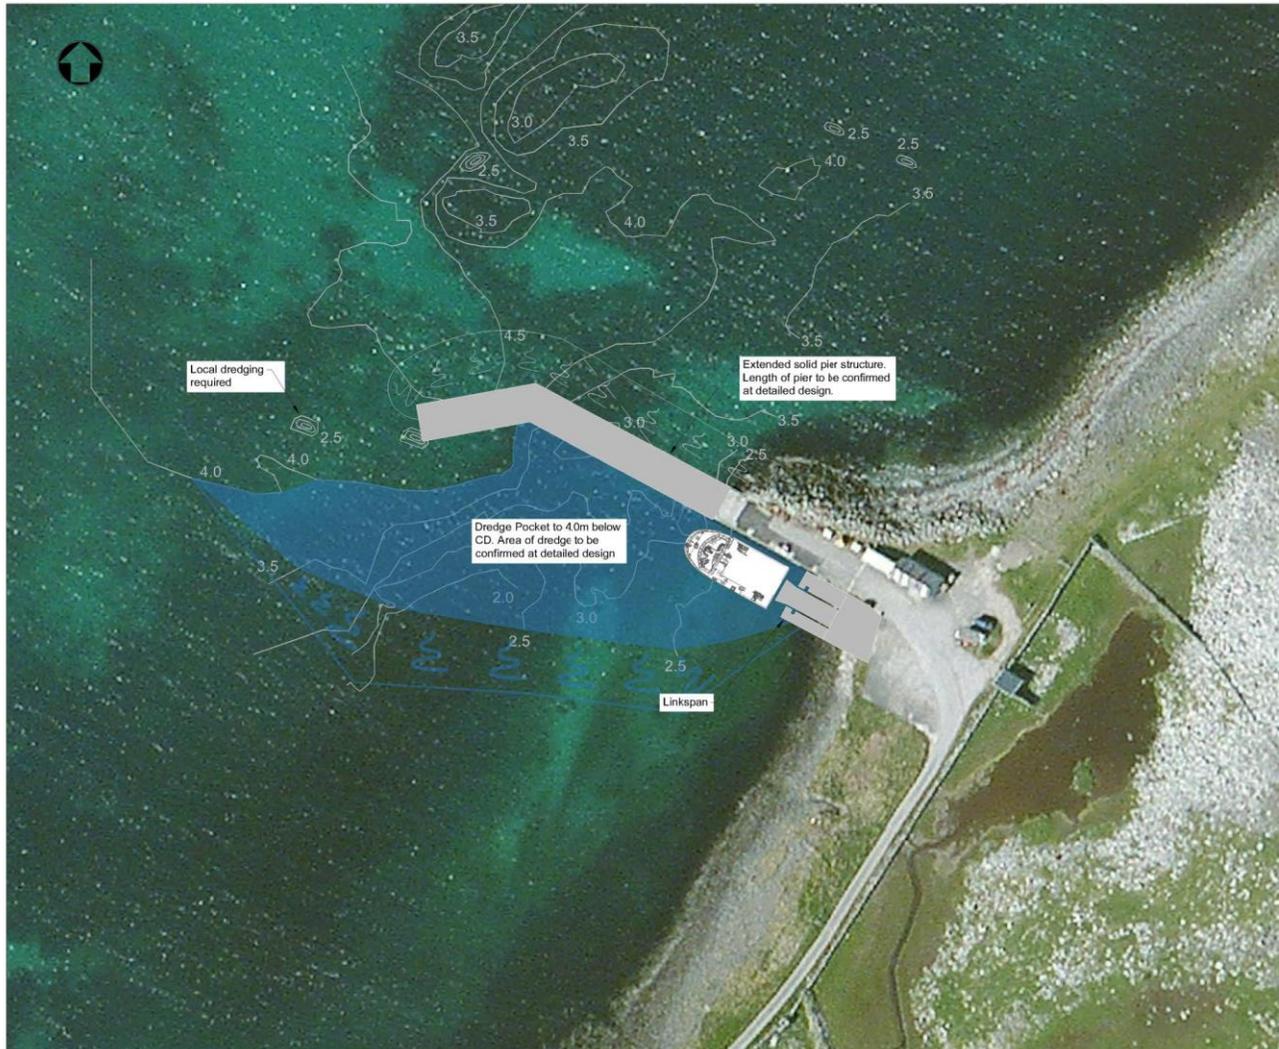
- All levels are to Chart Datum
- Bathymetric information sourced from Shetland Islands Council drawing no. SM-6-1-100
- Tide Levels:
  - MHWS = 1.8m
  - MLWS = 0.4m
- LAT has been taken as Chart Datum
- Assumed vessel MD240 or similar with:
  - LOA = 23.98m
  - Beam = 11.20m
  - Service Draught = 2.8m
- Dredge level allows for 1m UKC, bed understood to be soft material therefore bed overdredged to minimise need for maintenance dredging

■ Dredging to -4.0mCD

Image 2 – Grutness: General Arrangement of Proposals

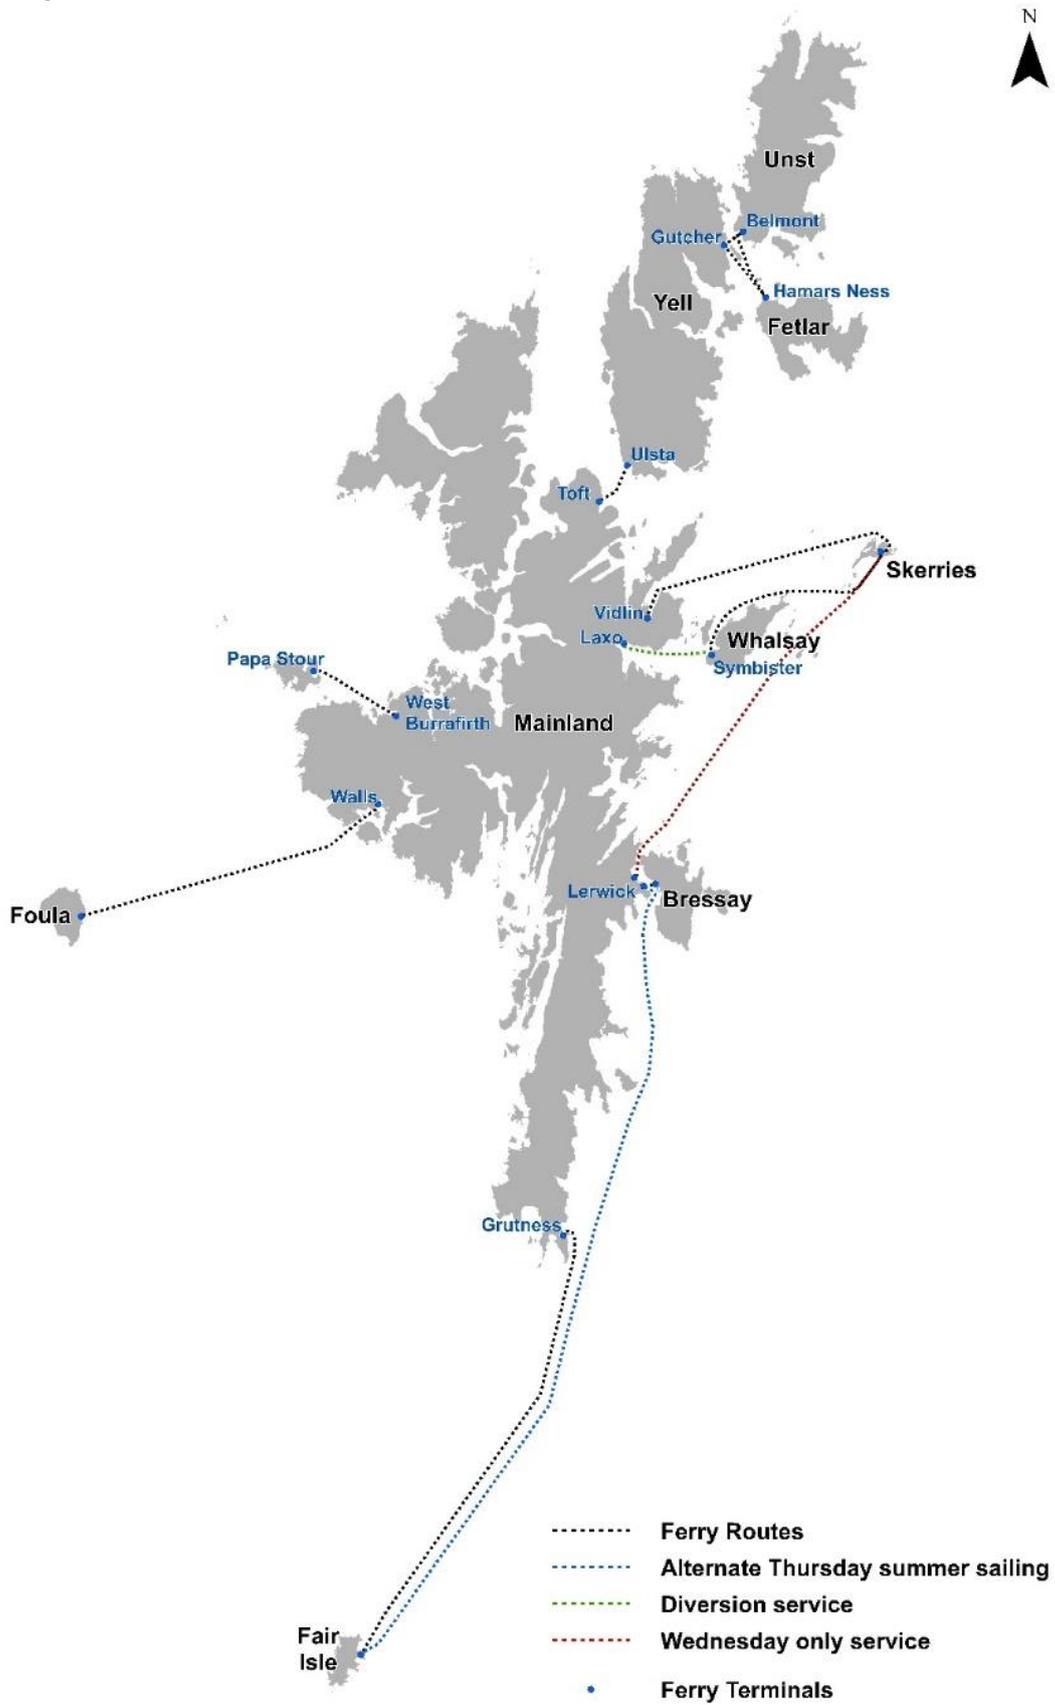
Image 3 – Shetland Islands Inter-Island Ferry Route Map

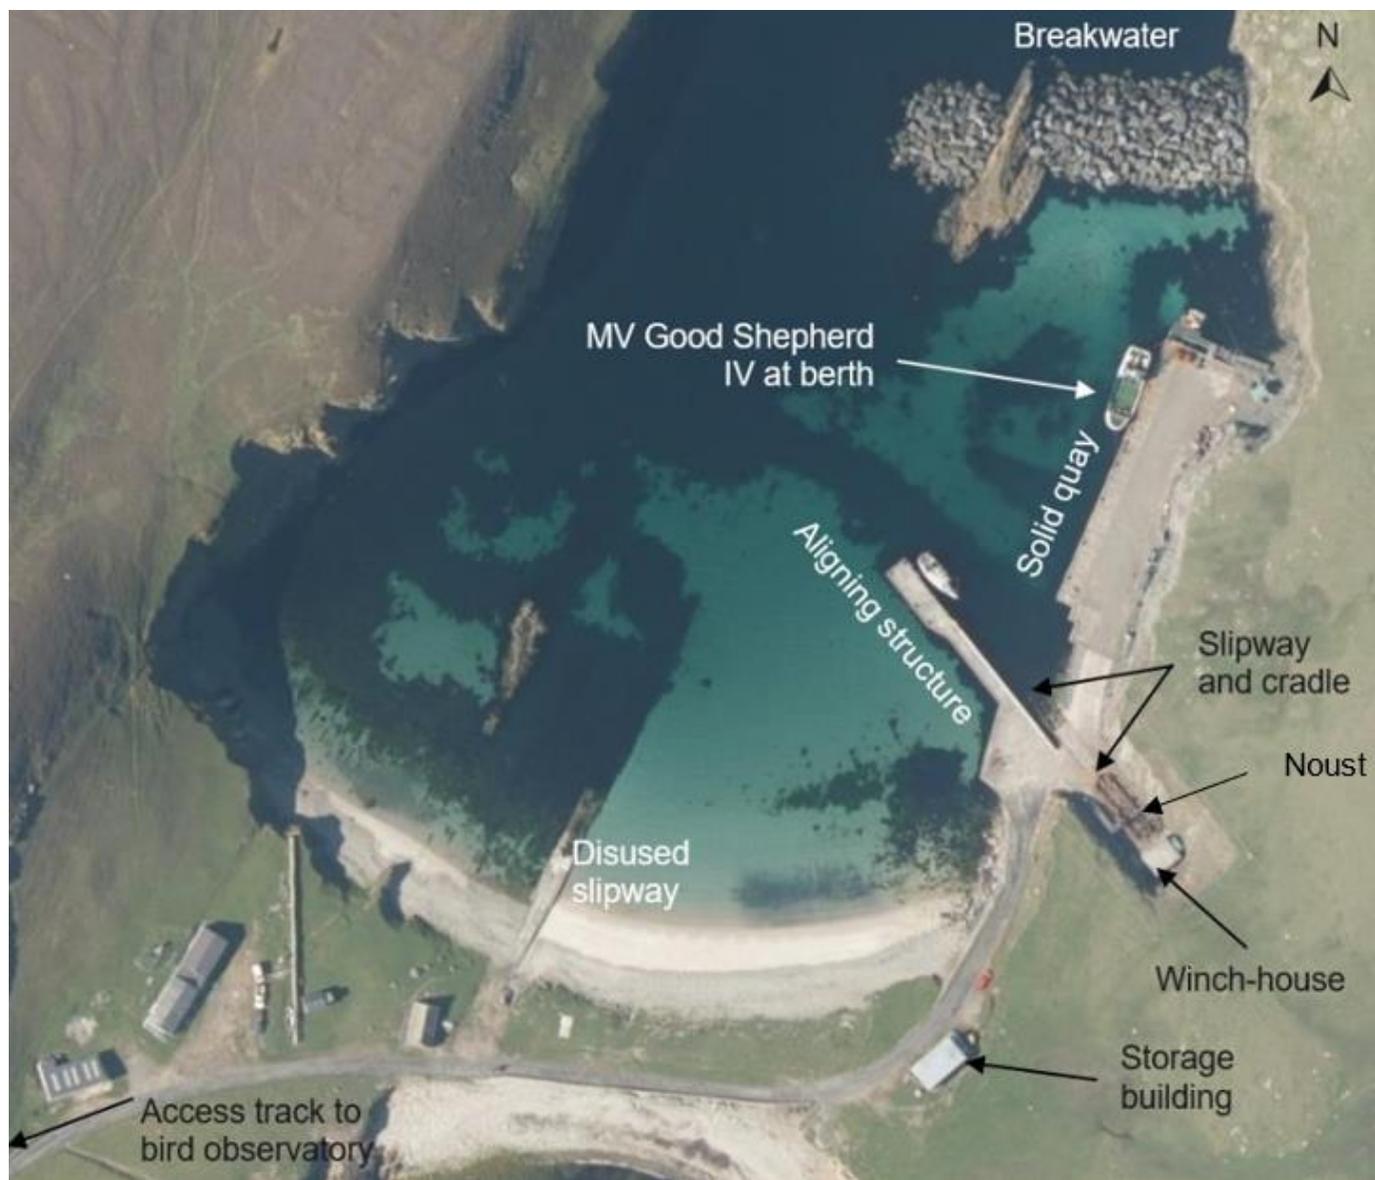
Image 5 – Fair Isle: Annotated image

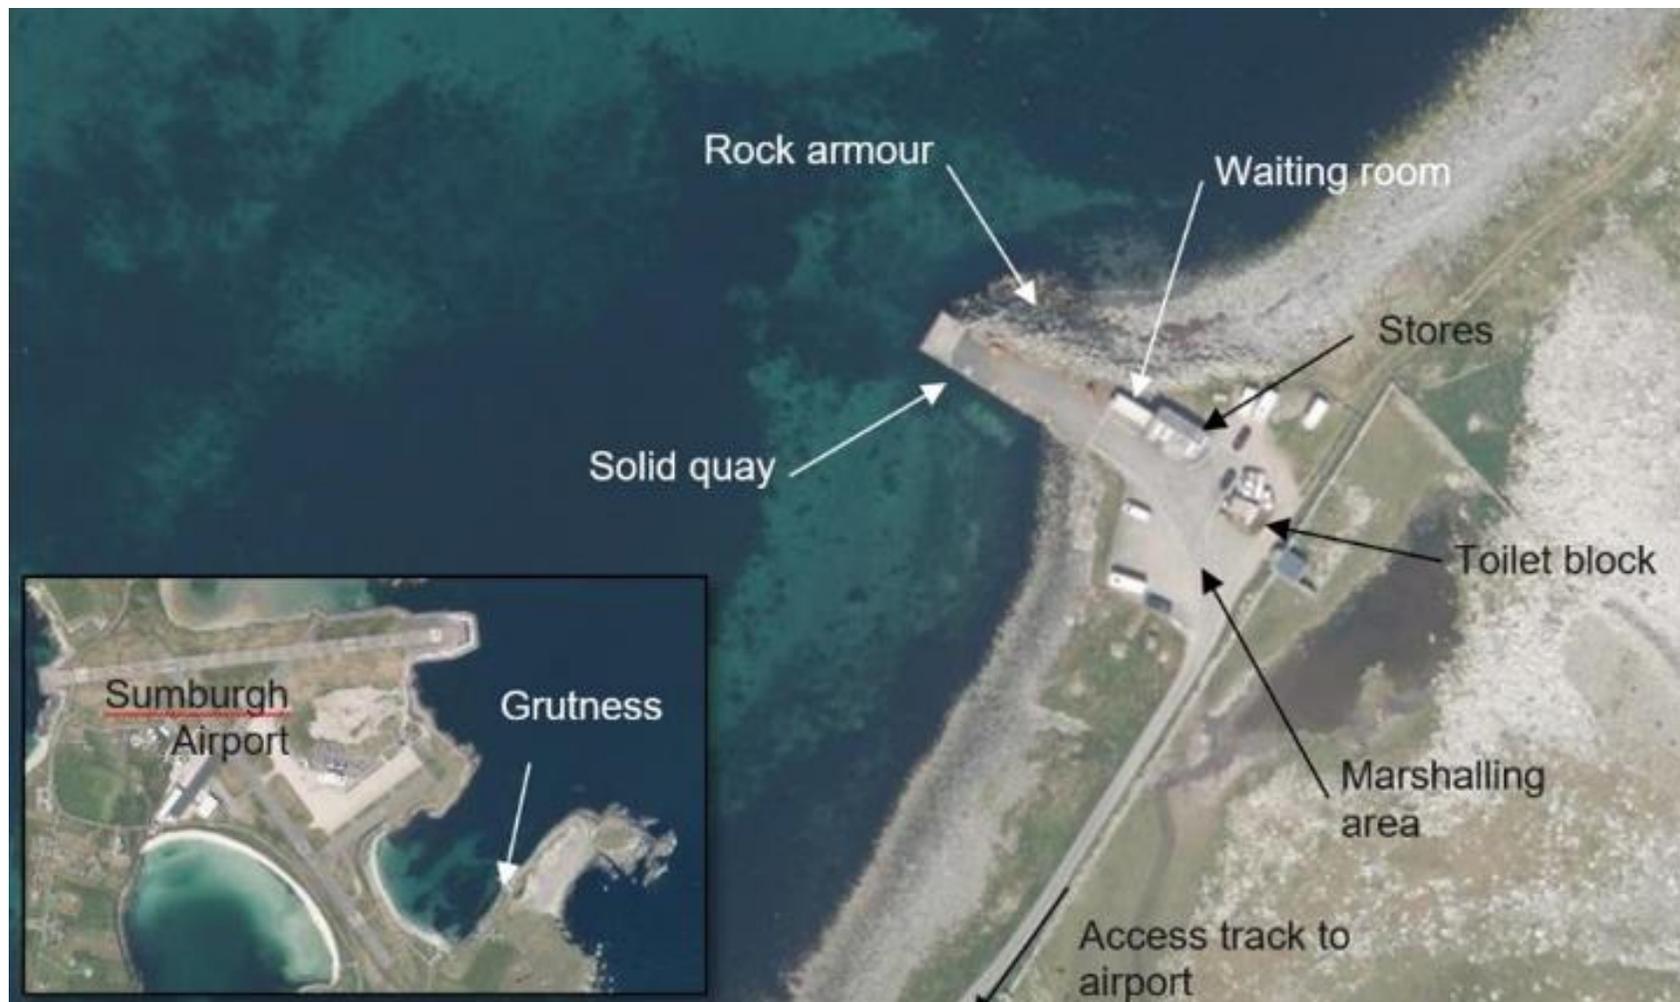
Image 8 – Grutness: Annotated image
