Intended for
Viking Energy Wind Farm LLP

Date
June 2024

Project Number
1620009158

VIKING ENERGY WIND FARM PLANNING MONITORING OFFICER AUDIT REPORT 044: 20TH MAY TO 14TH JUNE 2024

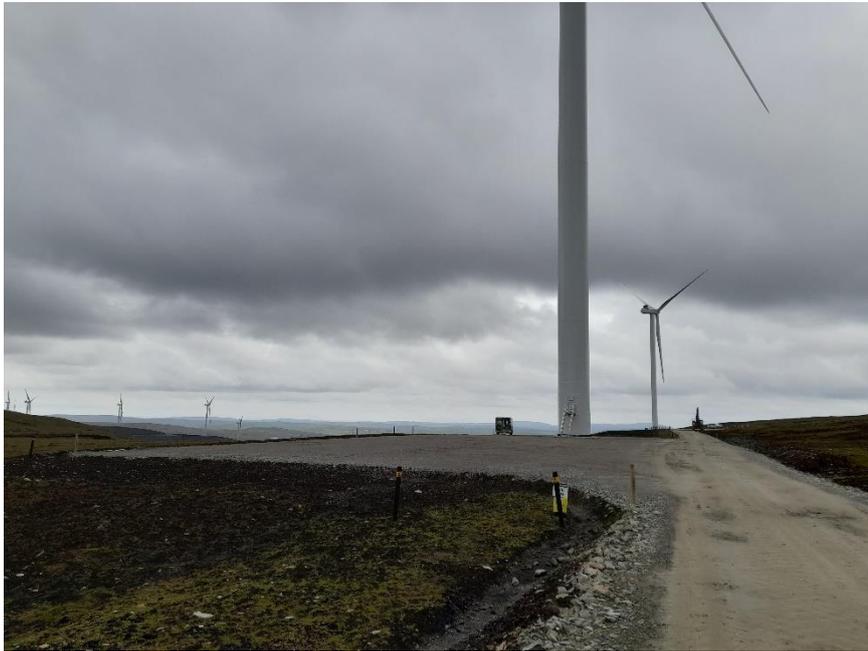
The majority of the works are complete in Kergord. The bases are in good condition (Photo 1) and minimal drainage works were being undertaken at the time of the audit (Photo 2). The final hydroseeding works are set to be undertaken in July..

Photo 1. Completed base at T029

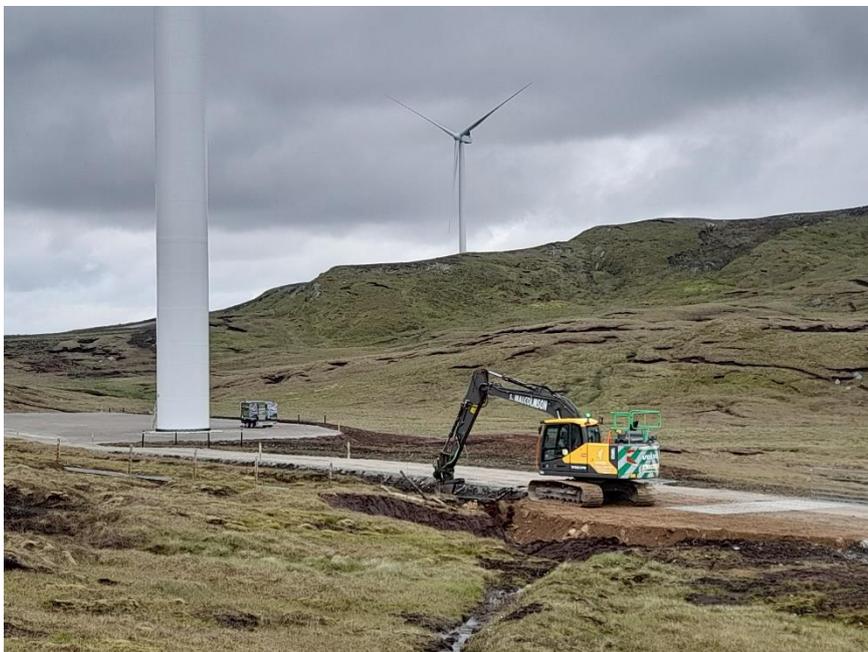
Photo 2. Drainage works near T027

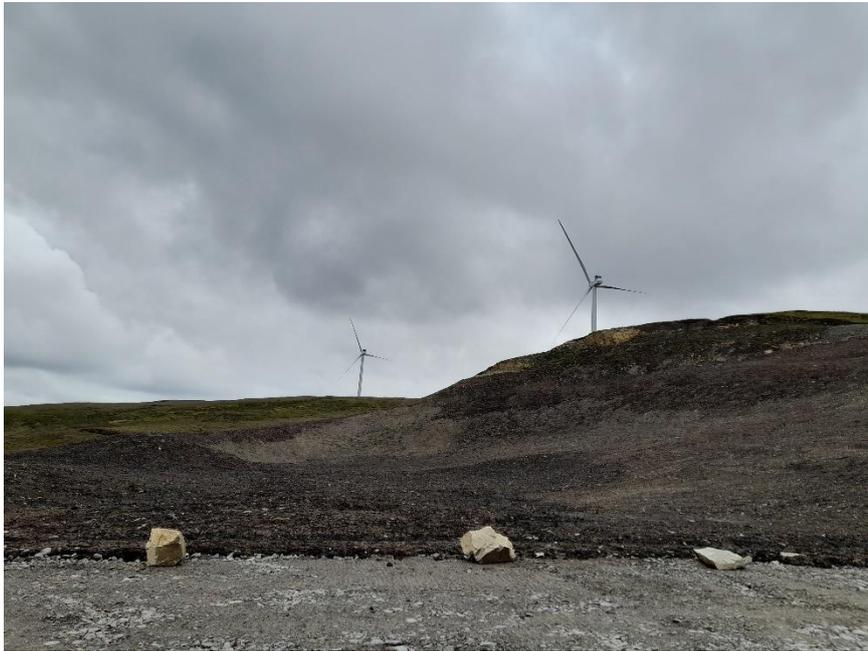
Demobilisation of KBP05 is now complete, and the area has been reinstated (Photo 3). All borrow pits across the site have now been reinstated and it is understood that final review of the borrow pit restoration works is being undertaken by all parties, prior to final agreement that the restoration works have been completed.

Photo 3. KBP05 reinstatement

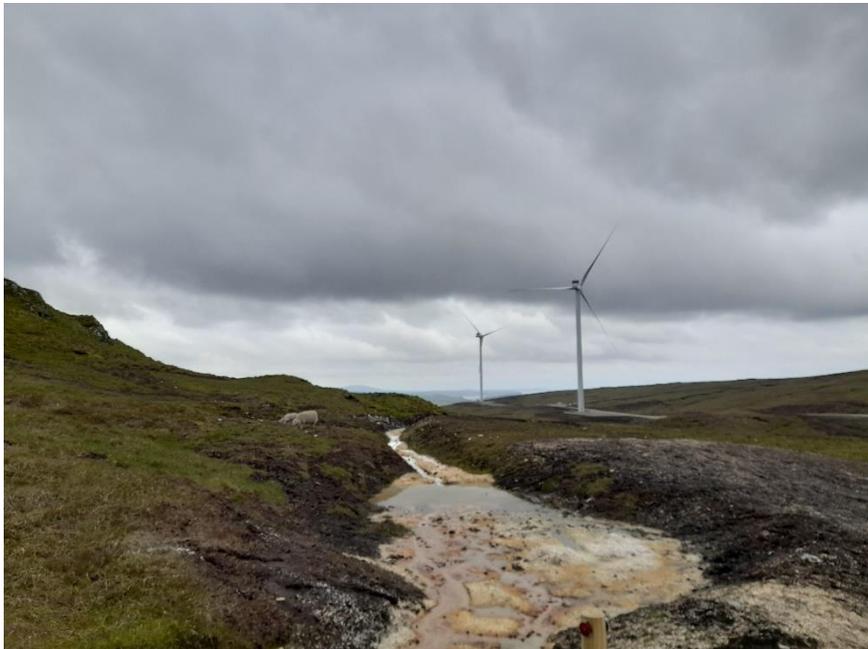
From the end of August, SSER will be taking on the management of the temporary drainage treatment system located downstream of KBP02 (Photo 2). The treatment system will be maintained twice weekly for 6 months, with continued monitoring and sampling. There are initial indications that the water quality is improving and SSER and continuing to explore alternative treatment requirements should deterioration of the water quality continues to be recorded.

Photo 4. Drainage near KBP02

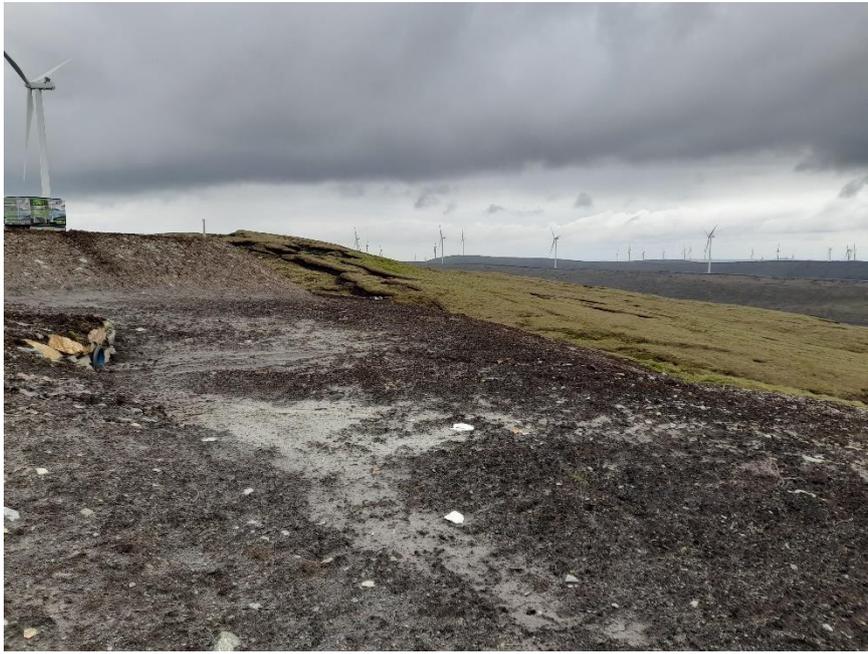
The culvert by T018 discharging directly onto peat as reported in April remains unchanged (Photo 5). This has been flagged to both SSE and RJM, and has been included in the snagging list being worked on by RJM. This should be monitored in the next audit.

Photo 5. Drainage culvert near T018

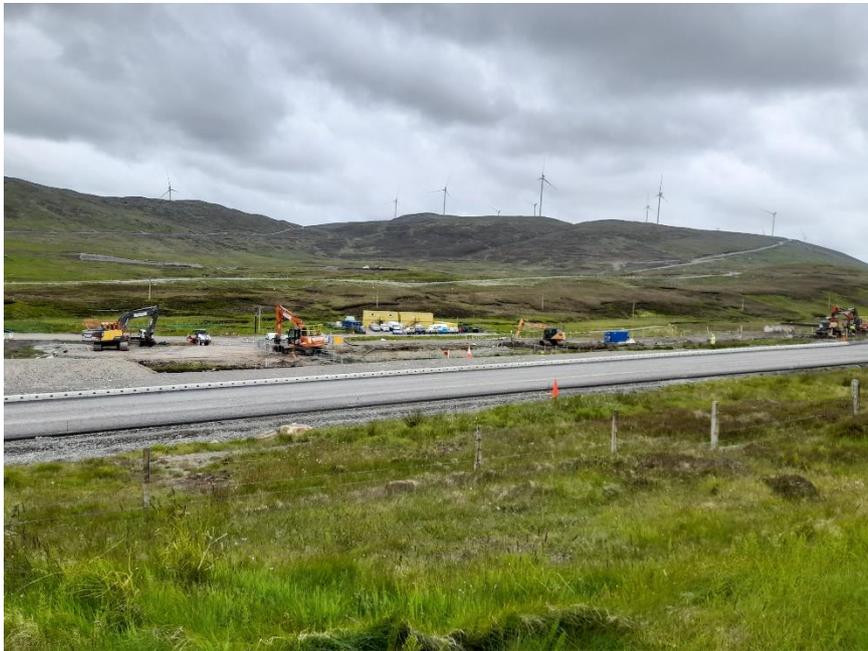
During the visit, the Sandwater track was closed to site vehicles; however, it was observed from the B9075 that some surfacing works had commenced (Photo 6). It is understood that the programme is running slightly behind schedule due to issues at the council's batching depot. The remainder of the track is undergoing final preparations ahead of being covered in tarmac in the coming weeks.

Photo 6. Surfacing laid on the Sandwater Road

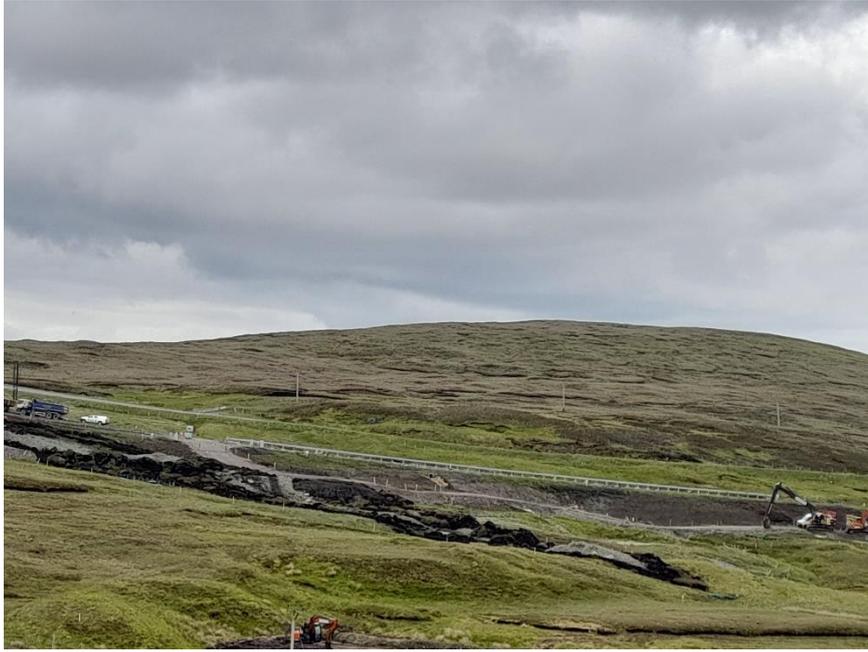
A peat movement event was recorded on the 8th May 2024 on a section of cable track being prepared by SSEN (under CDM transferred to them from RJM). The section of cable track where the event occurred runs parallel with the new Sandwater Road on the shallow downslope approach into Kergord Valley. The PMO understands that SSEN is currently investigating the event and will remediate the area once it is deemed safe. In the meantime, works are not being undertaken in the direct vicinity of the peat movement (Photo 7). The ACoW, ECoW, and GCoW will have the opportunity to comment on the remediation plans drafted by SSEN, once received. All remedial action will be carried out by SSEN and monitored by SSER.

On the day of the audit visit, the area of the peat movement remained untouched; however, works were being undertaken in the vicinity. Mitigation measures have been implemented to prevent any silty washout from migrating to the Weasdale burn, which sits downgradient from the peat movement. The burn has been monitored since the beginning of the project, with two monitoring points downstream of the peat movement. These locations continue to be monitored, and to date have not measured adverse effects caused by the peat movement.

Photo 7. Area of peat movement

The ACoW have confirmed that the final extent of the peat movement does not extend across previously recorded archaeological assets, and this information has been shared with the Shetland Amenity Trust. The ACoW will confirm whether a watching brief will be required during remediation once a remediation plan has been finalised.

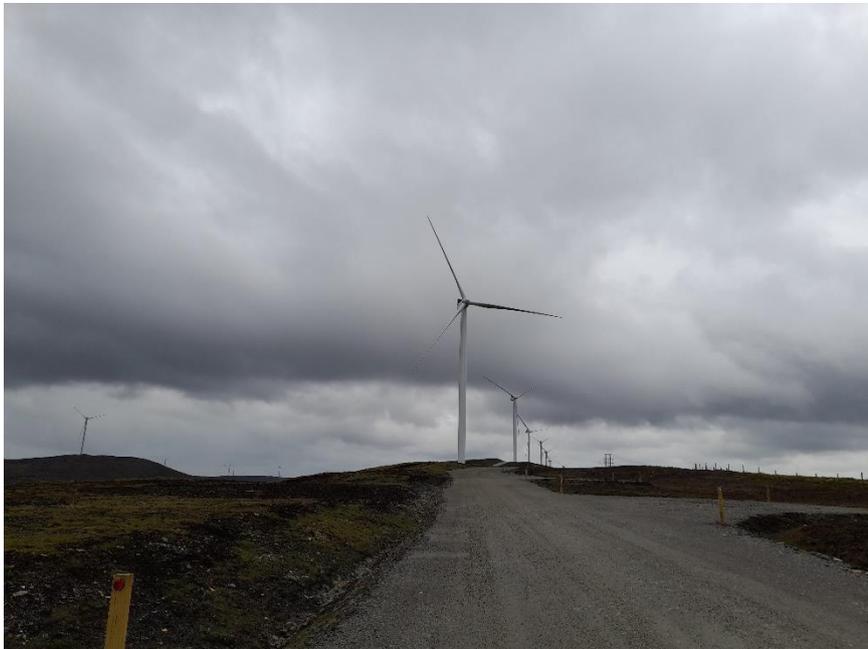
Similarly to Kergord, the turbine / base areas on the Mid Kames Ridge were completed to a good standard (Photo 8). The turbines were undergoing a programme of commissioning and testing at the time of the visit.

Photo 8. Turbines along the Mid Kames Ridge

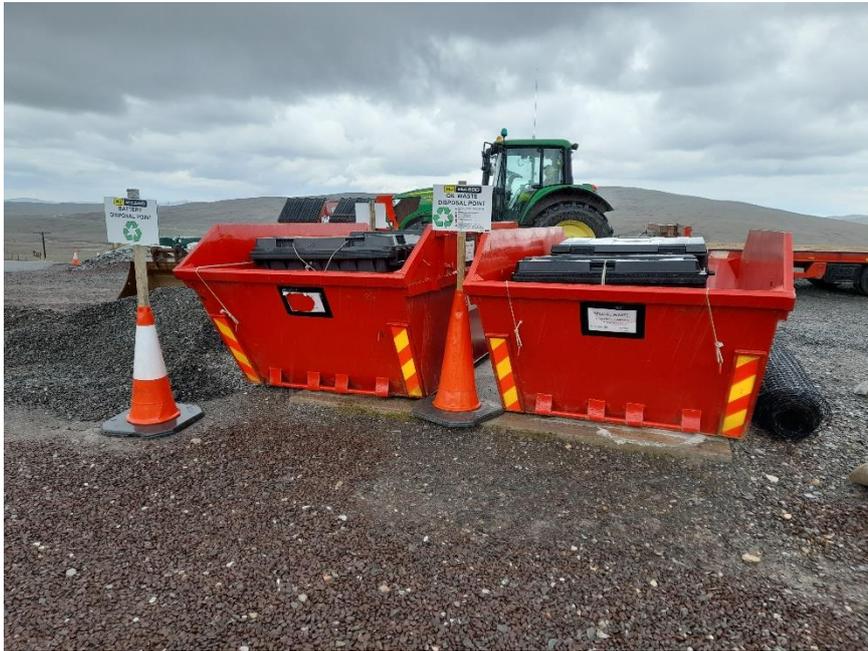
Following the observations noted in the February, March and April audits, the main compound was visited again. It was observed that previously missing signages on waste skips have now been replaced (Photos 10 and 11). The clearing out of the upper level has just begun with some items being moved to the lower level.

Photo 9. Labelled skips in main compound

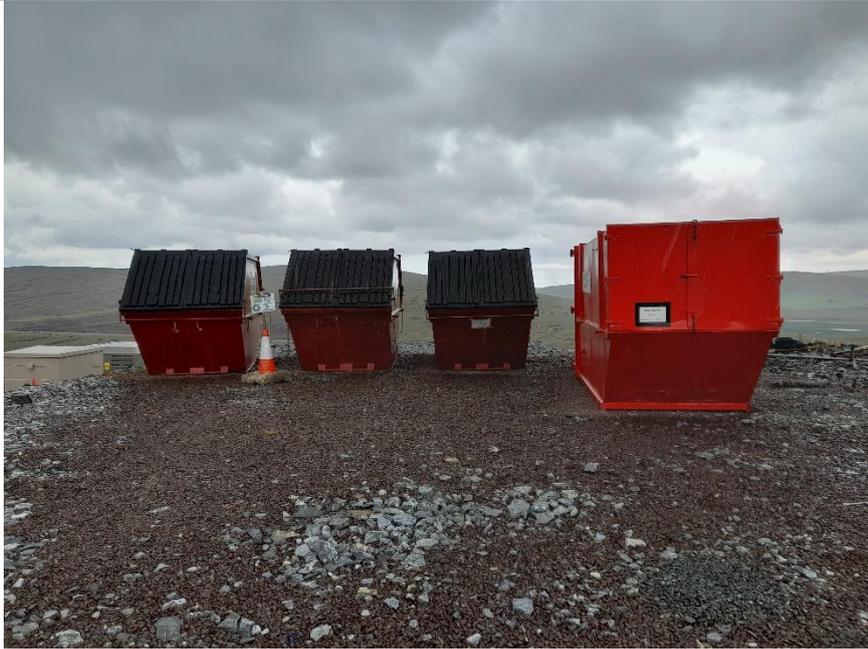
Photo 11. Labelled skips in main compound

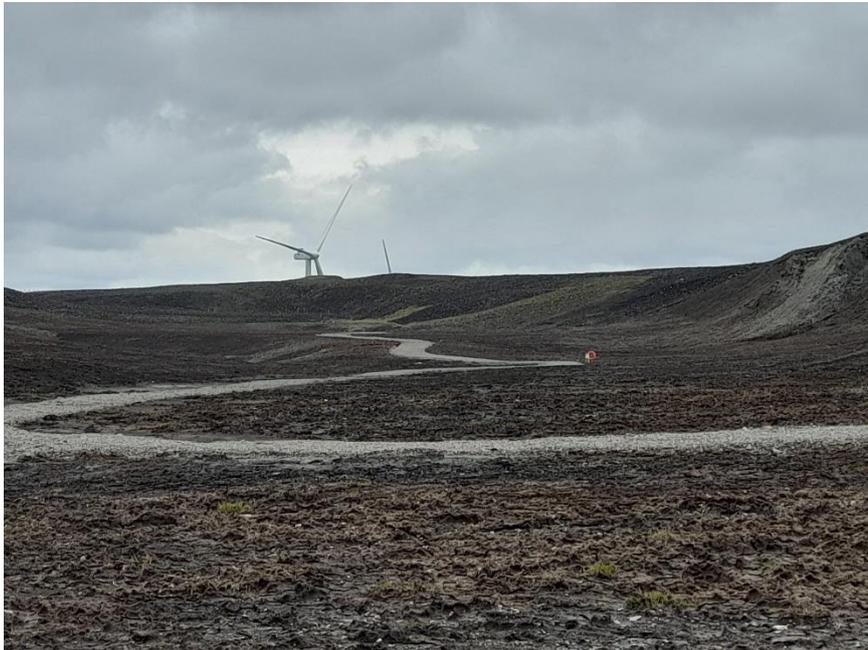
The borrow pit restoration in NBP05 has been made ready to accommodate the planting of the native woodland and installation of permanent drainage features (Photo 12).

Photo 12. NBP05 restoration

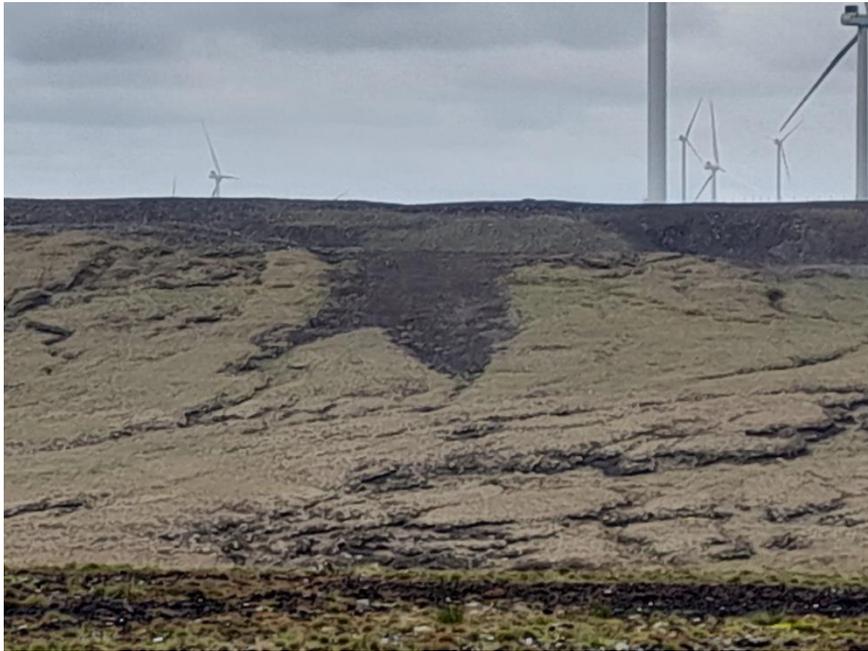
Outstanding works required at geotechnical event GE016 (corresponding to a movement of peat located on the eastern side of NBP05) have been completed (Photo 13).

Photo 13. Geotechnical Event 16 restoration works completed
