Date
August 2024

VIKING ENERGY WIND FARM PLANNING MONITORING OFFICER AUDIT REPORT 046: 20TH JULY TO 18TH AUGUST 2024

Audit Number	PMO 046
Location	Kergord Sandwater Road Nesting North Nesting Main Compound
Weather Conditions	Sunny, windy, dry, 15°C
Audit Date	14 th August 2024
Audit Period	20 th July – 18 th August 2024
Audit Owner	Ramboll UK Ltd

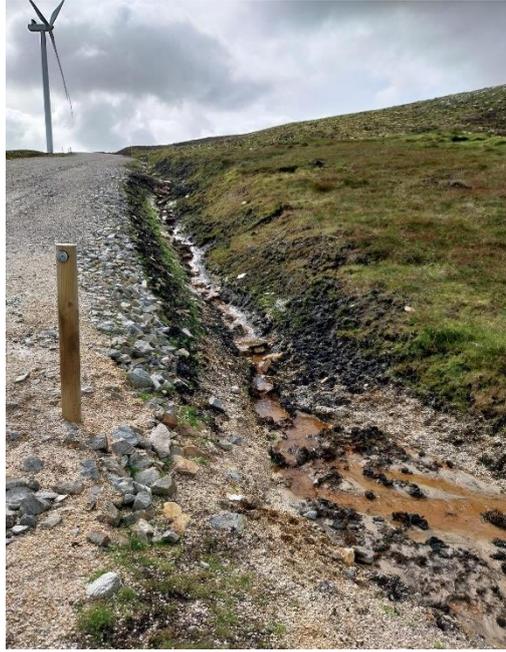
As reported in last month's PMO report, SSER has taken on the management of the temporary drainage treatment system located downstream of KBP02 (Photo 1). The system will be maintained twice weekly for 6 months, with continued monitoring and sampling. The water quality is improving though some variability exists depending on rainfall. Alternative treatment solutions requiring less intensive maintenance will be considered if required following the 6-month period.

Photo 1. Drainage near KBP02

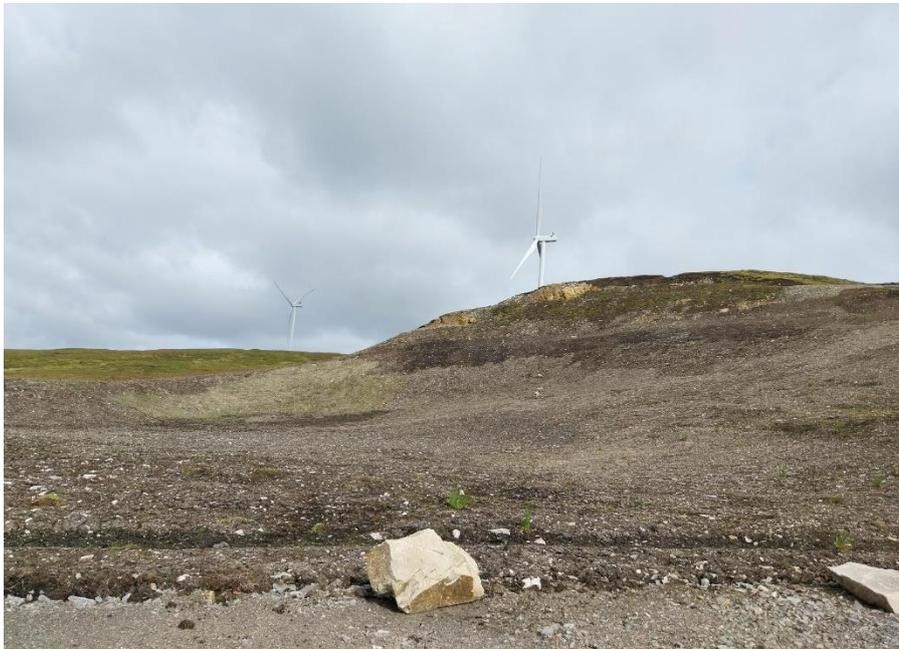
During the visit, hydroseeding is ongoing with KBP05 and KBP03 both on the schedule but yet to be hydroseeded. Both are expected to be hydroseeded before the next PMO visit. Some natural vegetation growth was observed on the edge of KBP05 (Photo 2).

Photo 2. Natural vegetation growth at KBP05

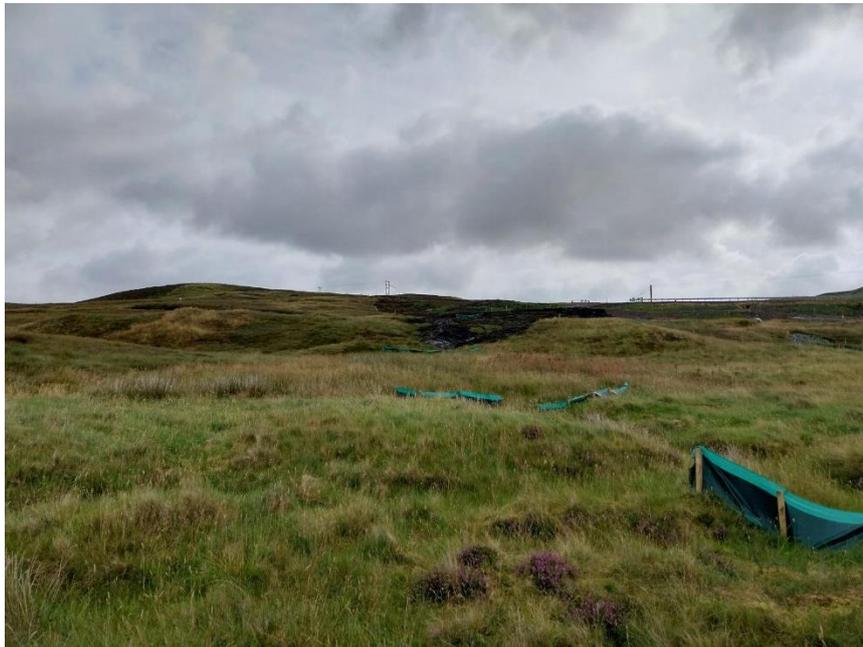
A peat movement event was recorded on the 8th May 2024 on a section of cable track being prepared by SSE Networks (SSEN) under CDM transferred to them from RJM. The section of the cable track where the event occurred runs parallel with the new Sandwater Road on the shallow downslope approach into Kergord Valley. The remedial works are being undertaken by SSEN and monitored by SSER. The area has been largely re-turfed (Photo 3) with seeding plans to be confirmed. Mitigation measures implemented to prevent any silty washout from migrating to the Weasdale burn which sits downgradient from the peat movement are still in place. The two monitoring points downstream of the peat movement continue to be monitored, with no reported adverse effect on the water quality from the peat movement or on-going remedial works.

Photo 3. Area of peat movement

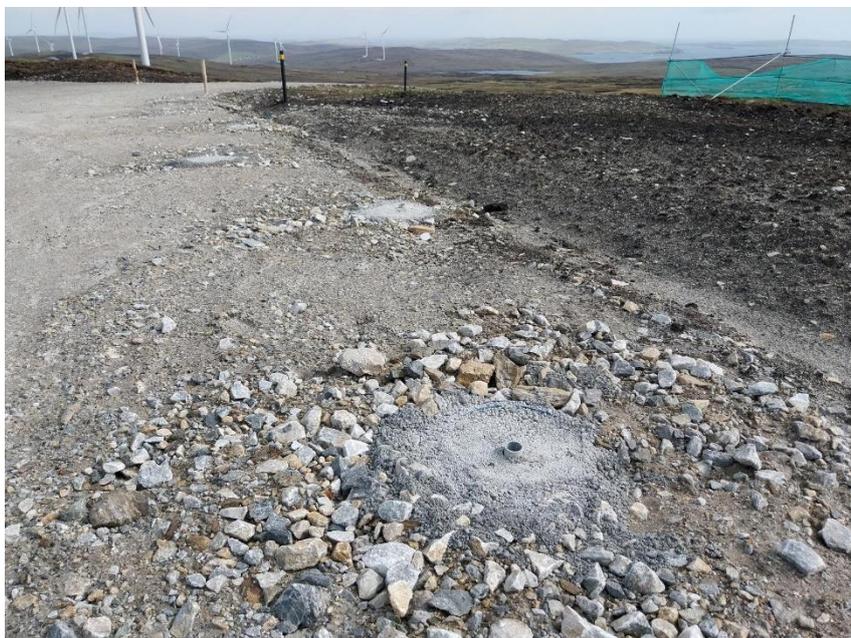
In preparation for operation, permanent bird screens are being installed in all five locations where temporary bird screens had been placed during previous breeding bird seasons. During the visit, foundations for the permanent bird screen were observed at T062 (Photo 4). The temporary bird screens will remain in place until the permanent bird screens are complete (Photo 5). Where breeding birds are still active, construction of permanent bird screens will begin following confirmation that breeding activities have ceased for the season.

Photo 4. Foundation for permanent bird screen by T062

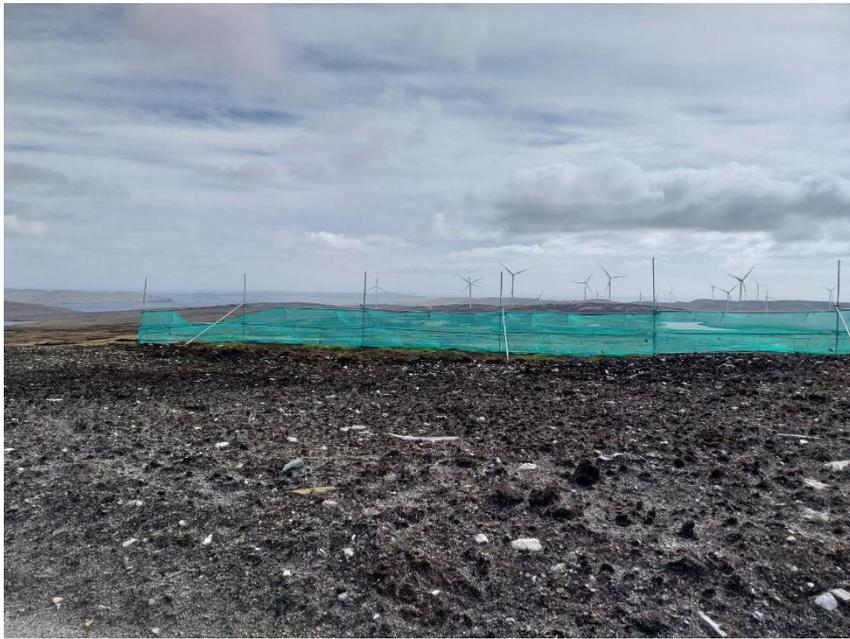
Photo 5. Temporary bird screen by T062

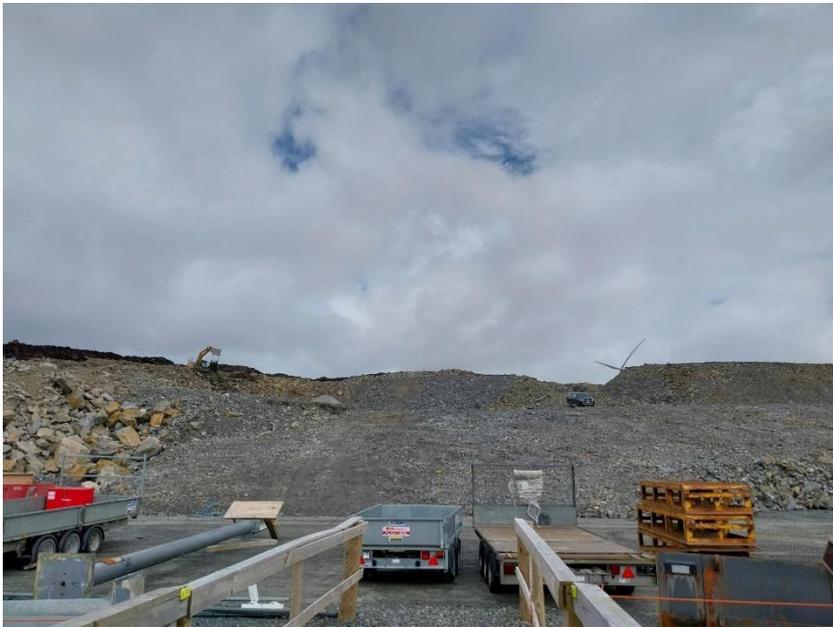
The upper main compound could not be accessed during the site visit due to reinstatement works being on-going at the time. However good progress was observed from a distance (Photo 6). The lower main compound was observed to be in good order with the ongoing clearing out of site offices.

Photo 6. Ongoing reinstatement works at upper main compound

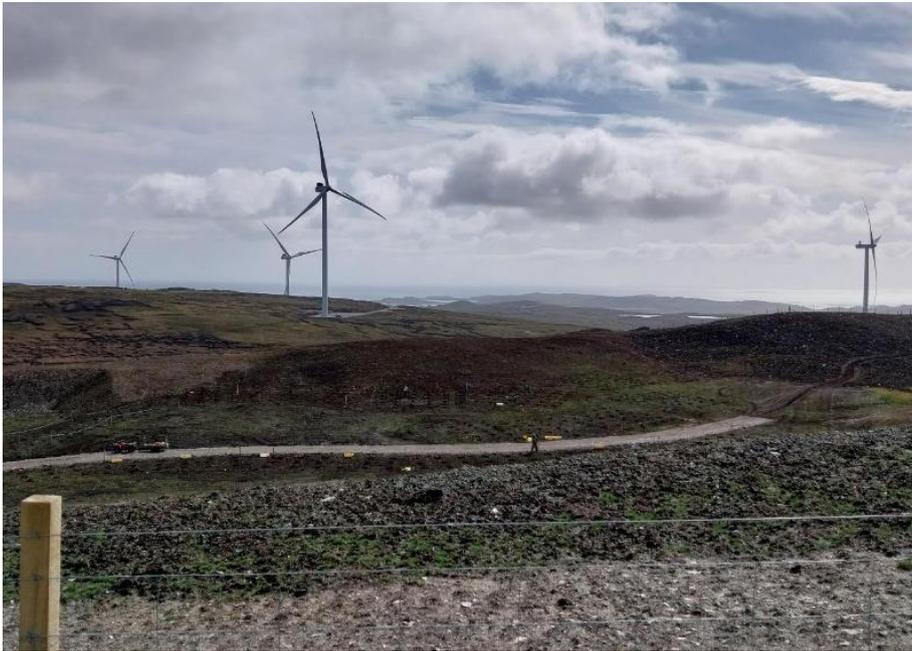
During the visit, planting was observed at the south of NBP05 (Photo 7), and preparation work at the north of NBP05 (Photo 8). The permanent drainage system is in place with on-going review of the localised water flow to maintain a conducive water table in the area. This should be queried and monitored in the next PMO audit.

Photo 7. Native woodland planting at NBP05

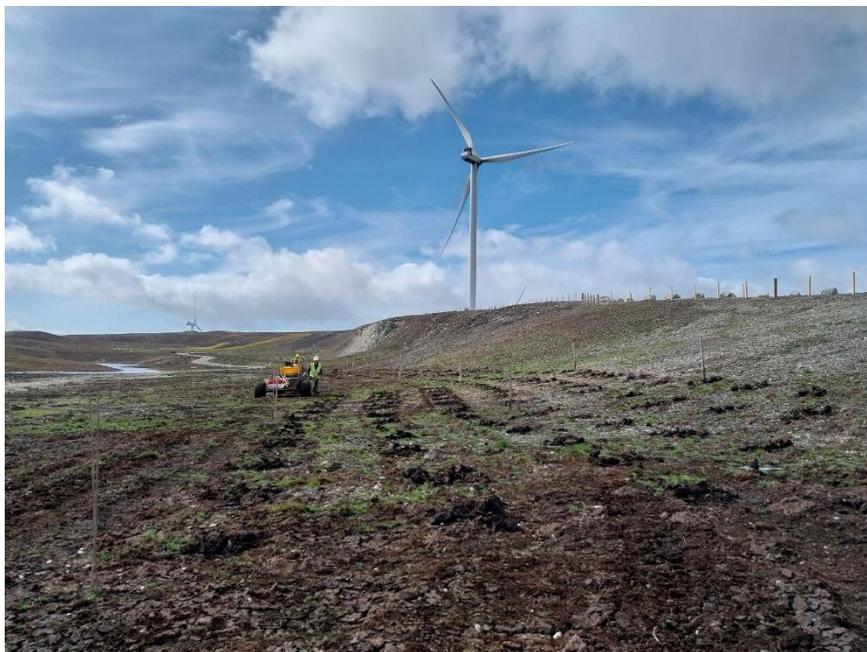
Photo 8. Preparation work for native woodland planting at NBP05

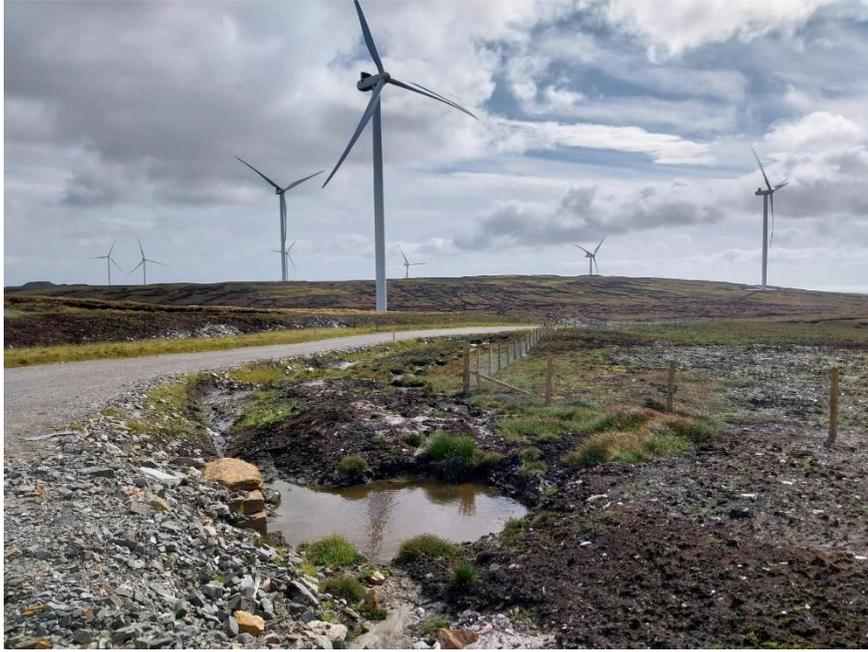
As observed during the visit, drainage at T076 continues to be effective (Photo 9). Removal of the secondary additional mitigation drains has been scheduled as part of the snagging works and should be observed for updates during the next audit.

Photo 9. Drainage at T076

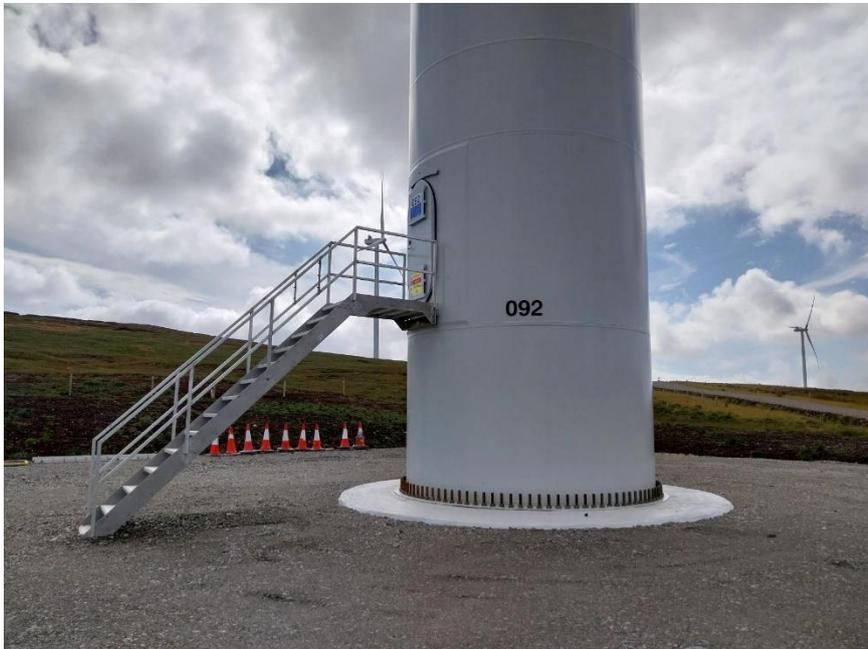
A temporary hybrid generator located next to T092 caught fire on 29th December 2024, as discussed in previous reports. The area was visited during the audit visit, and reinstatement works were observed to have been completed (Photo 10).

Photo 10. Reinstated T092

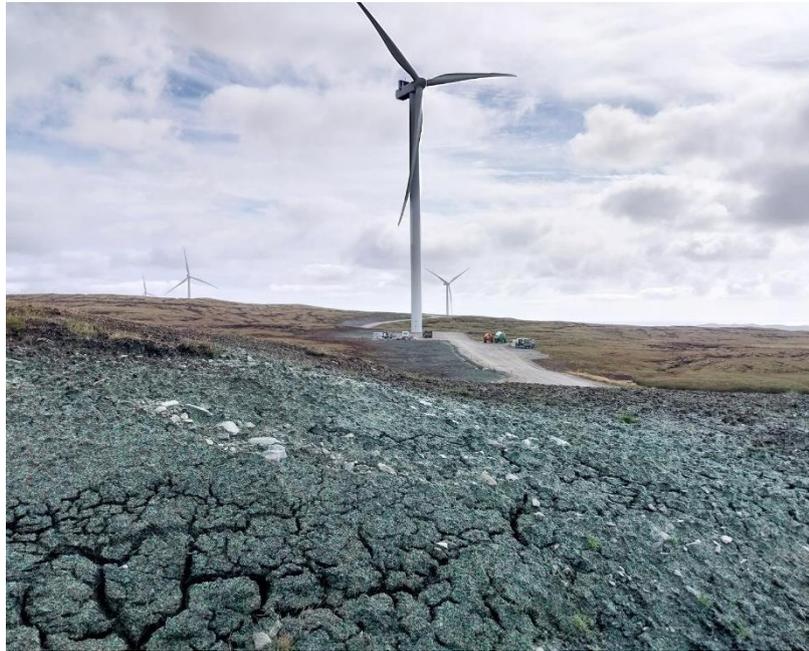
Hydroseeding activity was observed during the PMO visit in the Nesting area. Newly completed hydroseeding was observed at J21 (Photo 11), in continuity with hydroseeding completed during previous season at J22 (Photo 12).

Photo 11. Hydroseeding at J21

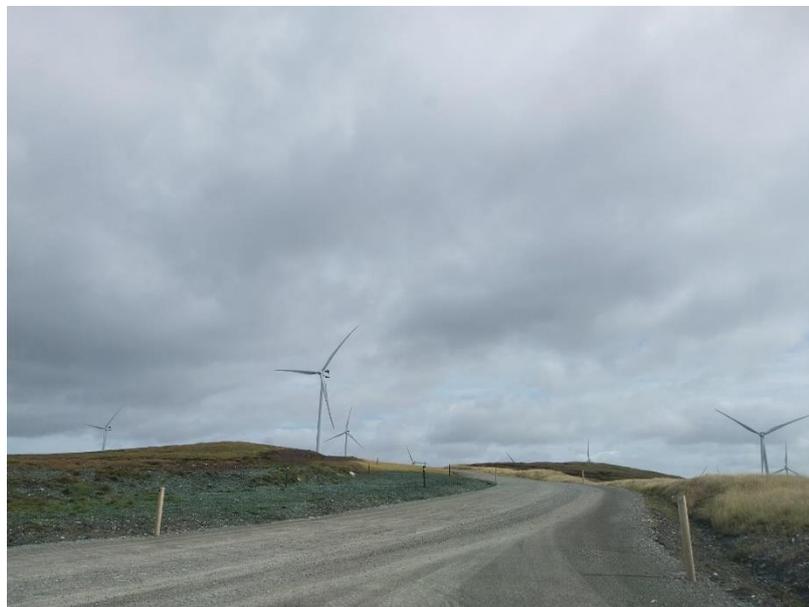
Photo 12. New hydroseeding at J22 connecting with hydroseeding from last year

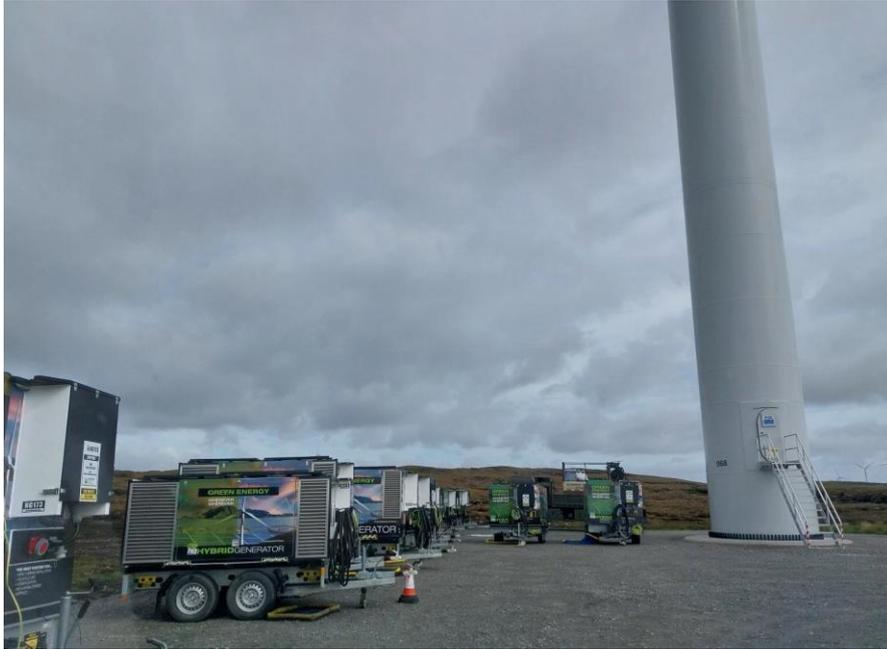
With most of the turbines being operational and no longer in 'preservation' mode, temporary hybrid generators are no longer required. T068 and T071 hardstands have been used as temporary storage area for the generators before they can be transported off-site. Good practice with the use of plant nappies under generators was observed (Photo 13). T068 is also being used as temporary storage area while the upper level of the Main Compound is under reinstatement.

Photo 13. Storage of temporary generator to be removed at T068

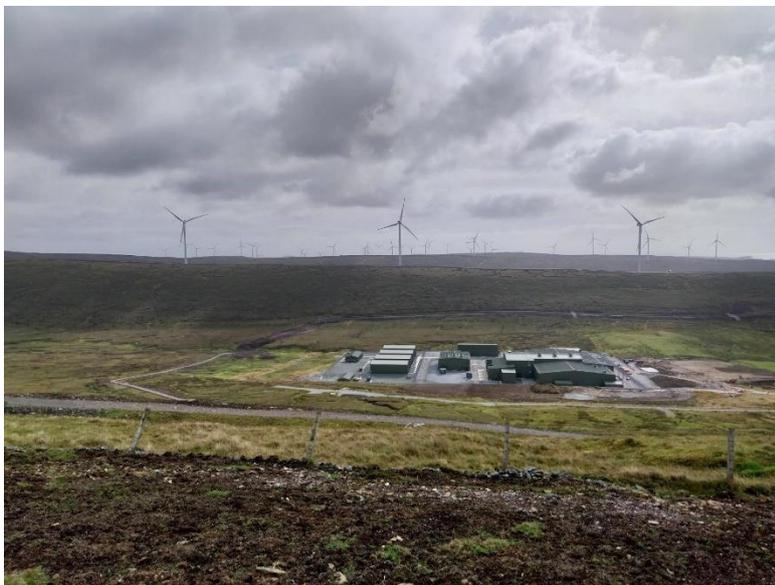
The substation was not observed during the site visit. However, the substation was observed from the KAT and noted all temporary generators have been removed (Photo 14). The substation has been handed over to operations and no longer needs to be visited during PMO audits.

Photo 14. View towards substation
