Date
September 2024

Project Number
1620009158

VIKING ENERGY WIND FARM PLANNING MONITORING OFFICER AUDIT REPORT 047: 19TH AUGUST TO 25TH SEPTEMBER 2024

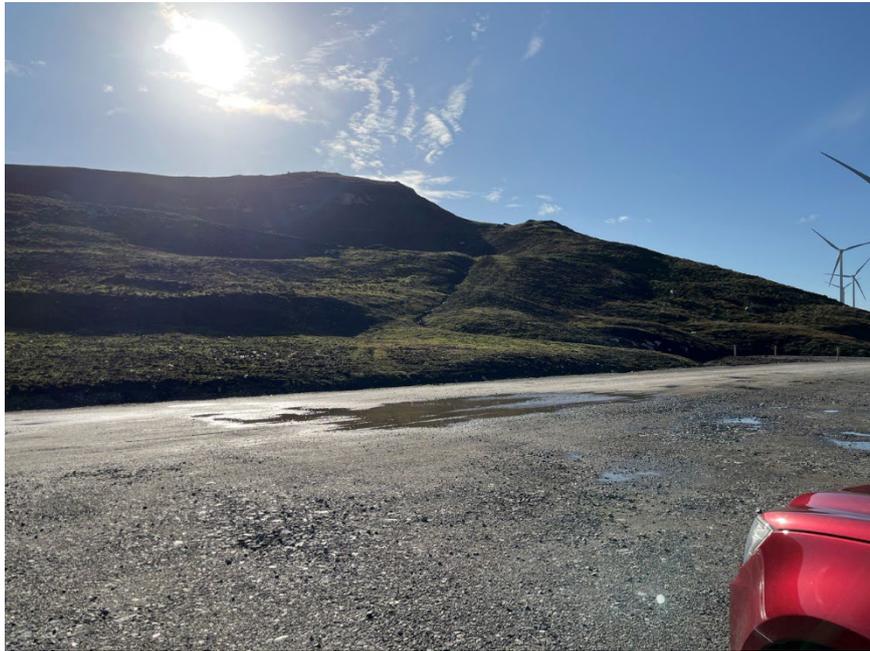
The borrow pit reinstatement profiles were noted to be in keeping the general landscape character and local topography (photo 1, Photo 2).

Photo 1. Borrow pit reinstatement KBP03

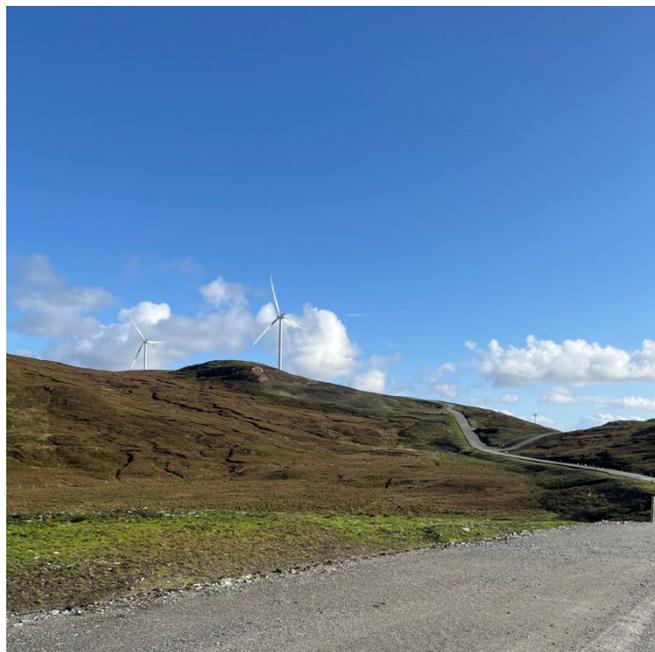
Photo 2. Borrow pit reinstatement KBP05

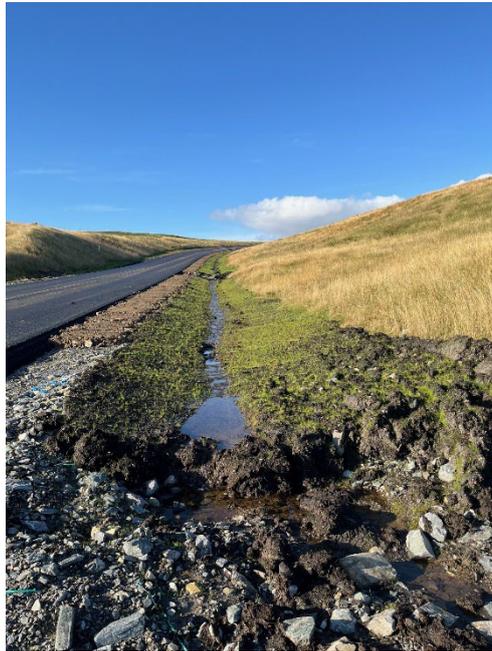
During the visit, it was noted that the asphalt/bitmac surface has now been completed on the Sandwater track. Work to provide a permanent surface water drainage solution for drainage in the Burn of Pettawater catchment was ongoing at the time of the audit. A road-side swale (photo 3) adjacent to the road will be directed into a permanent attenuation pond (photo 4) on the north

Photo 3. Sandwater Road - Swale

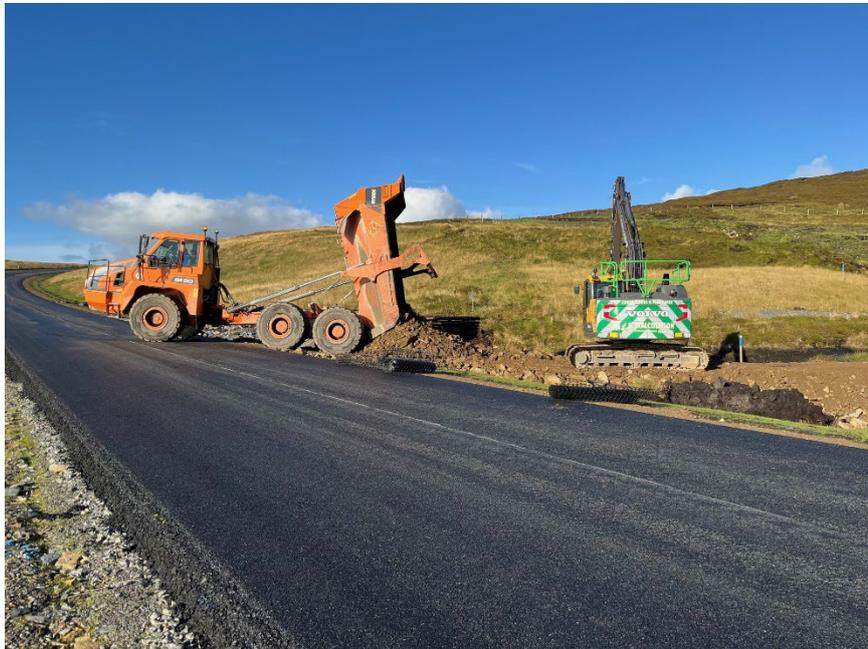
side of the road at Petta Dale. Work to dress the edges of the road are ongoing. Liaison with SIC to agree the 'stopping up' of the old Sandwater road is ongoing.

Photo 4. Sandwater Road – Attenuation Pond under construction(Petta Dale)

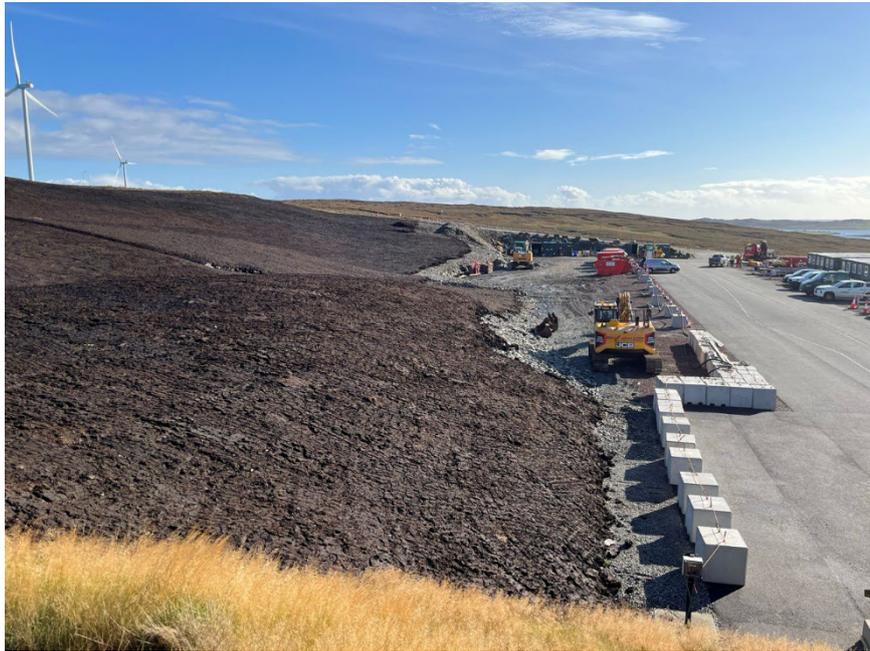
The Main Compound is located at the southern extent of the site, accessed from the A970. The lower level comprises car parking and site offices and welfare facilities. The upper level has now been reinstated (photo 5) and is awaiting seeding.

Photo 5. Main Compound – reinstatement progress

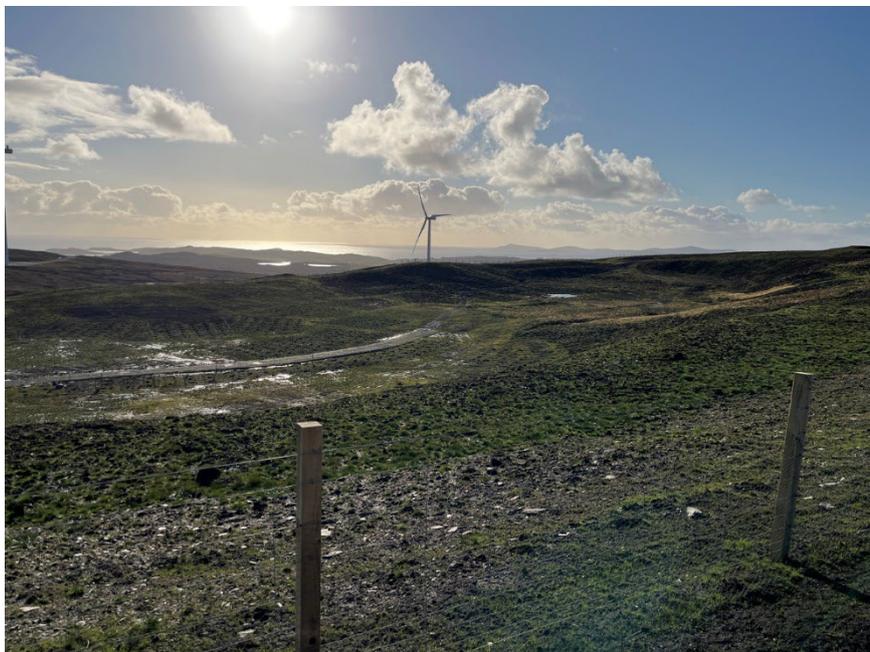
Activities observed in this area during the audit included turbine maintenance and mulching work in the areas of tree planting in NBP05 (photo 6).

The planting of the native woodland at NBP05 was noted to be completed with approximately 8000 saplings planted. Work to mulch around the saplings was ongoing at the time of the audit

Surface water was noted to be high in NBP05 and flooding over the footpath. It is understood that additional stone is to be added to the path to raise the level above the water table.

Photo 6. NBP05 planting/ landscaping progress
