Intended for
Viking Energy Wind Farm LLP

Date
November 2024

Project Number
1620009158

VIKING ENERGY WIND FARM PLANNING MONITORING OFFICER AUDIT REPORT 048: 26TH SEPTEMBER TO 27TH NOVEMBER 2024

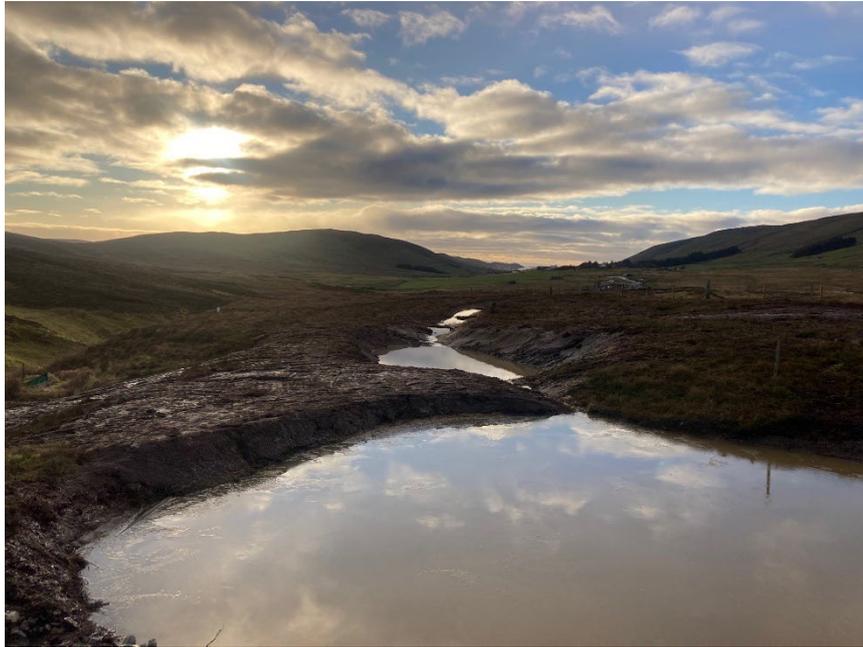
The new design for permanent surface water management to provide attenuation and treatment of surface water draining to the Burn of Droswell from the KAT has been completed (photo 1). The water present in the ponds appeared very silty (photo 2), SSER indicated that this is likely due to the fact that works have been recently completed. It is recommended that this area is being monitored by site personnel to ensure that the drainage system is working properly. This area should be visited during future PMO audits.

Photo 1. Permanent surface water management at the Burn of Droswell

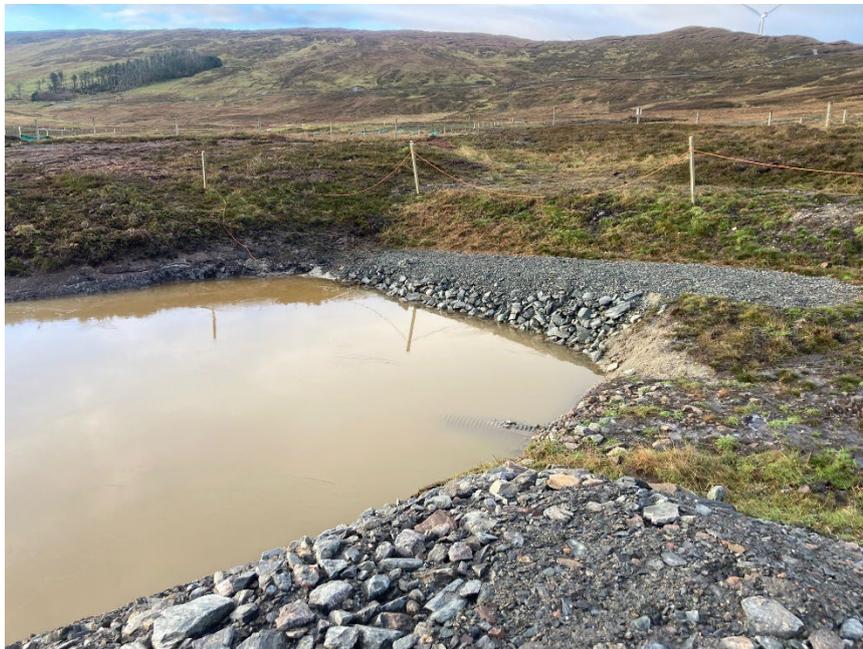
Photo 2. Permanent surface water management at the Burn of Droswell

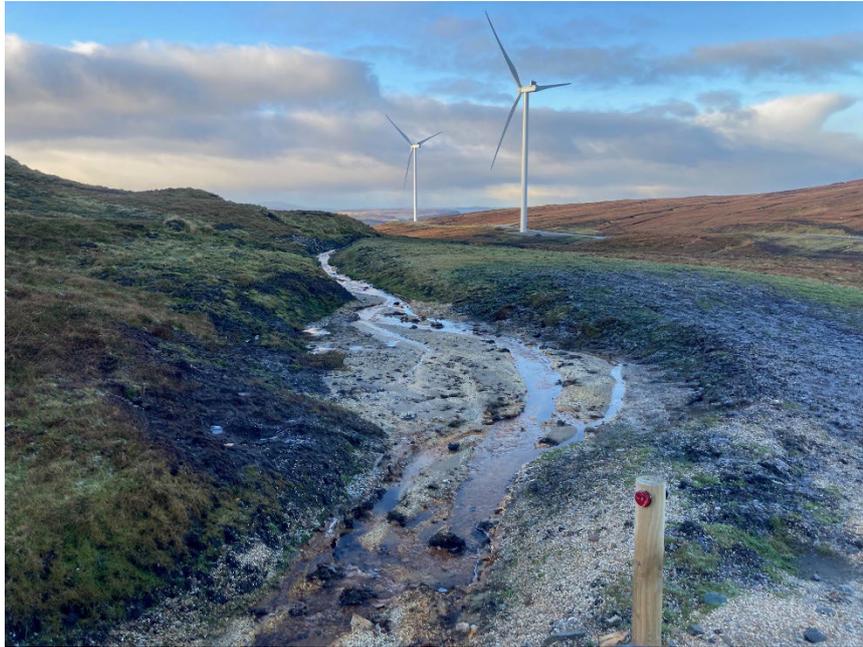
The PMO audit included inspection of the temporary drainage treatment at KBP02 (photo 3). It is understood that SSER have taken on the monitoring and maintenance of the treatment system, with continued water monitoring and sampling. Further data is required in order to confirm the acceptability of water quality or the need for additional interventions. Based on the additional data, a reassessment of stream condition will take place early 2025. This area should be visited during future PMO audits.

Photo 3. Temporary drainage treatment at KBP02

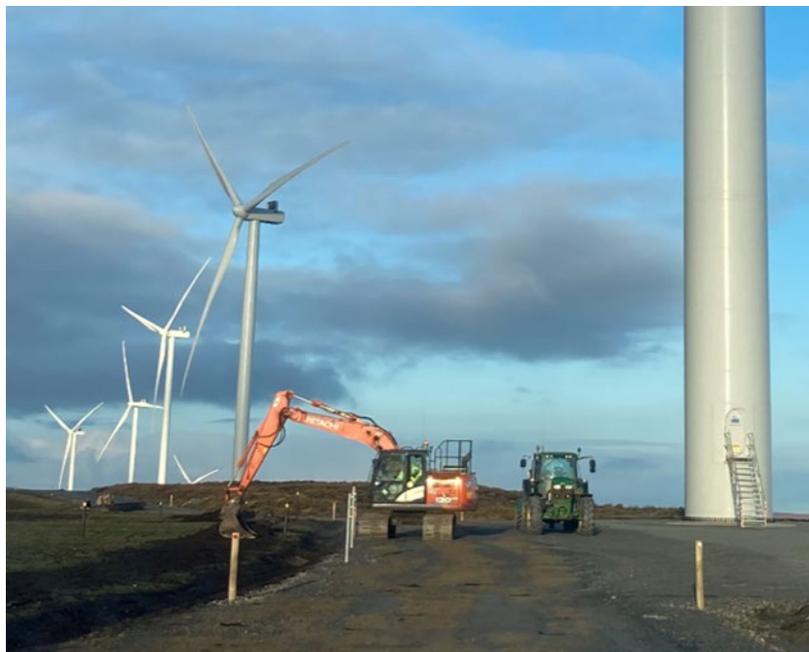
Along MKR, the track and drains appeared in good condition generally. Some works was on-going along the track (photo 6), consisting of placement of peat to tidy up the drainage along the track as part of the snagging phase.

Photo 4. Works along the track on MKR

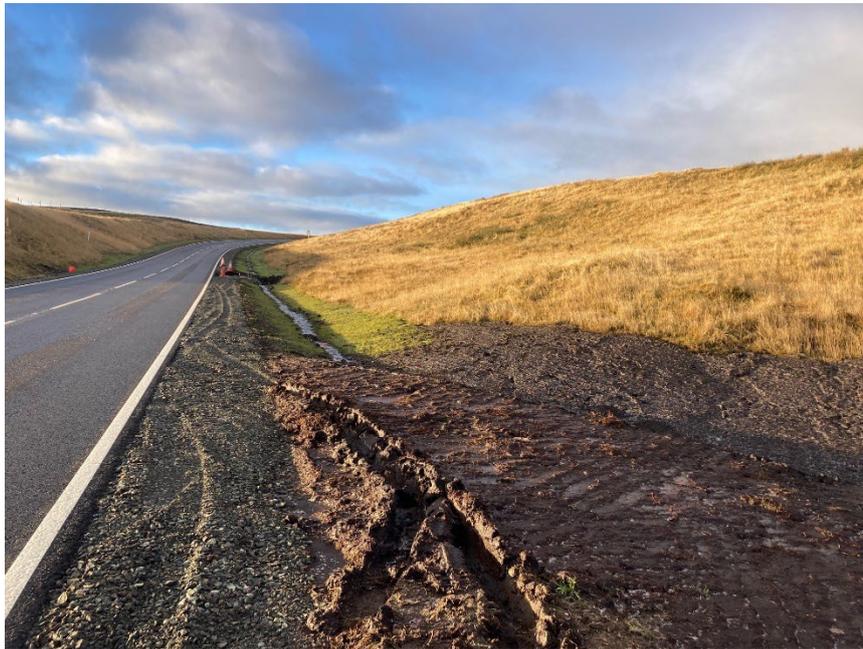
Along the Sandwater track, the works to provide a permanent surface water drainage solution for drainage in the Burn of Pettawater catchment were noted to have been completed. The road-side swale adjacent to the road has been directed into a permanent attenuation pond which has been recently completed on the north side of the road at Petta Dale (photo 7, 8). Works to dress the edges of the road appeared as near complete, with only fencing still to be undertaken (photo 9). Liaison between SSER and SIC to agree the 'stopping up' of the old Sandwater road is ongoing.

Photo 5. Sandwater Road – Swale (Petta Dale)

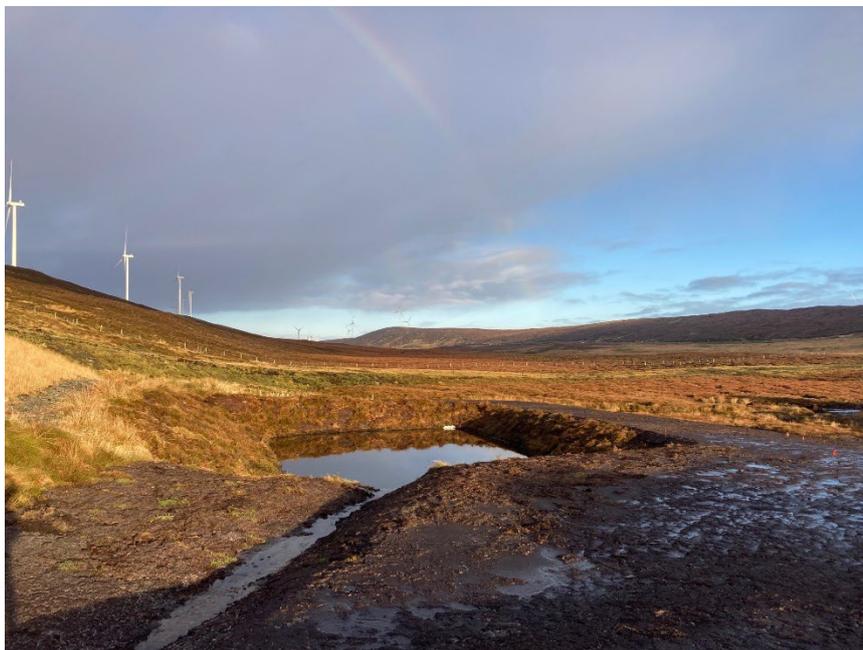
Photo 6. Sandwater Road – completed attenuation pond (Petta Dale)

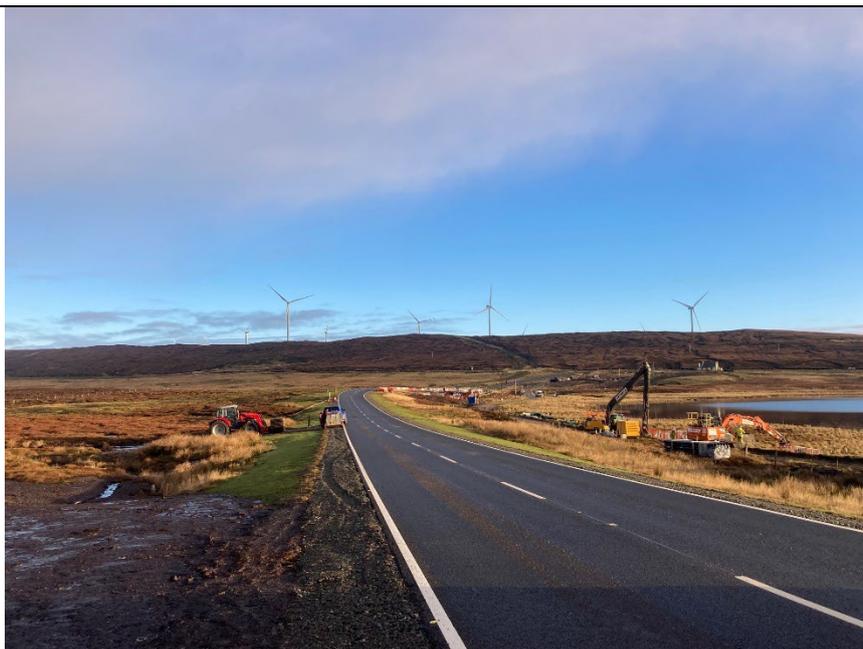
All wind turbine generators (WTGs) are now commissioned and operational. The majority of civil engineering work is now complete, with localised activities ongoing to deliver reinstatement work, e.g. reinstatement of the main compound. The new Sandwater Road has been surfaced with a permanent bitmac/asphalt running surface, with works to dress the edges of the road nearing completion.

Photo 7. Sandwater Road – road edges completed

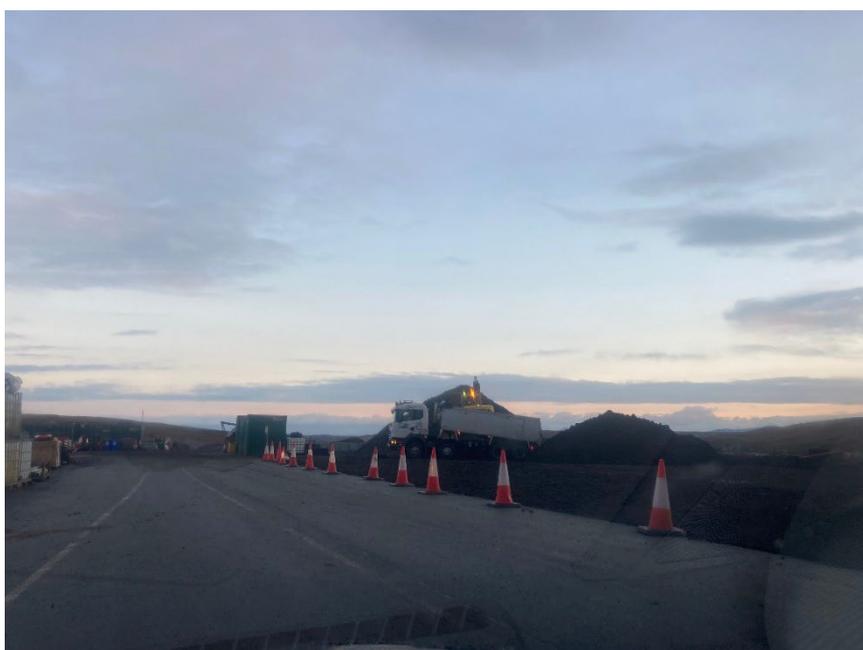
The Main Compound is located at the southern extent of the site, accessed from the A970. The lower level comprises car parking, site offices and welfare facilities, material and equipment laydown, and stockpiled material. The upper level has been reinstated and is awaiting seeding. Activities at the lower level compound, now main and only level, comprised the loading of concrete weight blocks onto a lorry, and loading of stockpiled material onto a tipper wagon (photo 10).

Photo 8. Loading of stockpiled material onto a tipper wagon at the main compound

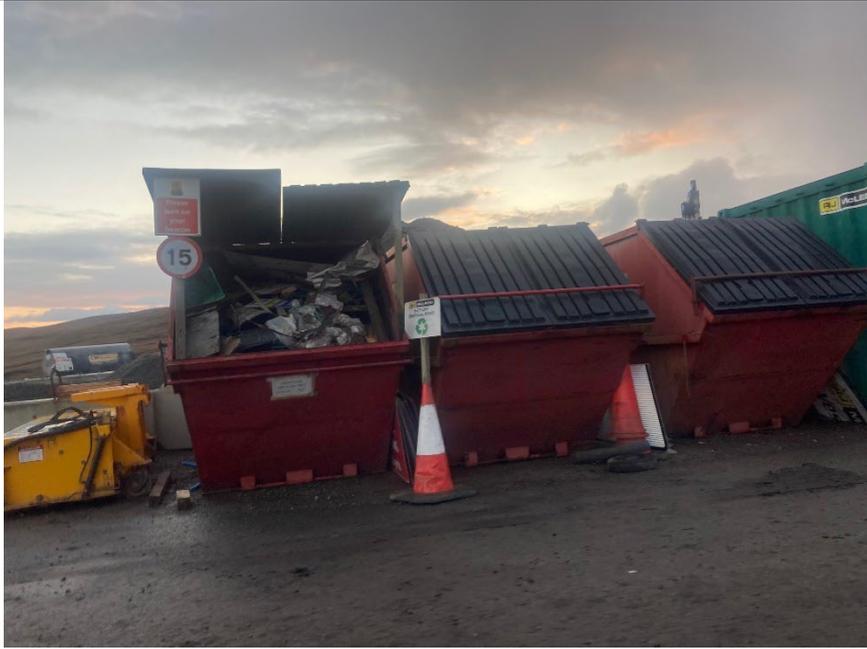
The main compound was observed to be in good order with the ongoing clearing out of site offices. Waste segregation was inspected and noted that it could benefit from improvement, with

the absence of signage for two skips present onsite, and incorrect signage for the third skip (photo 11). This was reported to SSER to be addressed by site personnel. General level of tidiness appeared satisfactory. This area should be visited during future PMO audits.

Materials Storage and Handling (e.g. oil/fuel storage and peat/mineral soil storage and handling).	Work was ongoing at the time of the audit to clear out stockpiled material and storage areas. Skip signage was observed to be absent for two skips present onsite, and incorrect signage for the third skip.	Improve waste management	N/A	Amber
Natural and Built Environment (e.g. ecology, biosecurity, protected sites, archaeology and site restoration).	Ecological constraints identified by the ECoW team are communicated to the Principal Contractor and Developer to allow mitigation measures to be implemented. The ECoW construction phase duties are now complete,	No action required.	N/A	Green

Photo 9. Main Compound – skips

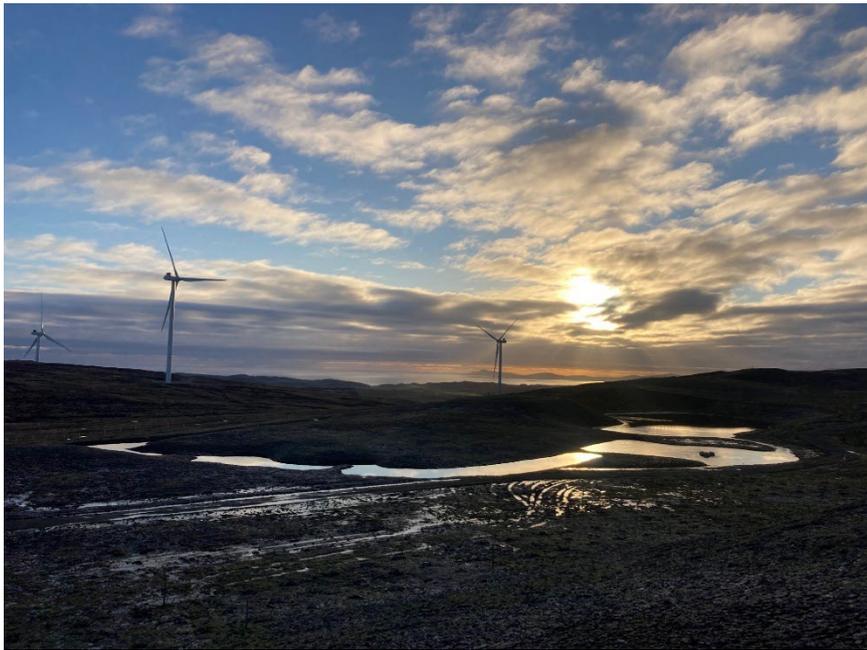
NBP05 was observed to be in general good condition during the audit visit, with some drainage remediation having taken place, with the creation of a ditch to the west of the footpath to deal with water ponding on the path (photo 12). The ground to the east the footpath and on the lower slopes appeared water logged (photo 13). Successful establishment of seeds was observed on the upper sections of NBP05 (photo 14).

Photo 10. NBP05- drainage

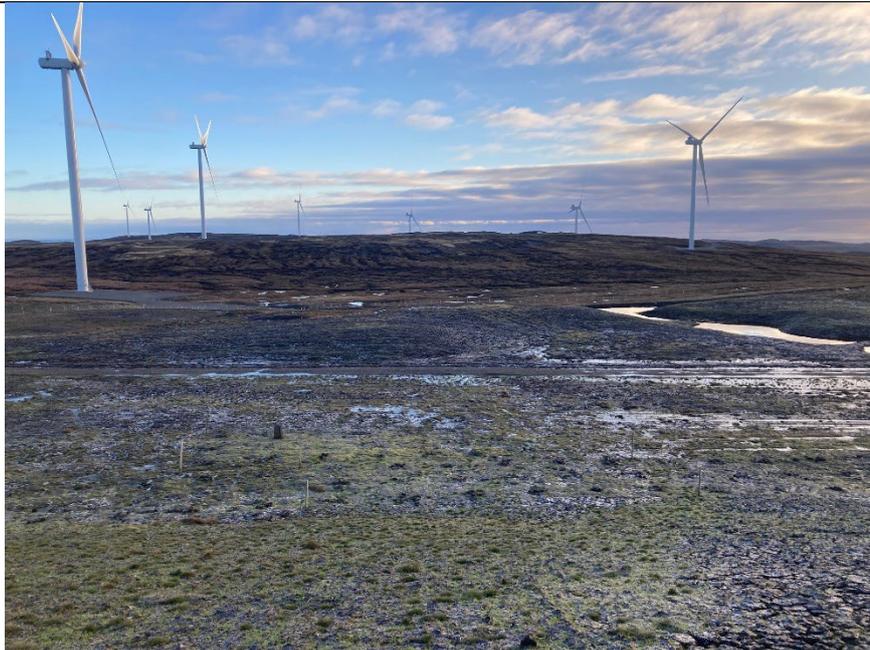
Photo 11. NBP05- waterlogged area west of the footpath

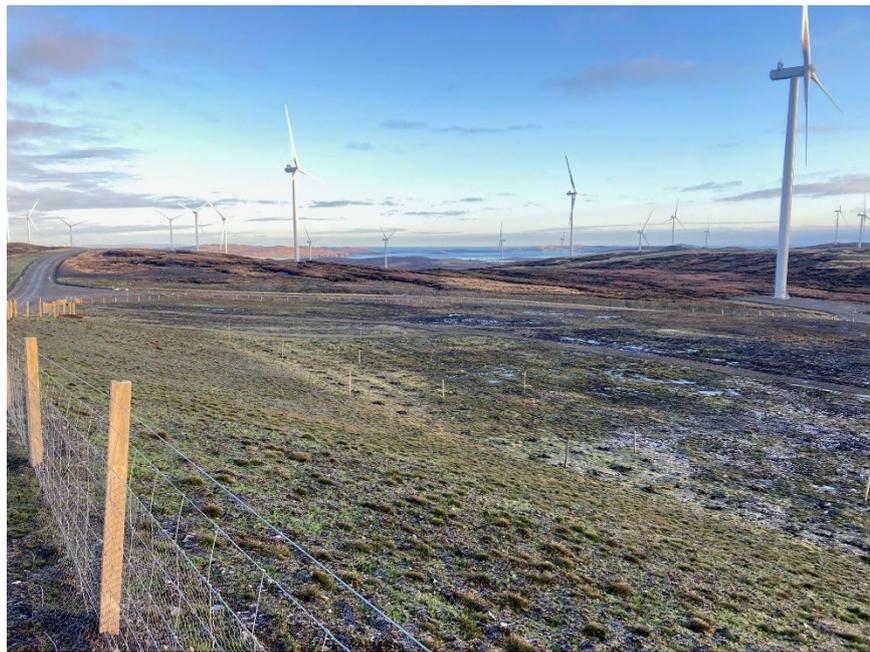
Photo 12. NBP05- vegetated slopes

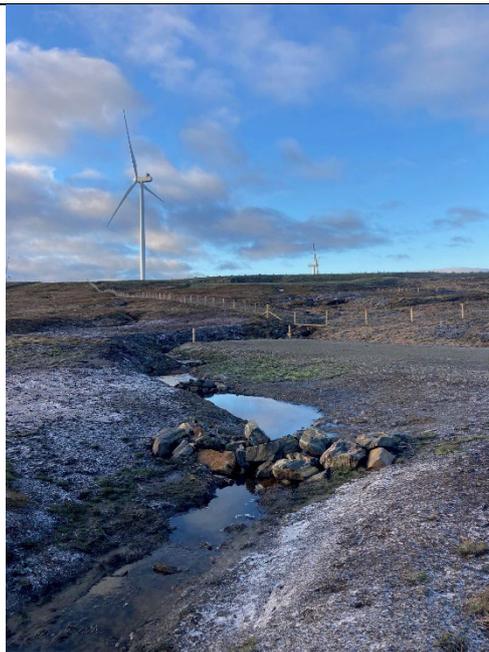
Drainage at T076 was observed. Removal of the secondary additional mitigation drains has taken place, with all drainage works completed. The water was noted to run clear indicating that the drainage remains effective (photo 15). This area should be visited during future PMO audits.

Photo 13. Drainage down from NBP05 along T076
