This Conservation Area Appraisal is a revised and updated version of the document prepared for Shetland Islands Council by the Scottish Civic Trust and adopted in 2010.

Scalloway Conservation Area Appraisal Contents

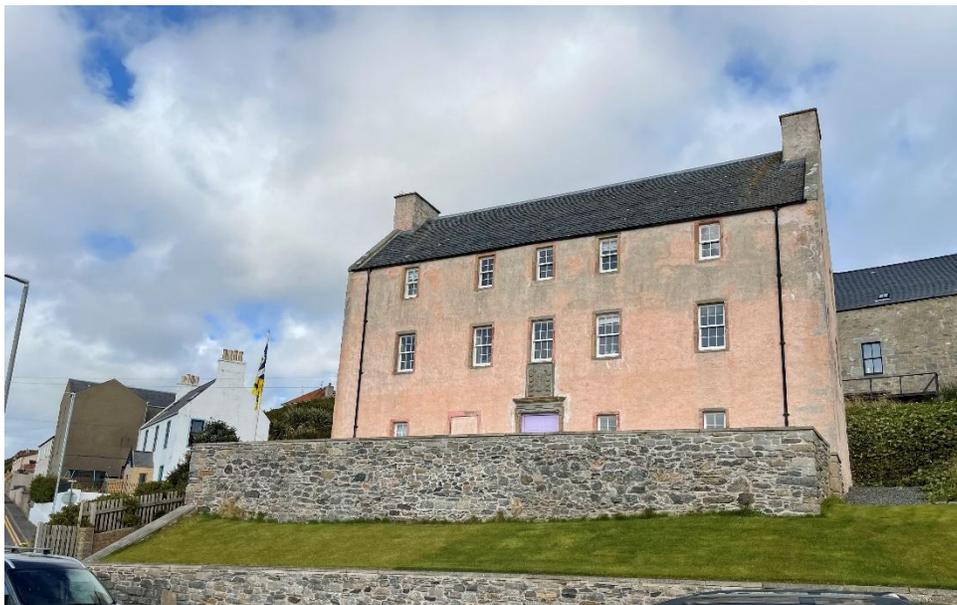
Scalloway Haa is a landmark building

Landmark buildings in the conservation area tend to be the larger non-domestic buildings – notably Scalloway Castle, Scalloway Haa, Norway House and the public hall. The buildings along New Street also form a picturesque group that is highly visible from other areas of the conservation area. Scalloway Castle is a significant landmark and is visible from many points within the conservation area.

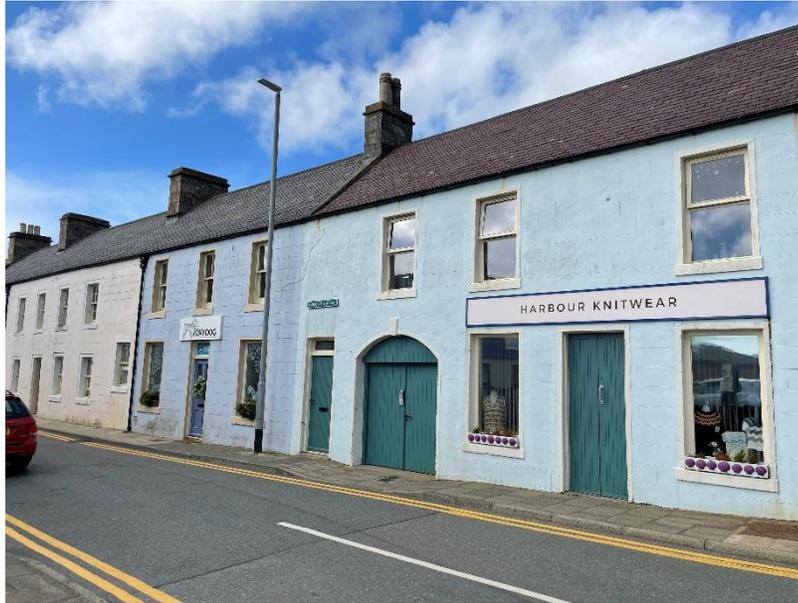
Anderson's Buildings, Main Street

Buildings on Main Street were built in the early 19th century as a two storey terraced shop with flats above. The terrace is listed at Category B as a group and individually listed at either Category B or C. The buildings have been significantly extended at the rear to allow conversion to residential use.

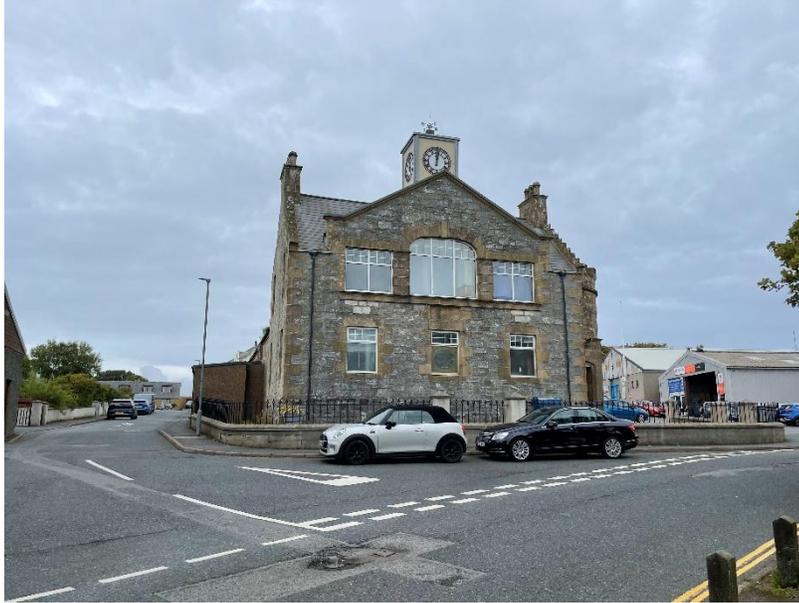
Scalloway Hall was built in 1902 in a freestyle design influenced by Art Nouveau and the English Arts and Crafts style. The hall is category C listed and is a popular venue for meetings and concerts. The walls are harl-pointed rubble with yellow sandstone dressings. The principal elevation to the south features a pedimented gable over a large Venetian window at first floor and a 2-storey circular crenellated entrance tower to the east.

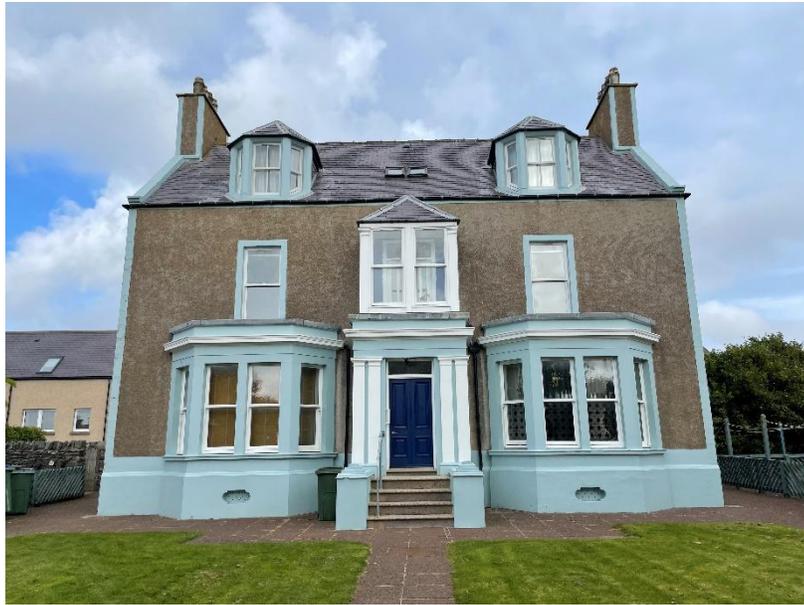
Gibblestone Haa

Gibblestone House on Main Street was built in the late 18th century as a merchant's haas. The house is one of a series of merchant's haas that were built by immigrant Scots lairds. Like many others Gibblestone was built with a formal relationship to the sea, with the main elevation facing a now demolished pier on the waterfront. The house is symmetrical with 2 storeys and an attic over 3 bays with harled walls and window and corner detailing. A central doorway is flanked by bay windows on the ground floor. The single storey houses set symmetrically in the garden were built when Richard Gibson converted the house to flats in 1989.

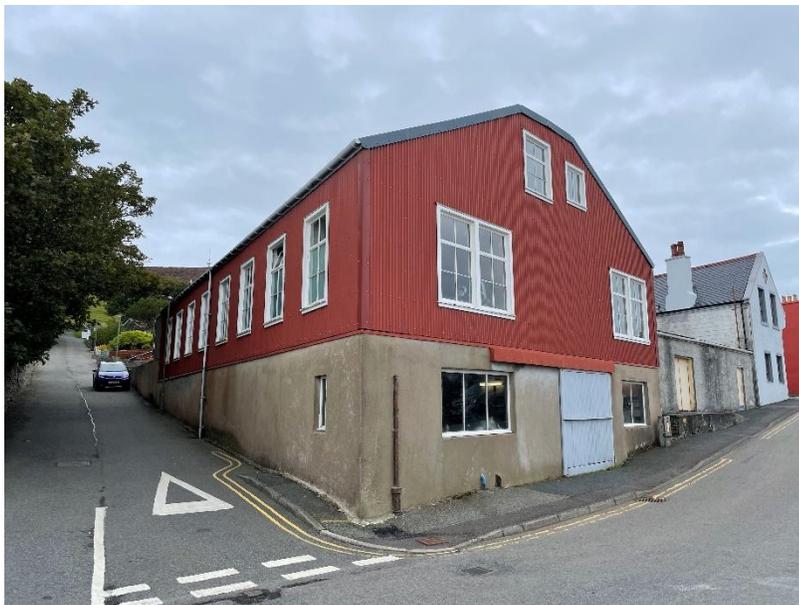
Norway House was built in the early 20th century as a sail loft during the Herring Boom and is a rare survivor of that period. It was then used during World War II to house Norwegian sailors during the operation of the 'Shetland Bus'. Now C listed; the lower storey is harled, while the upper storey is a timber frame clad with red corrugated iron. The building is currently under utilised with a gym on the first floor and storage space on ground level.

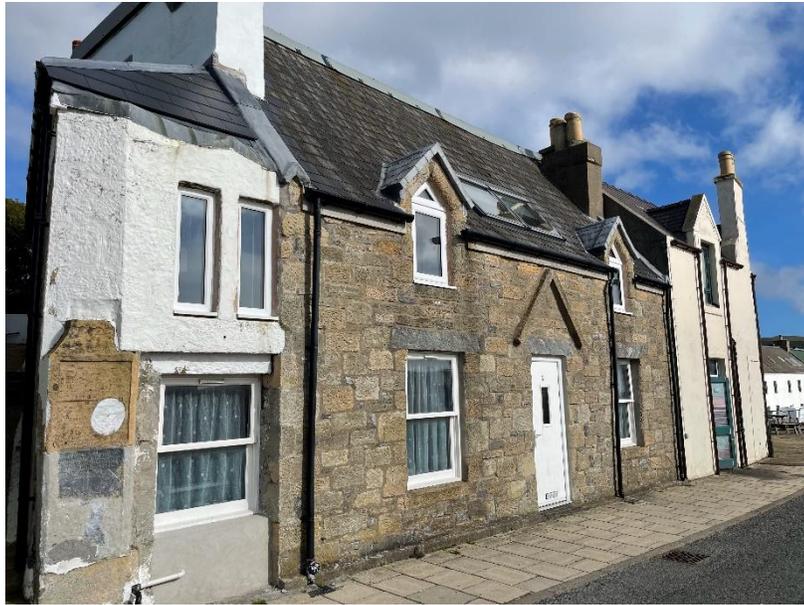
Houses on New Street with William Johnson's plaque to the left of the picture

Many of the properties within the conservation area are 1½ -2 storey, terraced or detached stone houses. Good examples are found at the terrace of cottages on New Street, which form a picturesque and almost identical group in the middle of the terrace. Each house in this terrace is 1½ storeys over 3 bays with a central doorway. Most are rendered and painted a variety of colours. The terrace has a slated roof with pitched wallhead dormers. Windows are generally timber sashes although there are some replacements.

There is a curious plaque situated on the southern end of the cottages on New Street, which was erected there by William Johnson, described by Finnie as a 'mason, inventor and philosopher'¹². The plaque explains his theories on tides and the moon. The plaque is made of sandstone with an inset piece of marble and is an interesting addition to the street.

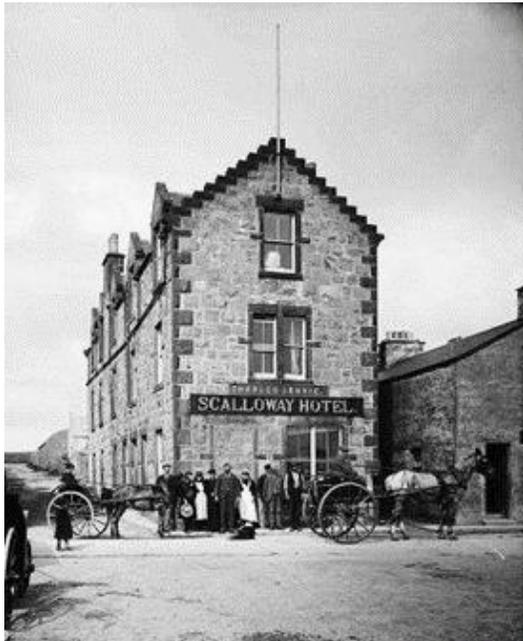
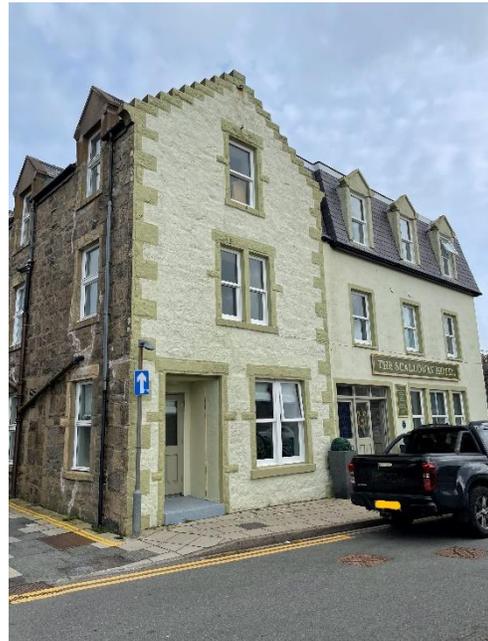
Scalloway Hotel is a prominent building on Main Street. It was built in 1886 by John Aitken for Donald McInnes and has 3 storeys over 4 bays with cream coloured painted stone or rendered walling, contrasting quoins and margins, a slate roof and a crowstepped gable to the west. Apart from the extension to the west, the building is little altered externally.

Scalloway Hotel c.1900 and 2024

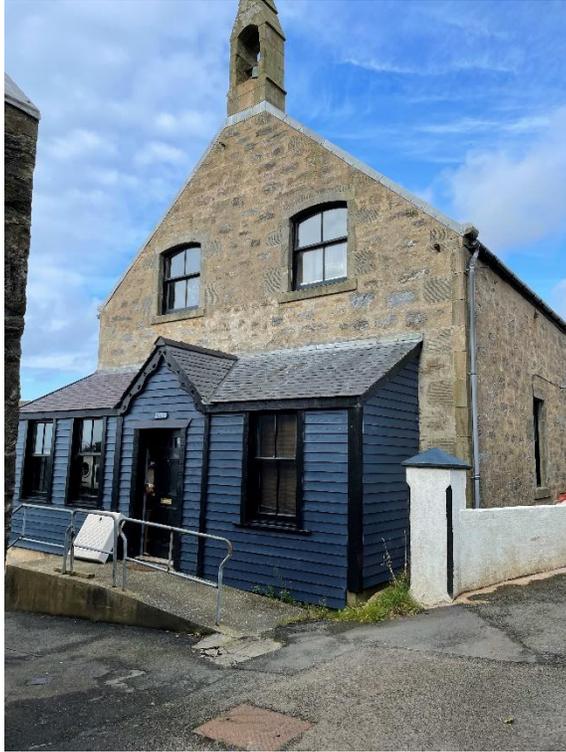
Former church, Braehead Lane

The former church on the corner of Braehead Lane is dated 1838. The building is 1½ storeys with a rectangular plan with an entrance porch on the south elevation. It features slaister (harl) pointed stonework and a pitched slate roof and has been converted to residential use.

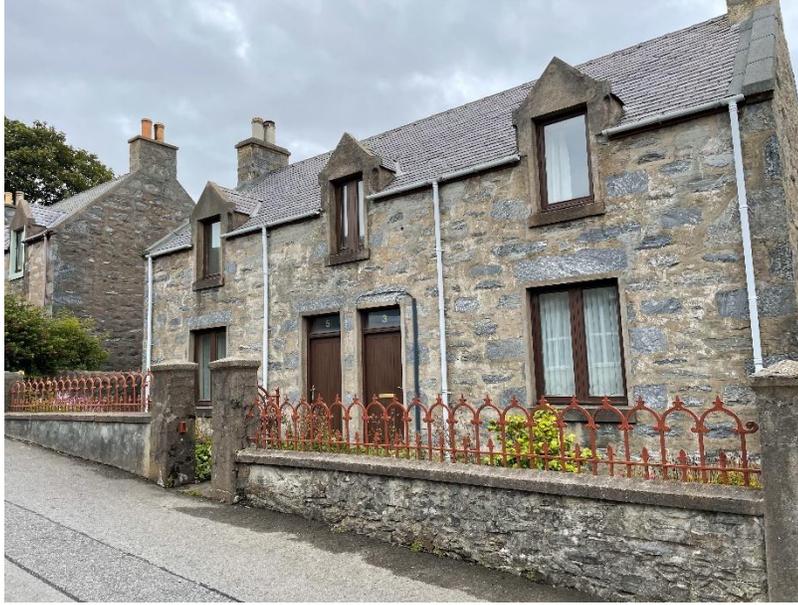
Houses on Kirkpark Road

The properties on Kirkpark Road form a distinctive and attractive group. The buildings are generally 1½ storey stone cottages with decorative garden railings and mature trees to the front. Seaton Lodge at the top of the cul-de-sac is the most prominent house on the street and features dormer windows on the pitched slate roof and a central entrance porch to the front.

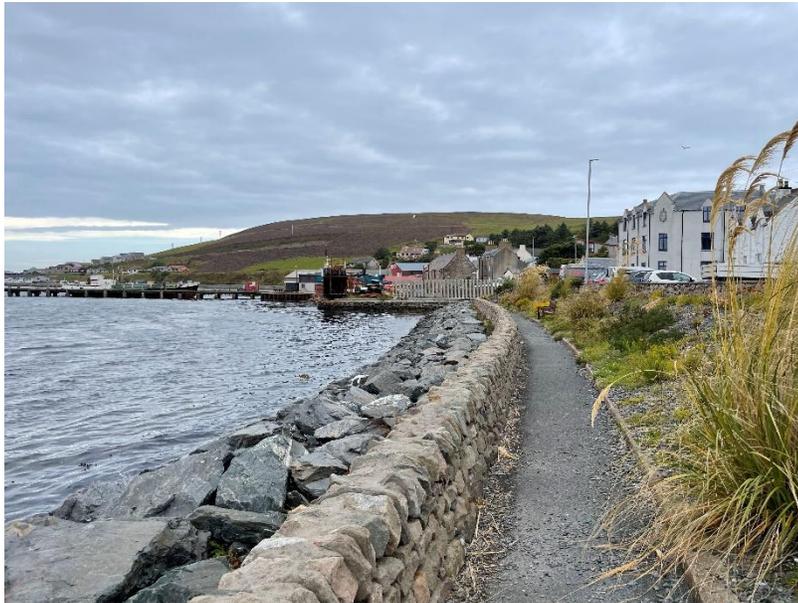
Landscaping along the waterfront

There have been public realm improvements in Scalloway in past years, which have created areas of hard landscaping on the waterfront and along Main Street with benches, interpretation panels and a memorial to the Shetland Bus. Environmental improvement works have been undertaken along New Street, including traffic calming and improved parking, reinstatement of semi-derelict gardens between the road and the sea, coast protection works, and the restoration of a ruined former fishing booth as

an artist's studio. This project received a commendation in the Civic Trust Awards. Also found within the conservation area are items of public art and street furniture that reflect the character and history of the village, such as the propeller next to the Scalloway Museum building. Many of these were part of the Art on the Waterfront project undertaken circa 1998 as part of the regeneration activities in Scalloway.

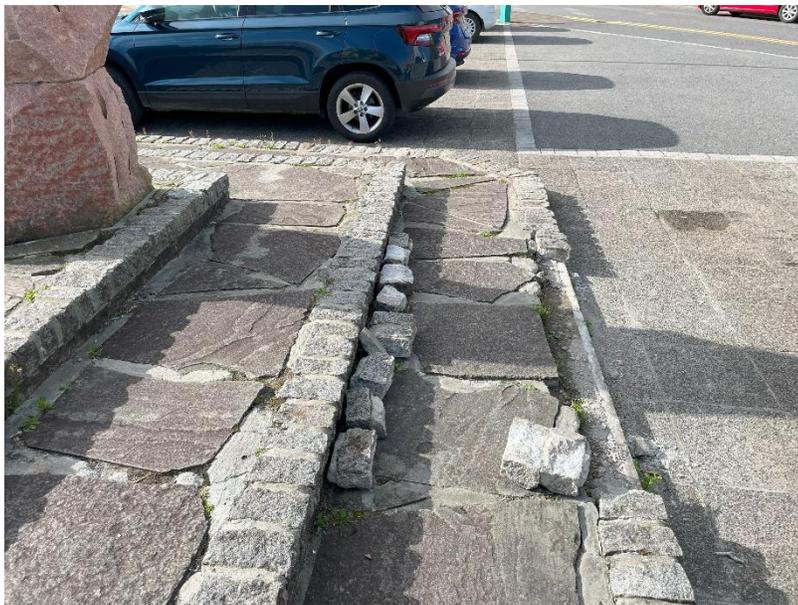
In other areas the public realm appears neglected however. There are signs of lack of maintenance and repair in a number of areas including along Main Street.

Some areas of public realm require repair

- The Council will endeavour to ensure that works carried out by statutory undertakers, including the Roads department, are coordinated as far as possible to minimise damage to the pavement surfaces and carried out to reflect the sensitive historic environment.

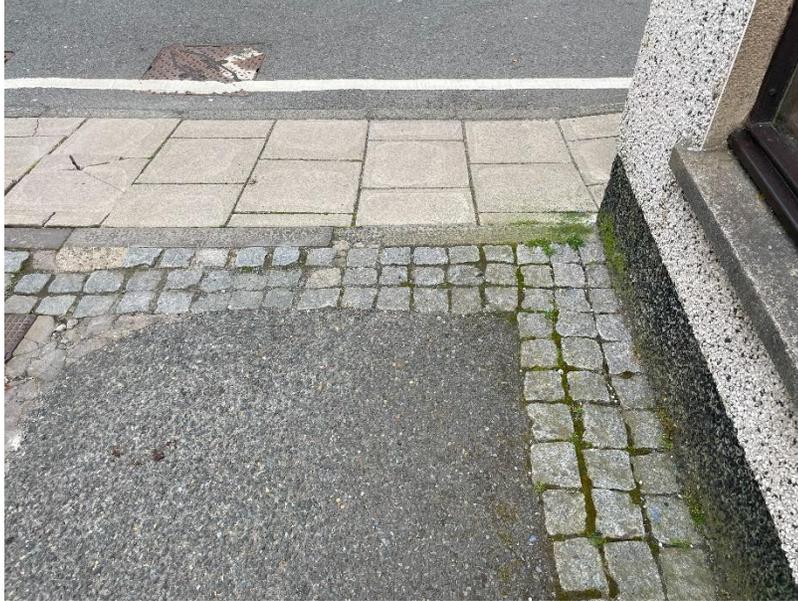
Road surfaces are tarmac, although there are some areas of stone kerbs and granite setts at the edge of the road and marking junctions, which enrich the character of the area. Pavements are generally unobtrusive concrete flags, with some areas of stone flags.

Granite setts at the edge of the pavement

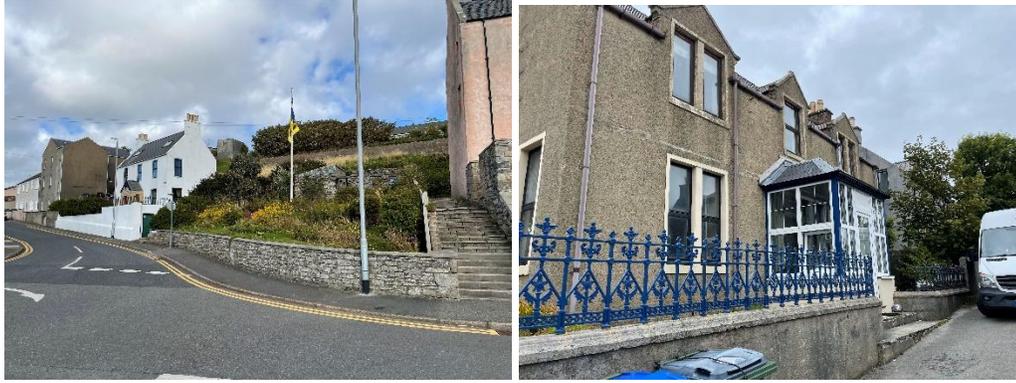
Boundary walls are a key feature of the conservation area and range from around $\frac{1}{2}$ a metre to 2 metres and are dry-stone or harled with stone copes. Some properties have low boundary walls with railings or hedges and gate piers. Shetland was largely spared from the removal of iron railings during World War II and there are some fine examples in Scalloway. Modern decorative railings can be found on New Street. On Main Street, boundary walls tend to be higher around $1\frac{1}{2}$ metres. The high boundary wall to Westshore is a significant feature of the conservation area.

Stone boundary walls and cast iron railings feature throughout the conservation area

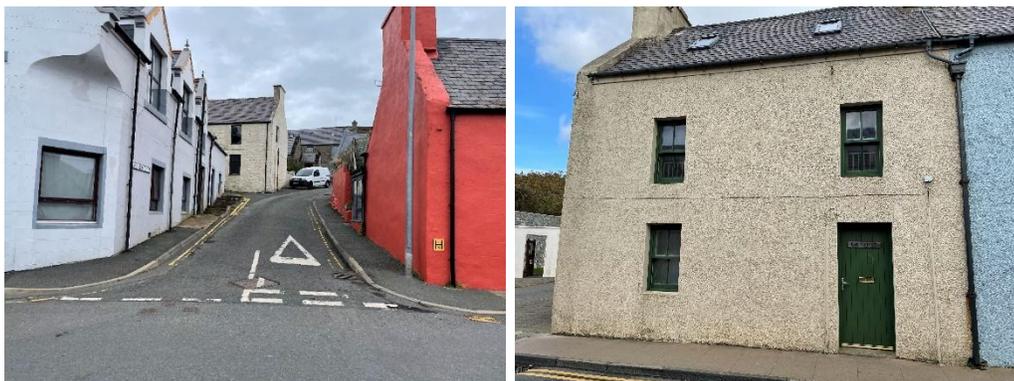
The existing Article 4 Direction was served in 1975. The types of work that are controlled include alterations to a dwelling, such as new windows and front doors, porches, front boundaries and painting are all controlled because planning permission is needed. These additional controls appear to be working reasonably well but there are examples of poor quality detailing and inappropriate replacement windows.

Buildings on Hillside Road (left) and Main Street (right)

Recent changes to the GPDO have introduced new permitted development rights in conservation areas, allowing changes of materials and of windows and doors and installation of PhotoVoltaic panels in certain circumstances. In light of the negative impact on the conservation area arising from changes to unlisted buildings set out above, a new Article 4 Direction should be prepared and adopted.

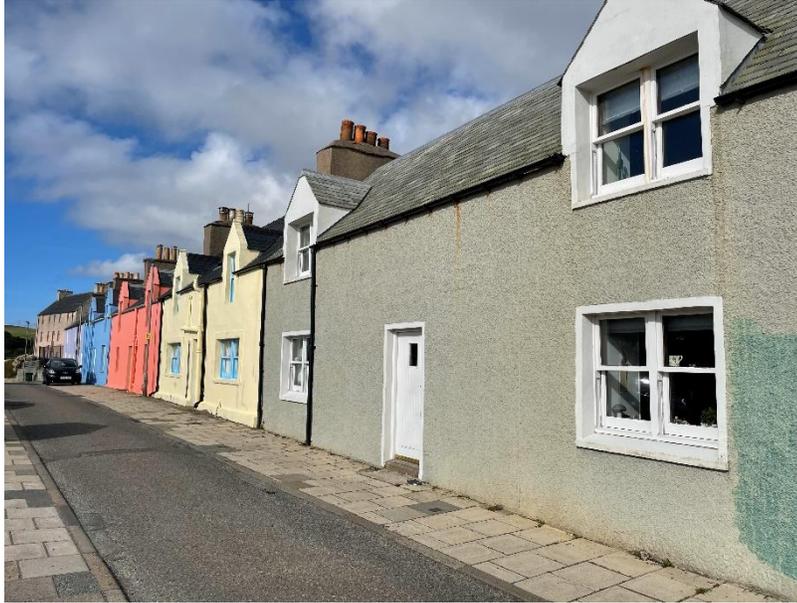
Painted facades on New Street

Stonework that is unpainted should remain so. Traditional limewash and lime mortars are ideal as they allow the wall below to “breathe”, rather than sealing-in any moisture and provide a flexible finish that expands and contracts with changes in temperature and humidity.

Consideration should be given to the preparation of guidance on the choice of colours and paints/limewashes to assist building owners.
