Date
March 2025

Project Number
1620009158

VIKING ENERGY WIND FARM PLANNING MONITORING OFFICER AUDIT REPORT 049: 2ND DECEMBER 2024 TO 12TH MARCH 2025

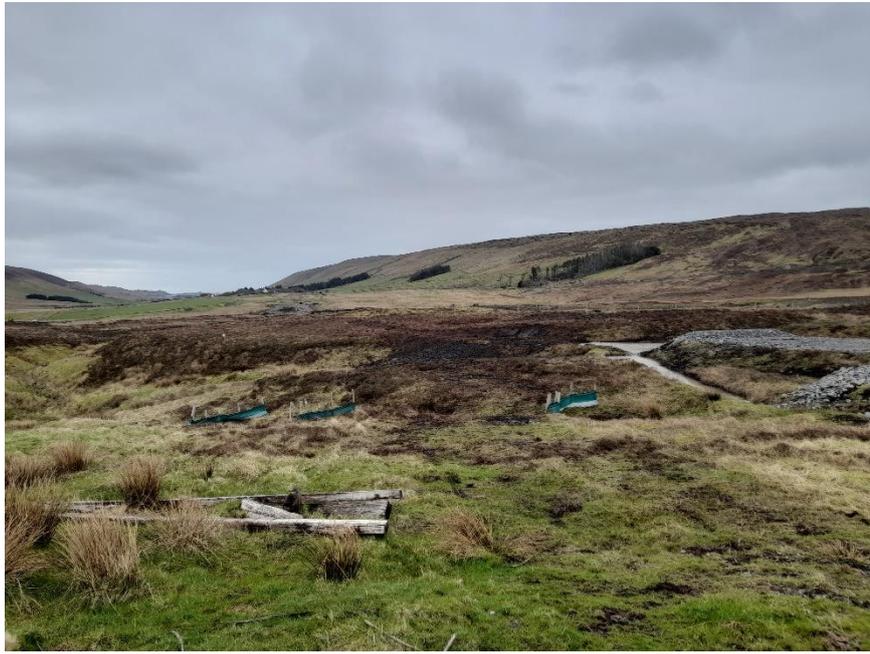
The new design for permanent surface water management to provide attenuation and treatment of surface water draining to the Burn of Droswell from the KAT has been completed (photo 1). Following an observation that the water appeared silty in the November 2024 PMO visit, the permanent drainage appeared to be working and holding the silt from the Burn during the March 2025 PMO audit. Temporary silt fences remain near the Burn, and it has since been confirmed that these are from the construction phase of works. It has been confirmed that these will be removed in the spring / early summer.

Photo 1. Permanent surface water management at the Burn of Droswell

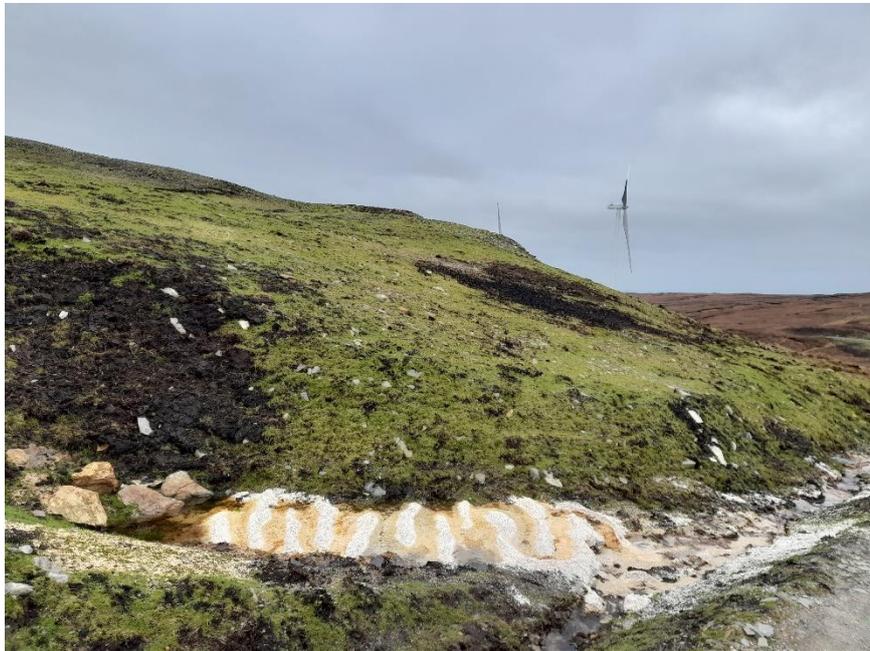
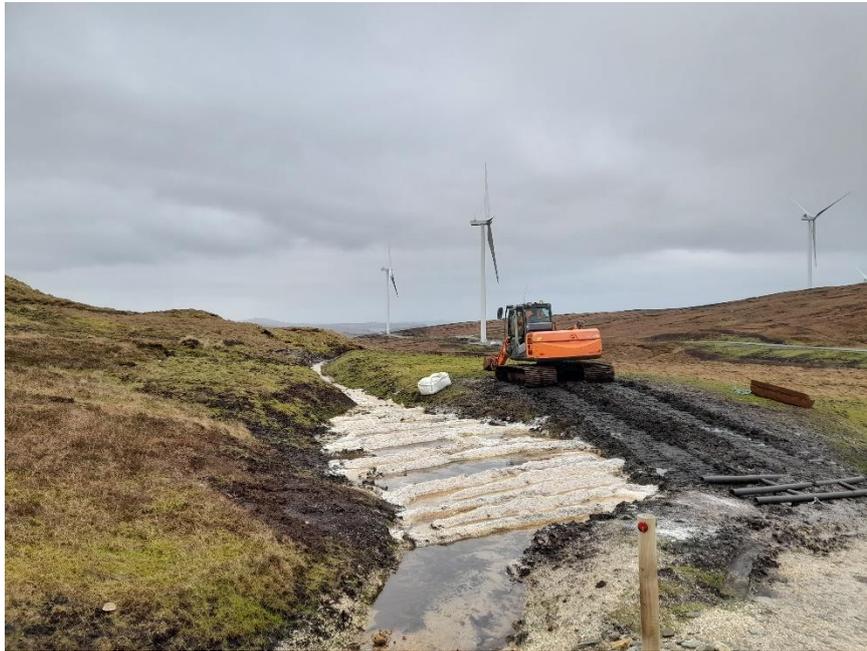
The PMO audit included inspection of the temporary drainage treatment at KBP02 (photos 2 and 3). It is understood that SSER have taken on the monitoring and maintenance of the treatment system, with continued water monitoring and sampling. Further data is required in order to confirm the acceptability of water quality or the need for additional interventions. There are ongoing discussions with subject matter experts and SEPA on how the permanent treatment system will work. This area should be visited during future PMO audits.

Photo 2. Temporary drainage treatment at KBP02

Photo 3. Temporary drainage treatment at KBP02

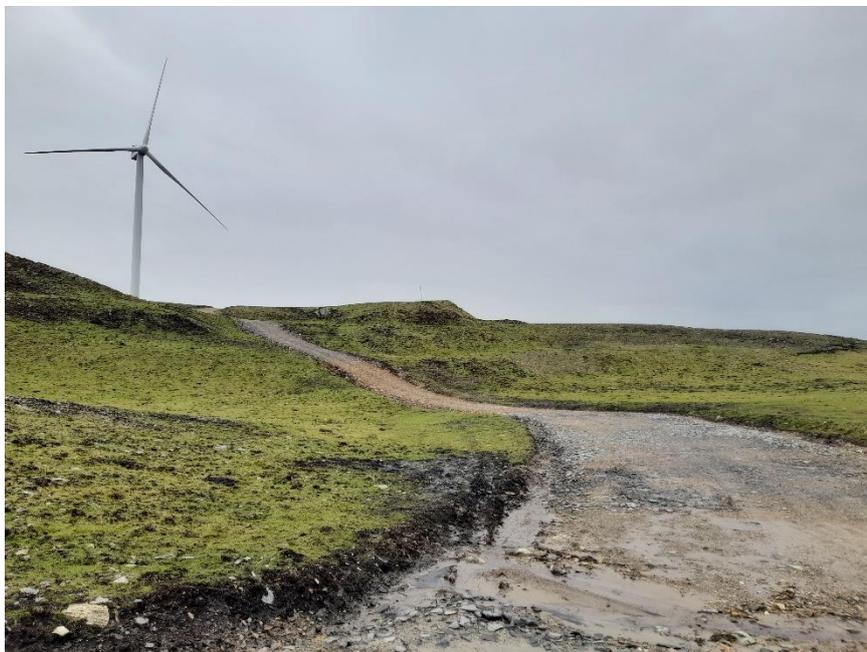
KBP02 borrow pit reinstatement profiles were noted to be in keeping with the general landscape character and local topography, with successfully vegetated slopes through the previous year's hydroseeding (photo 4).

Photo 4. Hydroseeding in KBP02

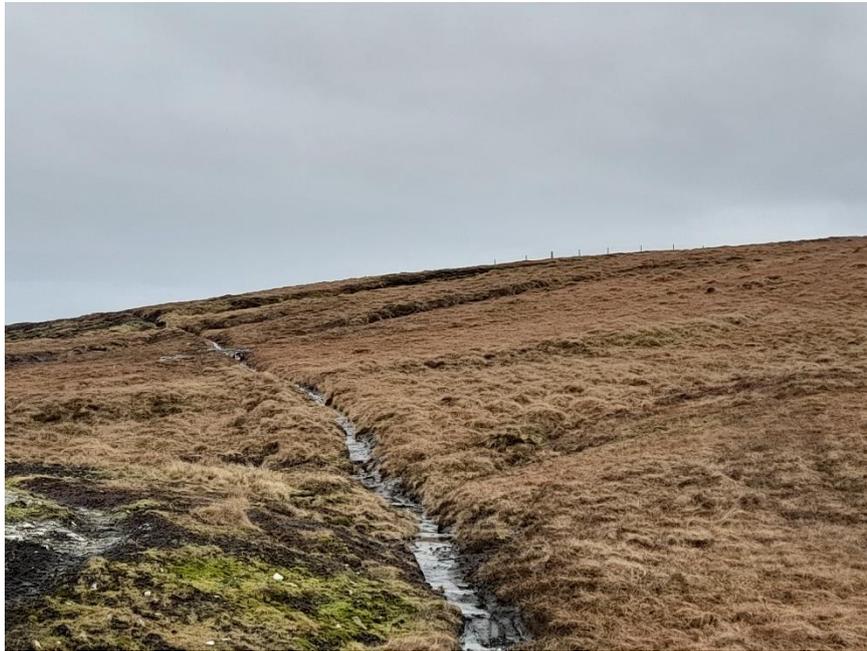
Additional reinstatement work around the site to remove/block up or reinstate construction cut-off ditches that were used during construction to mitigate pollution risks is being undertaken (photo 5), with a number of ditches having already been reinstated in order to prevent these features contributing to the draining of the restored peatland.

Photo 5. Ongoing reinstatement of cut-off ditches in Kergord

Natural and Built Environment (e.g. ecology, biosecurity, protected sites, archaeology and site restoration).	<p>Ecological constraints identified by the ECoW team are communicated to the SSER operational team to allow mitigation measures to be implemented. The ECoW construction phase duties are now complete, albeit follow up surveys are proposed for 2025 to assess the success of reinstatement and the need for any remedial work. The construction phase duties of the ACoW are complete.</p>	No action required.	SSER Operational Team	Green
Pollution Prevention and Response (e.g. use of spill)	Additional reinstatement work is required around the site to remove/block up or reinstate	Continued reinstatement of cut off ditches	SSER Operational Team	Amber

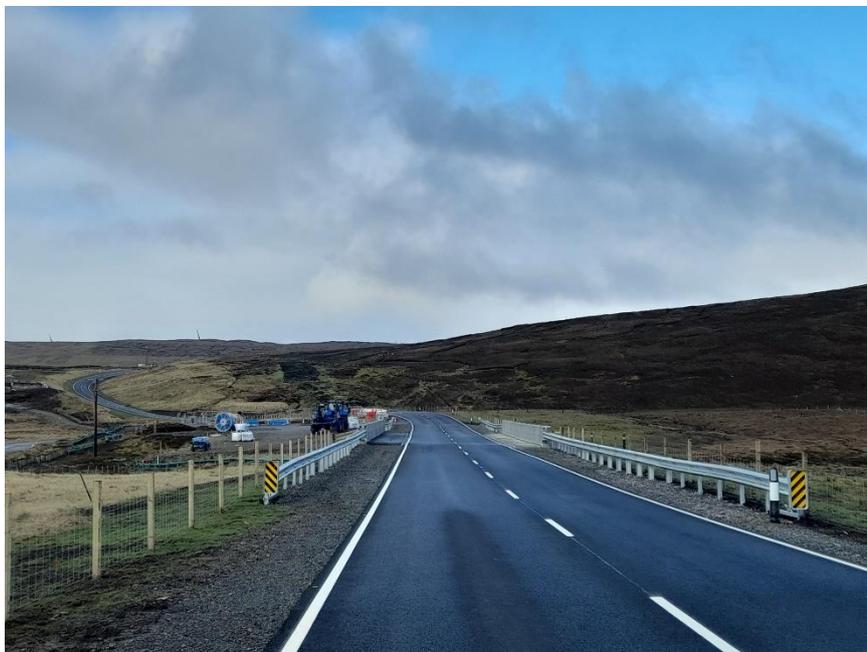
The Sandwater Road has now been surfaced and is being used by the public (photo 6). The former B9075 is currently being used for trafficable installation works by SSE networks. The former road will become a recreation route once a planning application has been submitted to 'Stop Up' the former BS9075 road. A temporary car park remains on the new Sandwater Road (photo 7) with an adjoining bus stop to be constructed in Spring-Summer 2025.

Photo 6. Sandwater Road

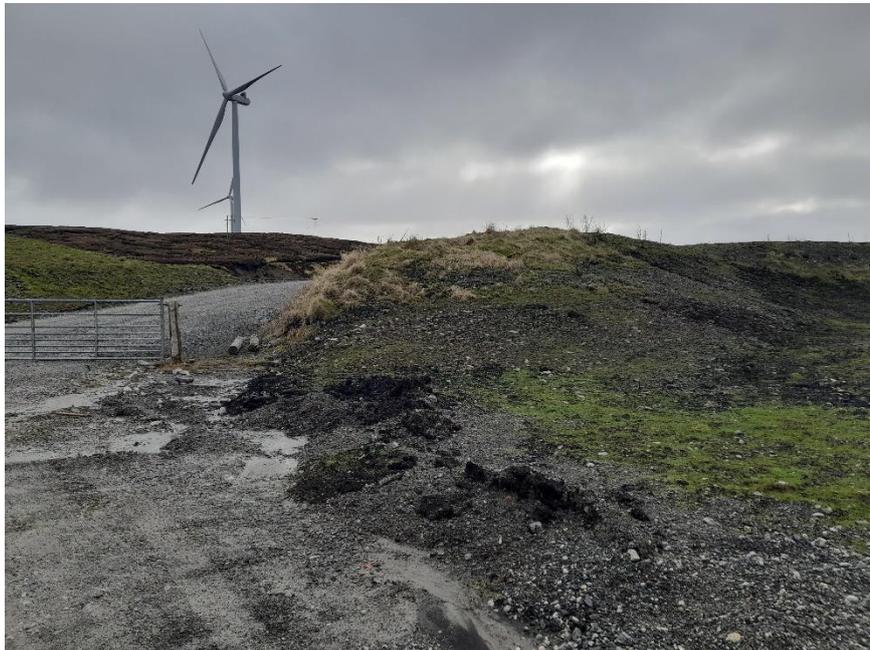
The North Compound is currently closed off and no works are being undertaken in this area, and was observed from the gate to the compound (photo 8).

Photo 8. North compound

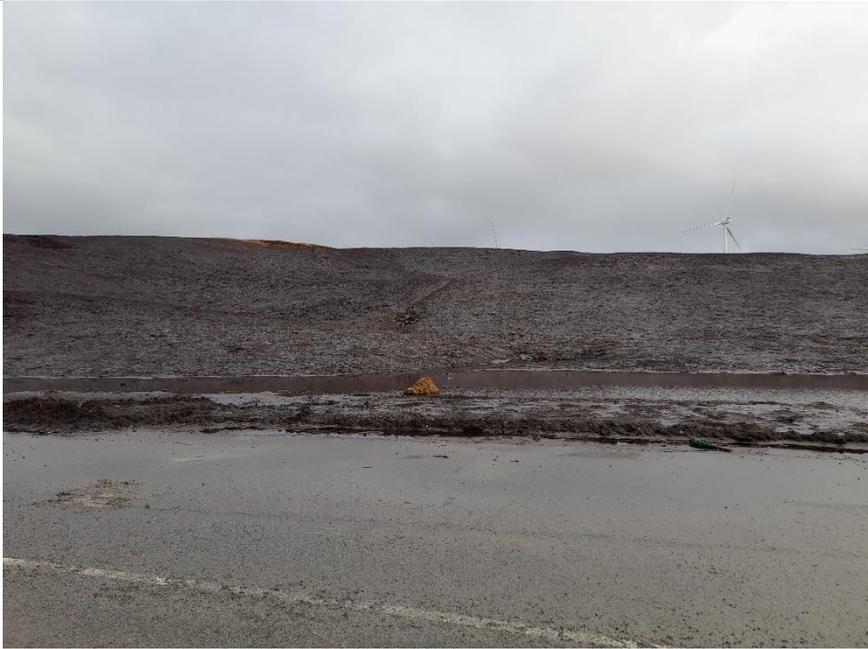
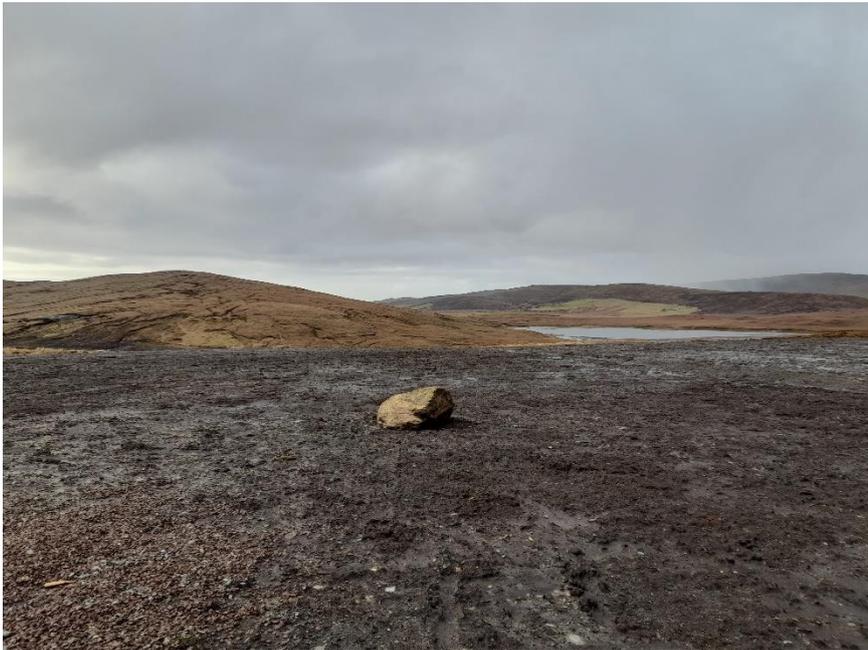
The site offices, laydown equipment and skips have been demobilised and the majority of the area has been reinstated with peat (photos 9 and 10). A small area remains for vehicle parking; however, this will be reinstated in the next few months. Seeding will be undertaken in the spring / summer months.

Photo 9. Main compound reinstatement

Photo 10. Main compound reinstatement

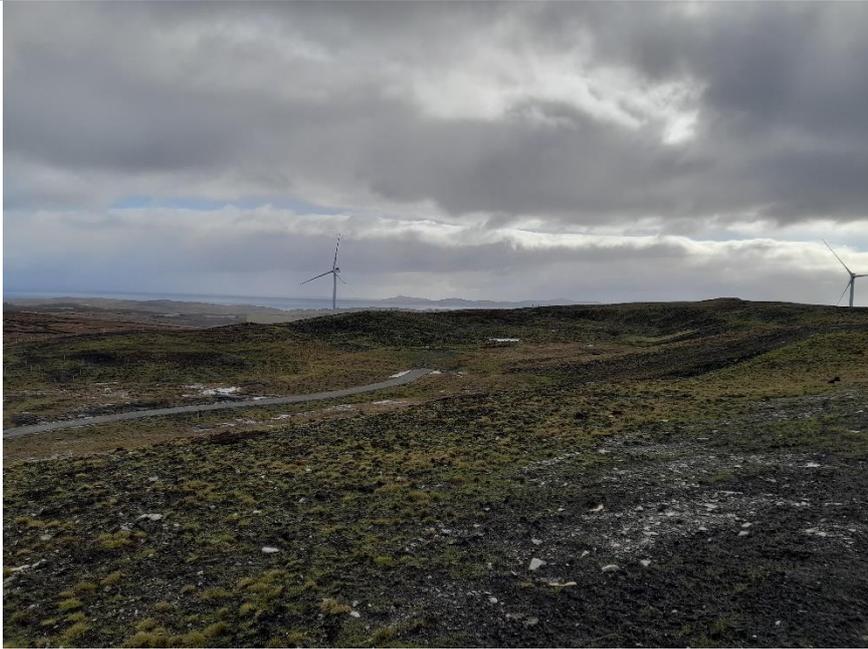
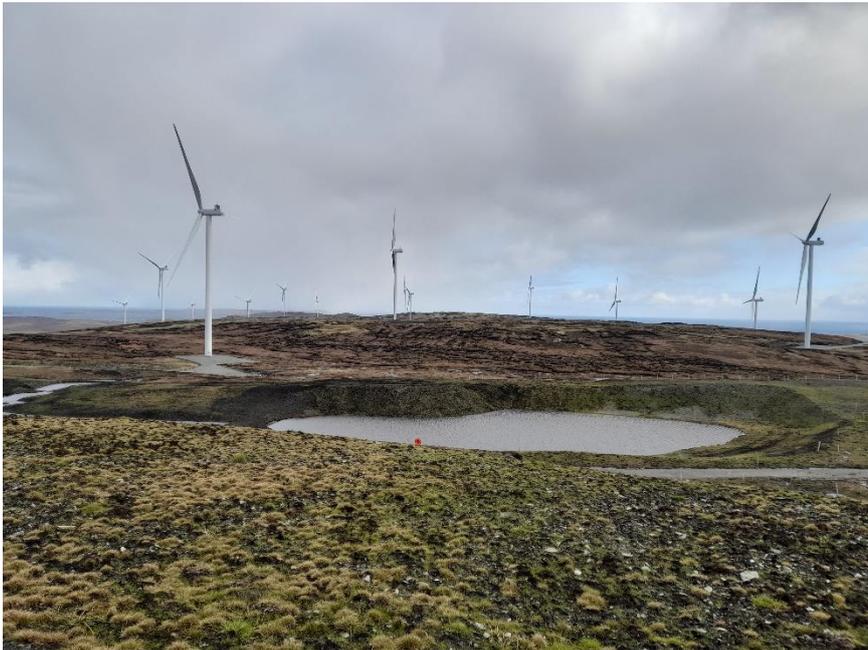
NBP05 was observed to have been reinstated during the audit visit. The restoration area includes peatland, a small water body and trees have been planted across the south-western part of the restoration area (photos 11 and 12).

Photo 11. NBP05 restoration

Photo 12. NBP05 restoration

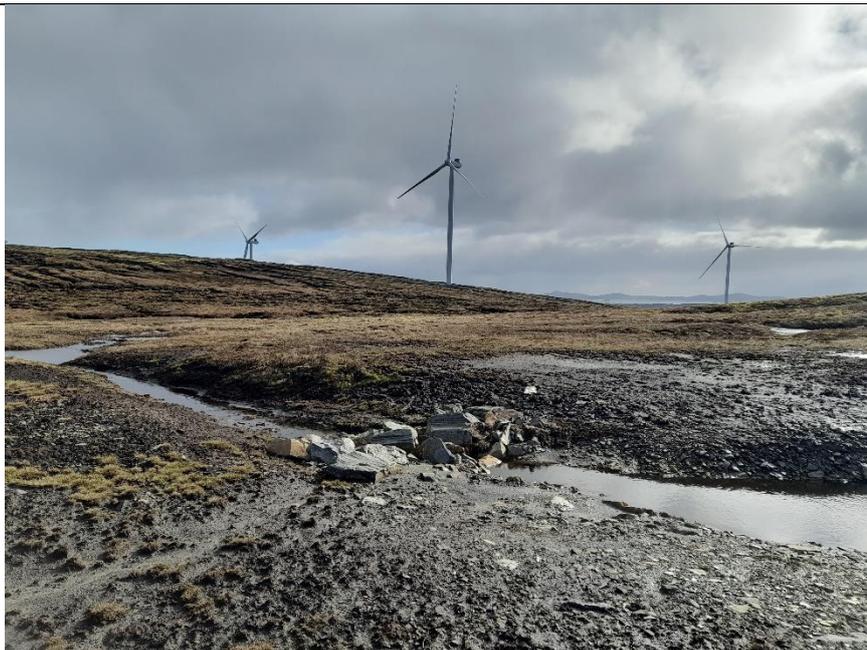
Drainage at T076 was observed (photo 13). The mitigation drains have been removed and the water was noted to run clear. Ongoing monitoring of groundwater and surface water levels are continuing in this area.

Photo 13. Drainage at T076
