The Knab, Lerwick

Desktop Survey Report

Shetland Island Council

November 2018

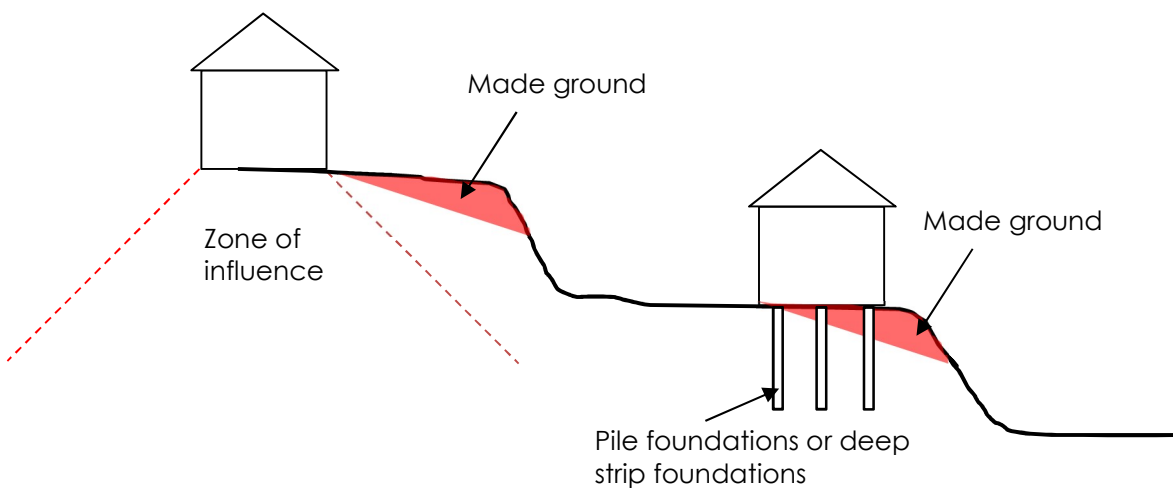
Figure 1: Foundations zone of influence

Consideration should be given to the proximity of new buildings to the edge of the embankments. It is good practice to position the footings of new buildings far enough from an embankment that it does not encroach on the zone of influence of the foundations (Figure 1). If new buildings were to be positioned close the edge of an embankment, the foundation strategy would need to incorporate deep strip foundations or pile foundations.
