SHETLAND ISLAND COUNCIL

Shetland Inter-Island Transport Study

Piers and Harbours - Existing Assets

WORKING PAPER

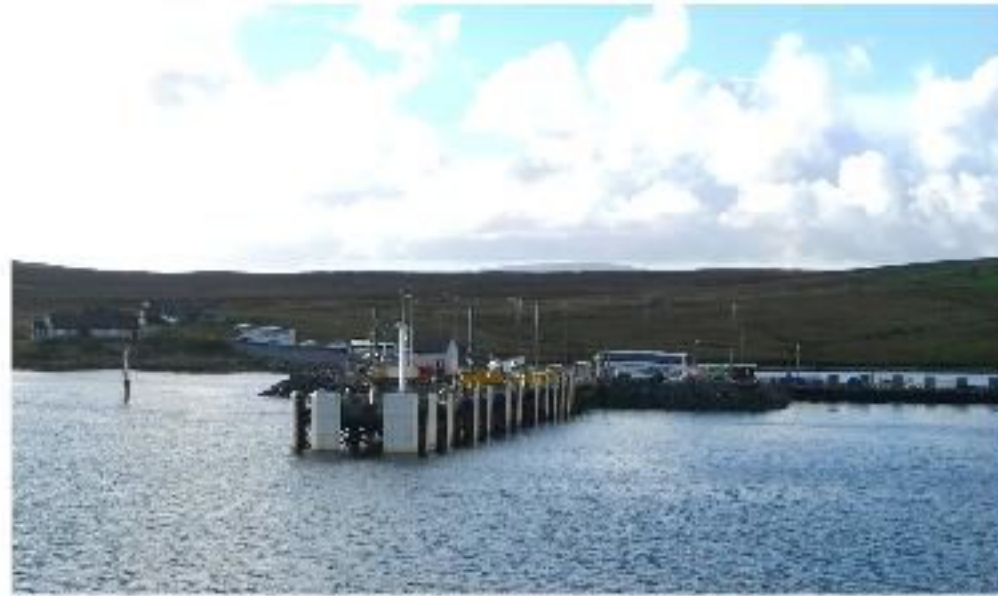
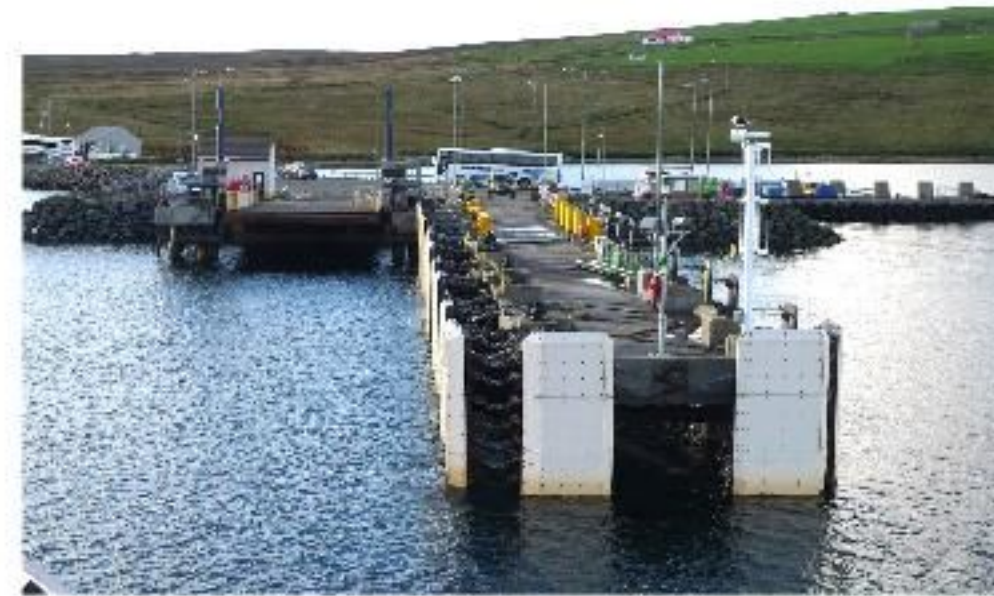
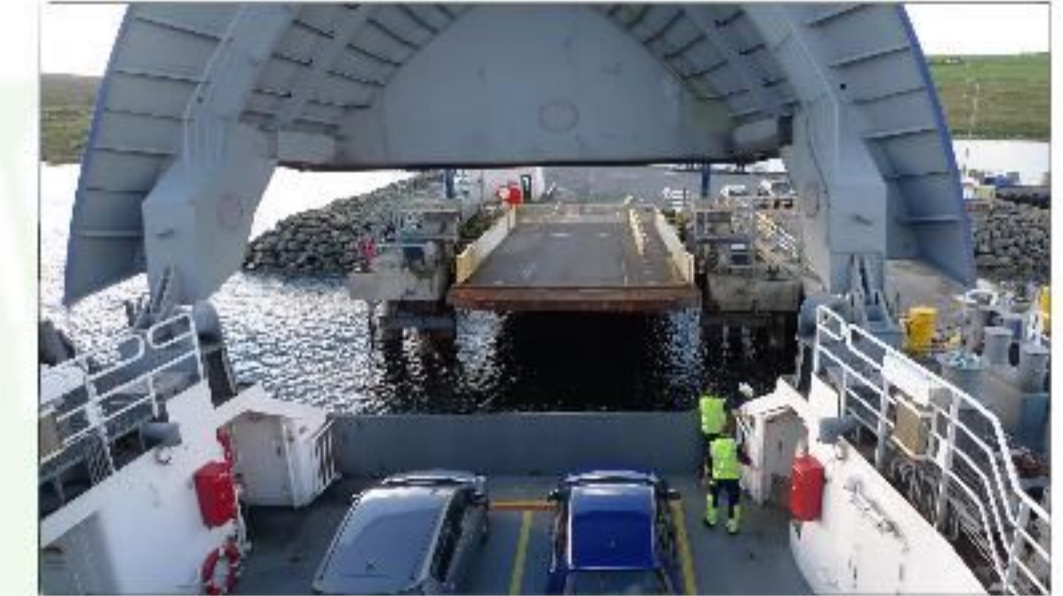
Toft

The 65m long by 14m beam ferry "DAGGRI" was observed on the berth. While there is a small amount of parking available at the terminal, vehicles waiting for the ferry queue on the road leading up to the terminal.

The terminal was found to be in serviceable condition.

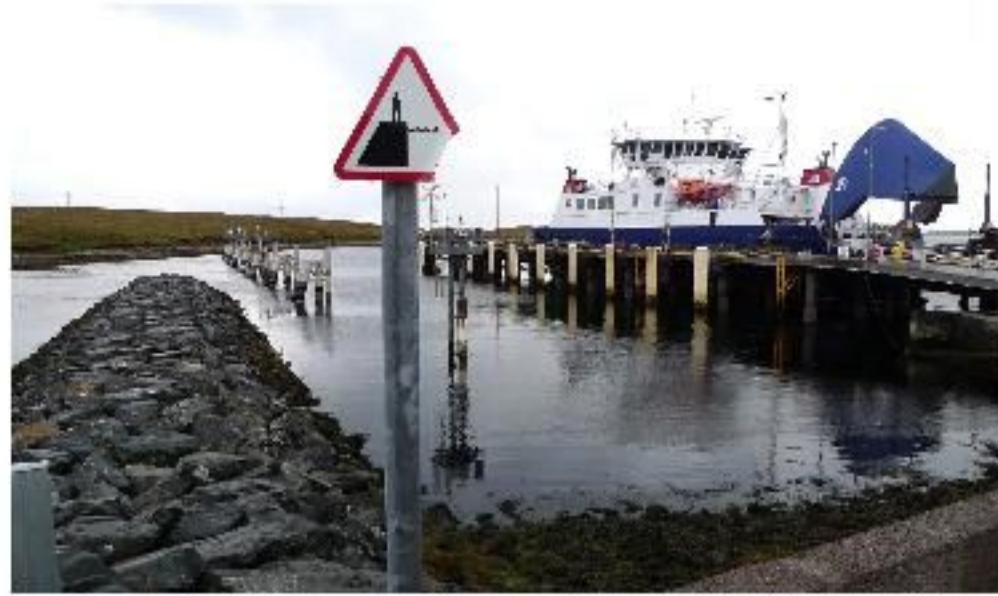
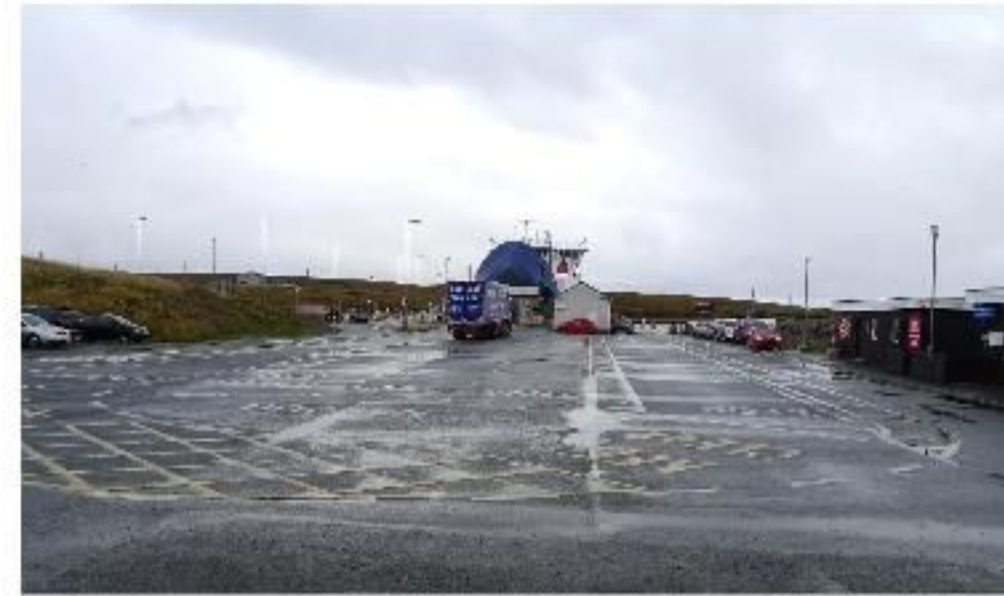
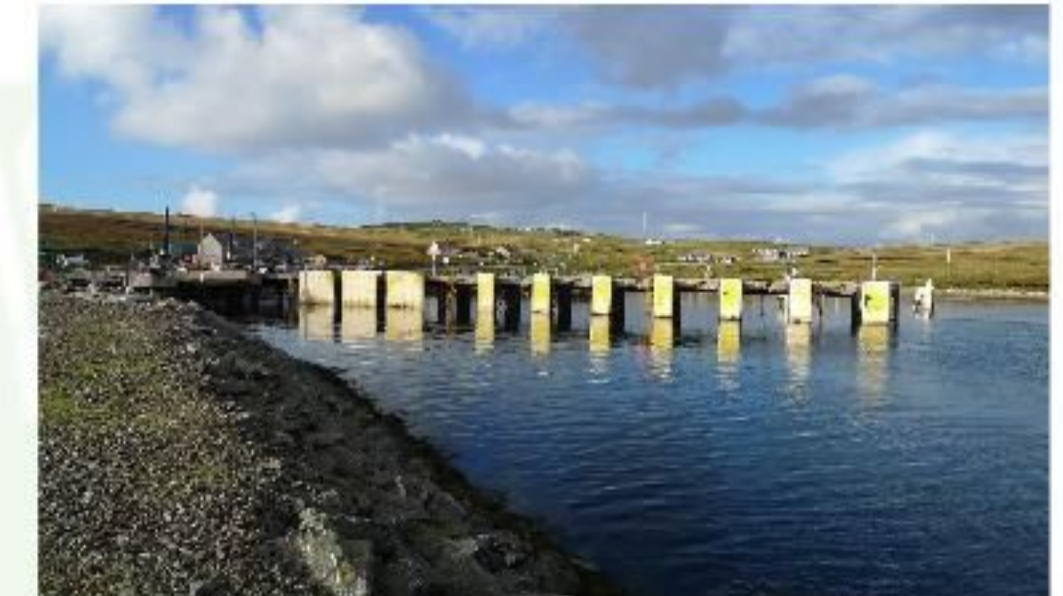
Ulsta

The 65m long by 14m beam ferry "DAGGRI" was observed on the berth. About 200 lane metres of parking is provided for vehicle waiting for the ferry which is adequate for 1 vessel.

The terminal was found to be in serviceable condition.

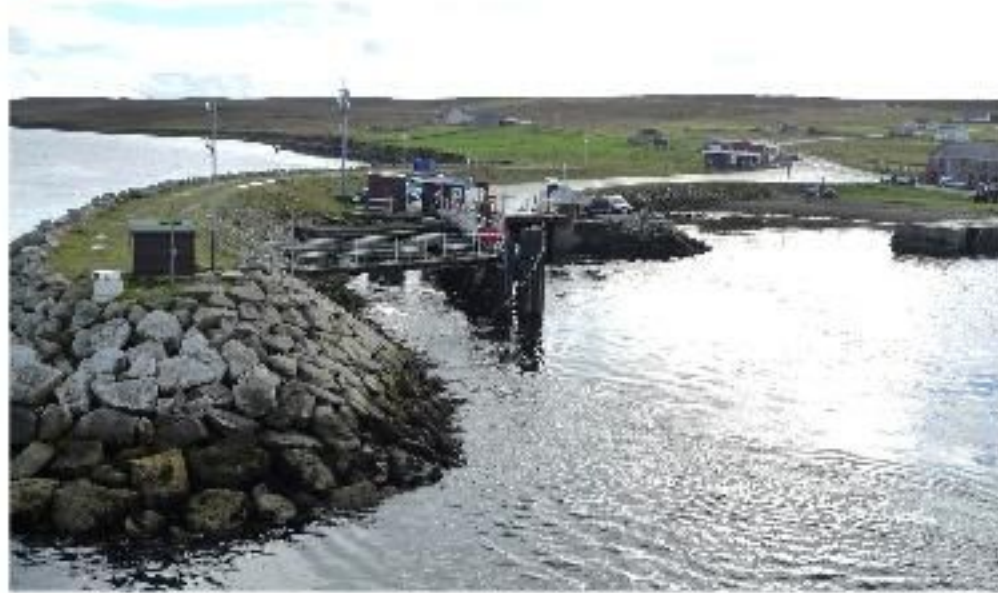
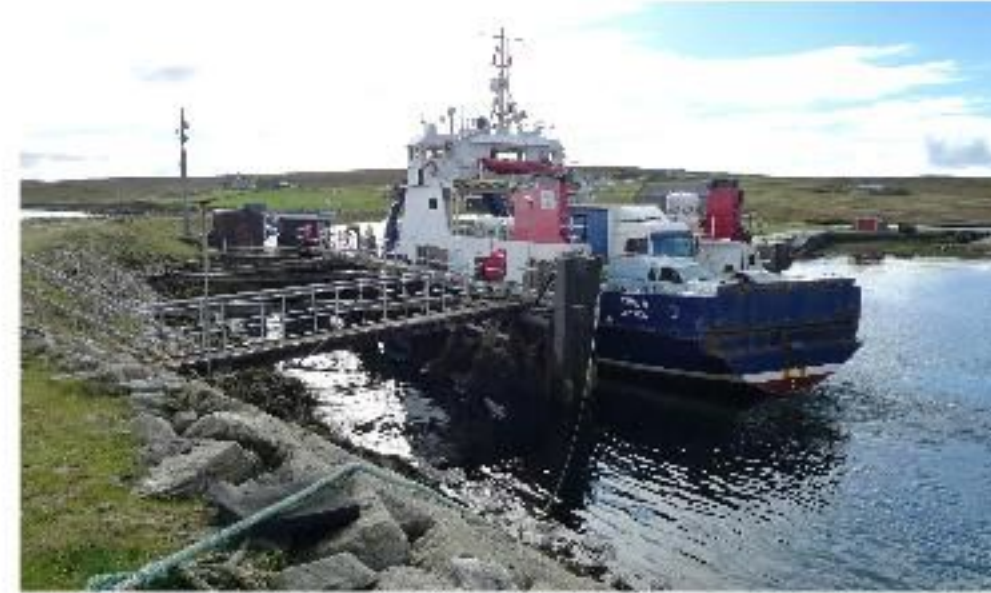
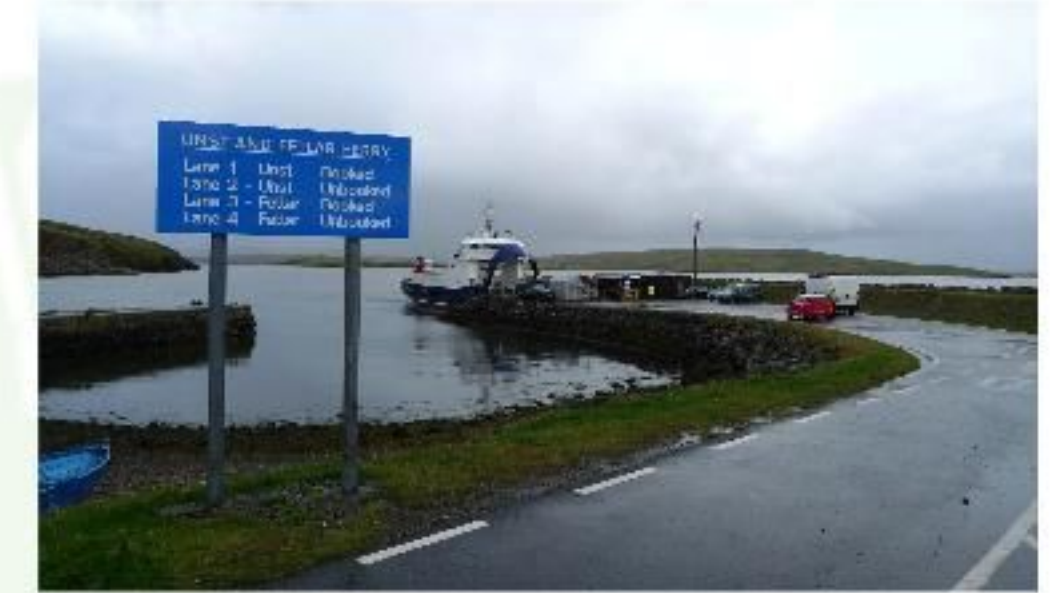
Gutcher

Vessels berth against a row of 3 dolphins on the lee side of the rubble mound breakwater and extend 25m from the end of the linkspan. These timber dolphins are supported against the breakwater by a series of horizontal diagonal timber struts founded on concrete blocks. They are faced with vertical rubber D fenders supported in steel H sections. Plans have been prepared for the construction of an additional dolphin that would help vessel manoeuvring in windy conditions.

The terminal was found to be in serviceable condition.

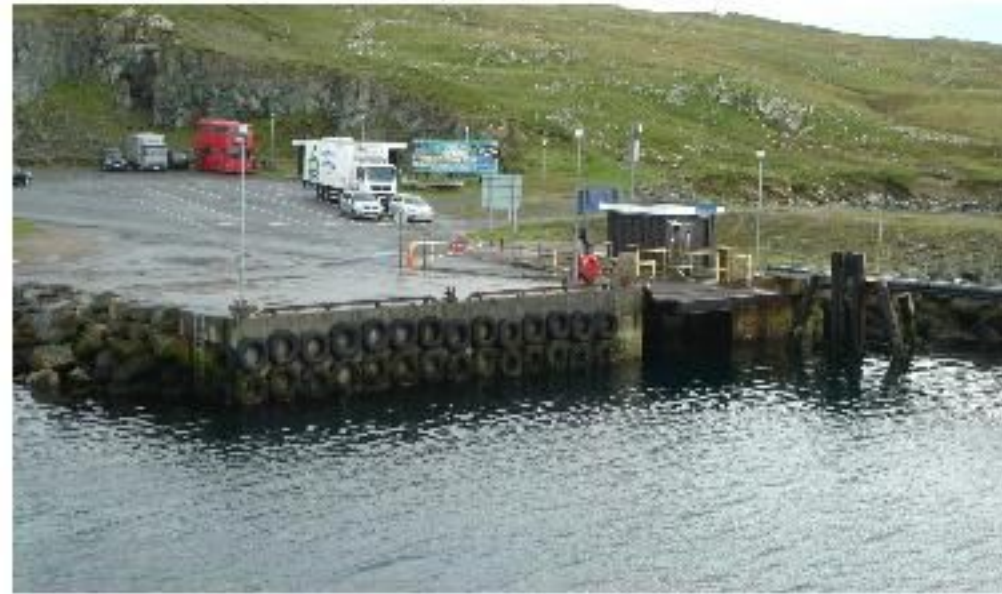
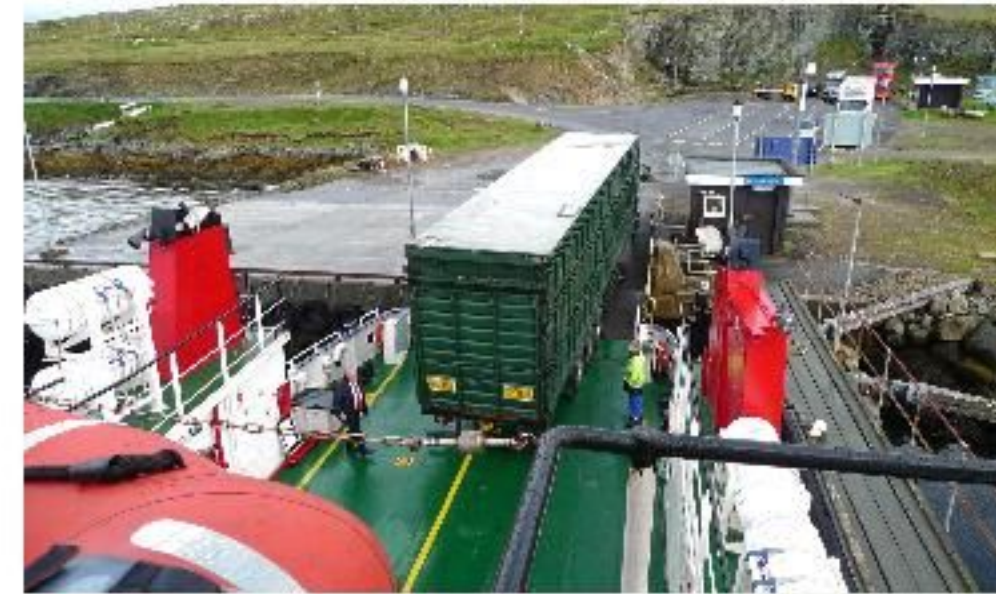
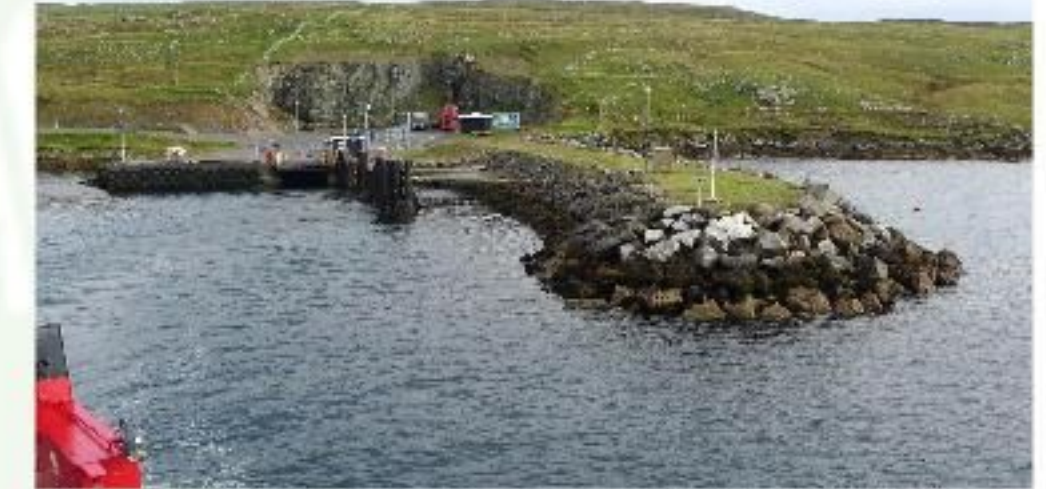
Belmont

Vessels berth against a row of 3 dolphins on the lee side of the rubble mound breakwater and extend 25m from the end of the linkspan. These timber dolphins are supported against the breakwater by a series of horizontal diagonal timber struts founded on concrete blocks and are faced with vertical rubber D fenders supported in steel H sections.

The terminal was found to be in serviceable condition.

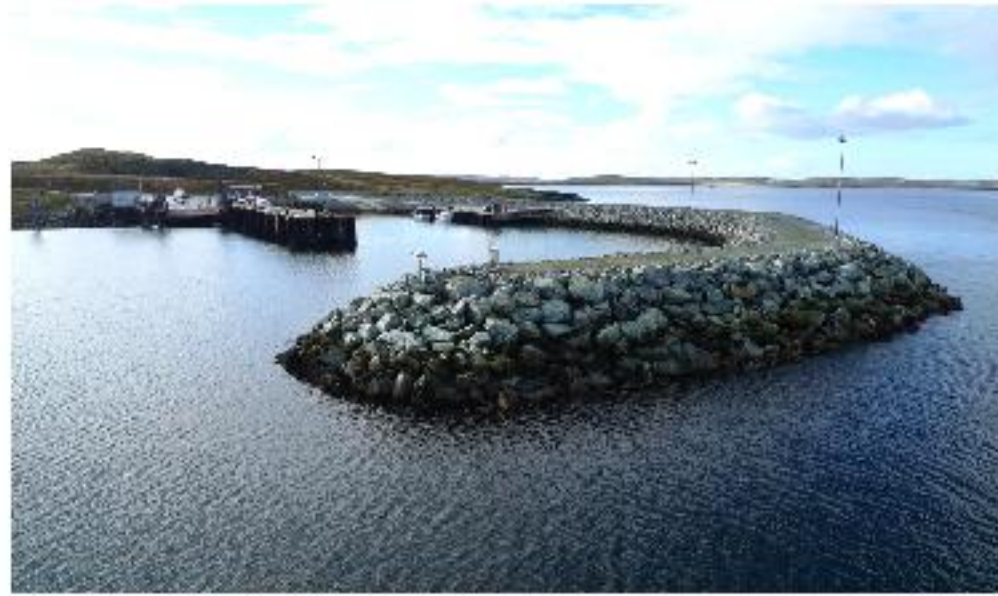
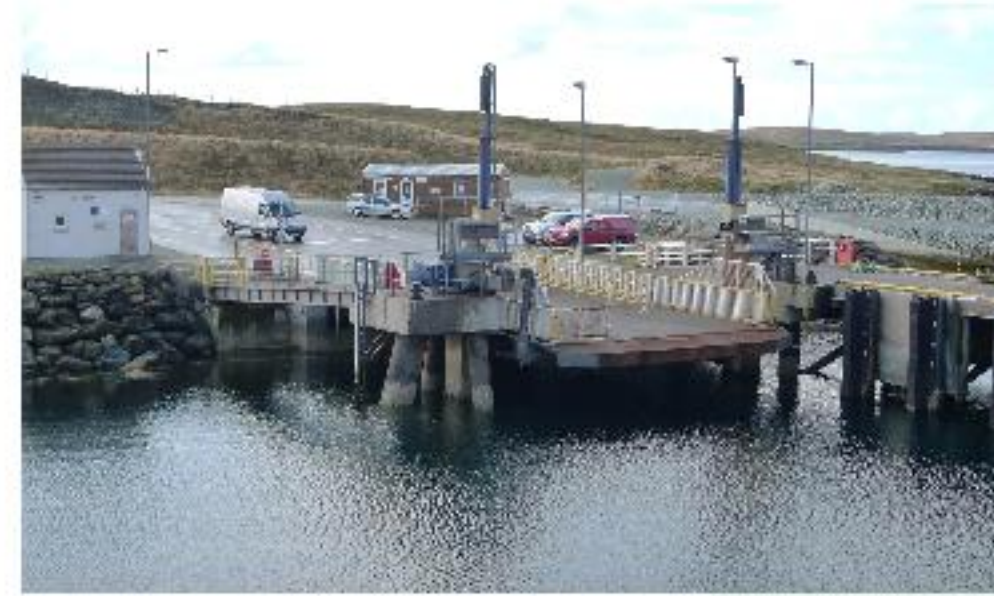
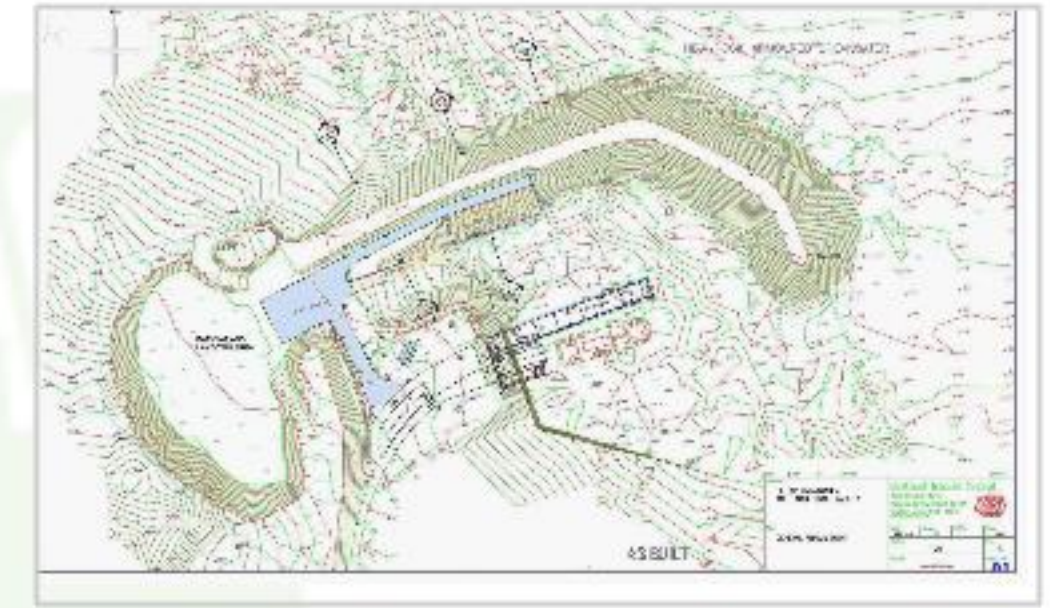
Hamars Ness

The terminal was found to be in serviceable condition.

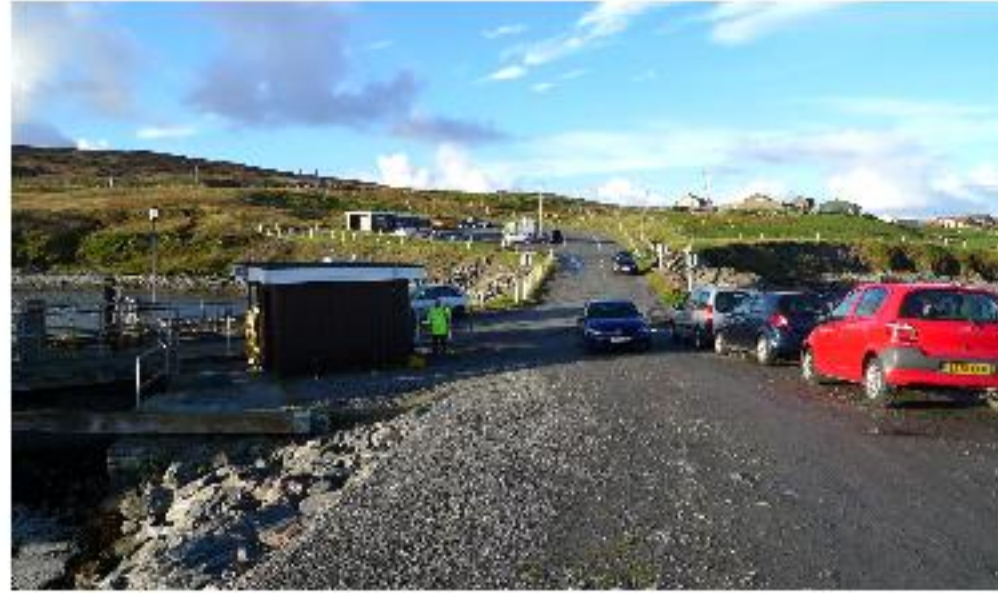
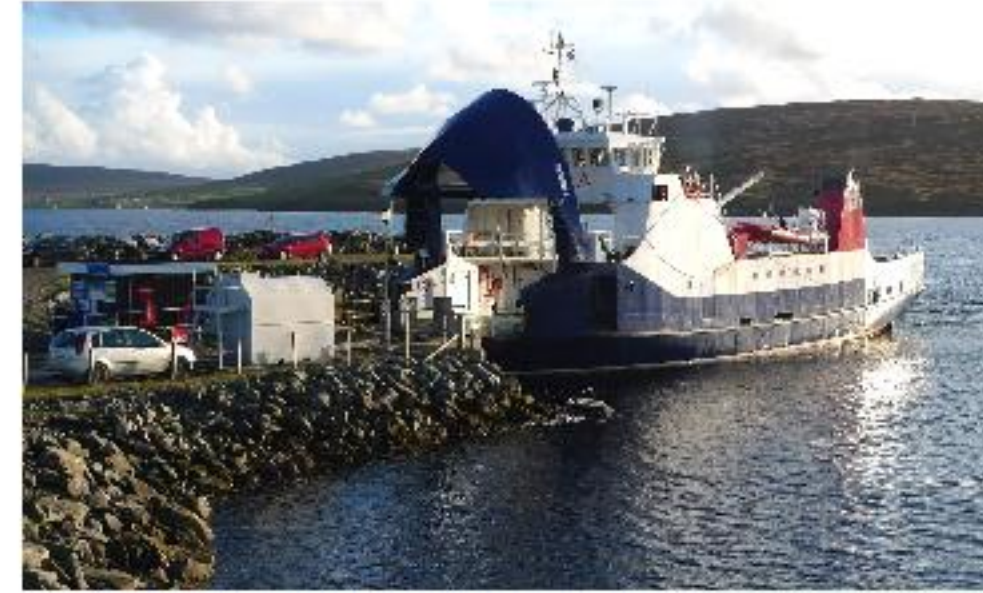
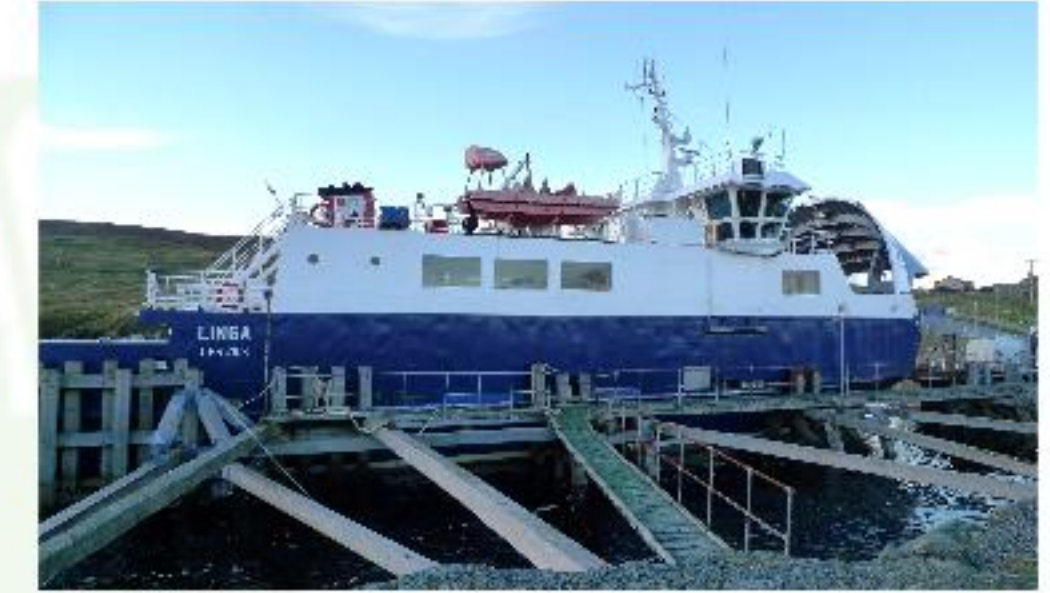
Laxo

Vessels berth against a row of 5 dolphins on the lee side of the rubble mound breakwater and extend 38m from the end of the linkspan. These timber dolphins are supported against the breakwater by a series of horizontal diagonal timber struts founded on concrete blocks and are faced with vertical rubber D fenders supported in steel H sections.

The terminal was found to be in serviceable condition.

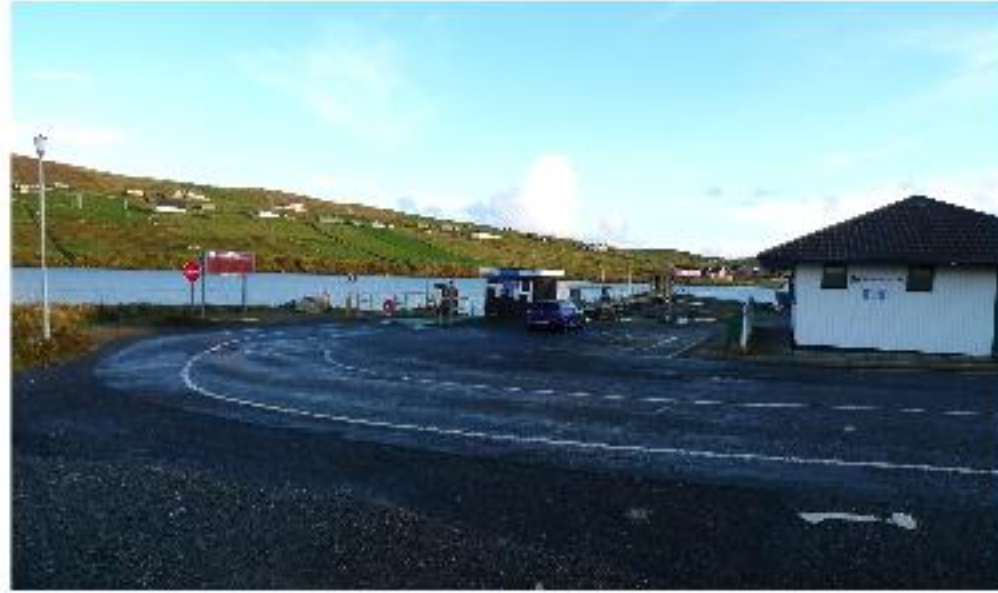
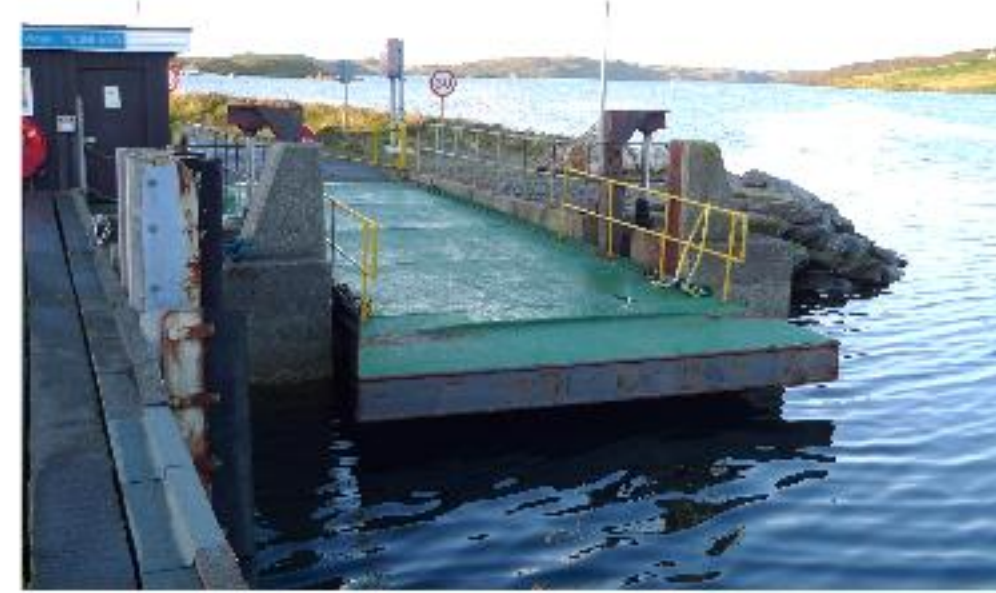
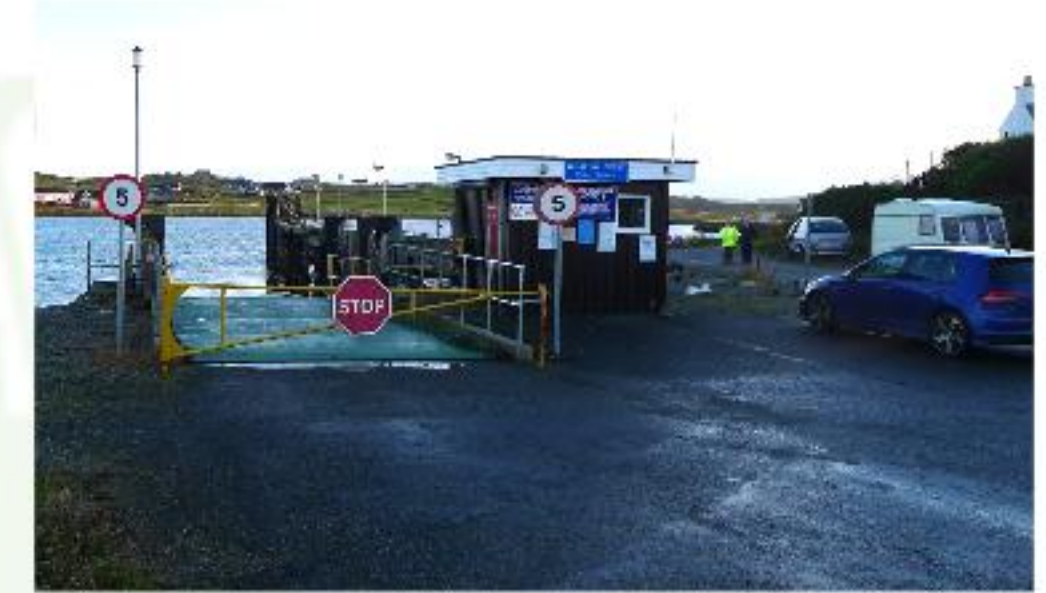
Vidlin

Vessels berth against a row of 4 dolphins alongside a rubble mound and extend 33m from the end of the linkspan. These timber dolphins are supported against the breakwater by a series of horizontal diagonal timber struts founded on concrete blocks and are faced with vertical rubber D fenders supported in steel H sections.

The terminal was found to be in serviceable condition.

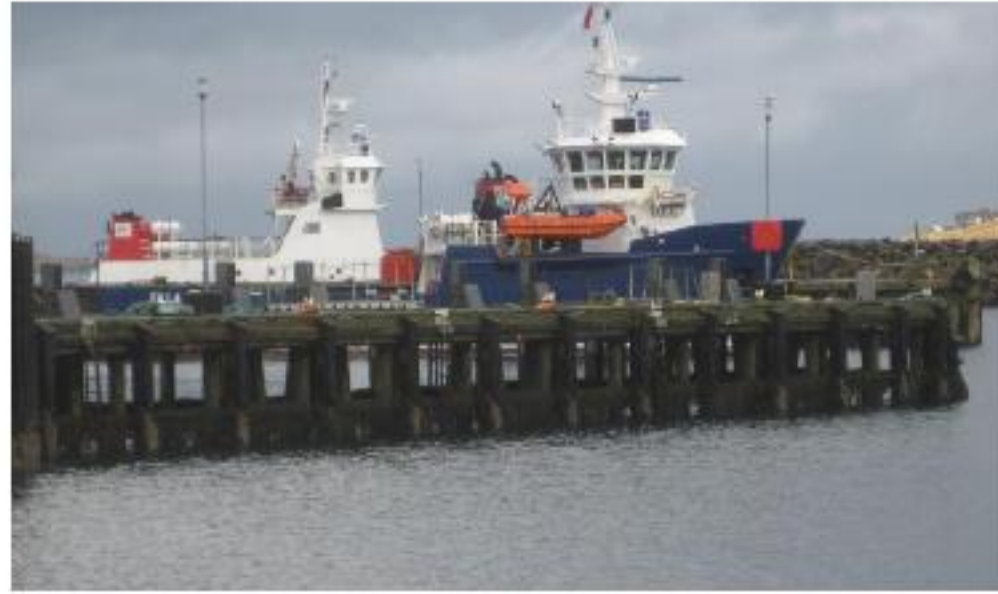
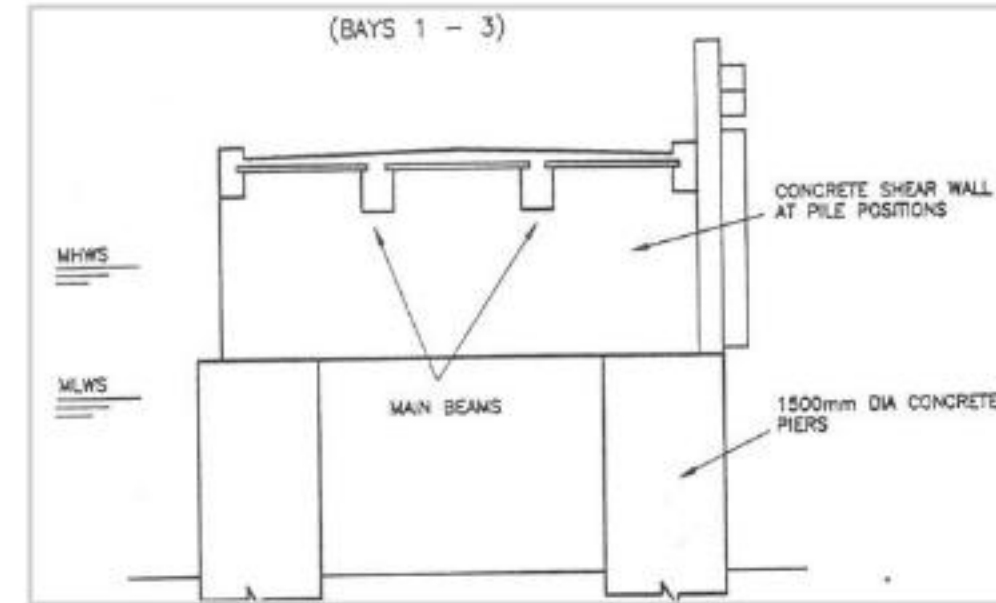
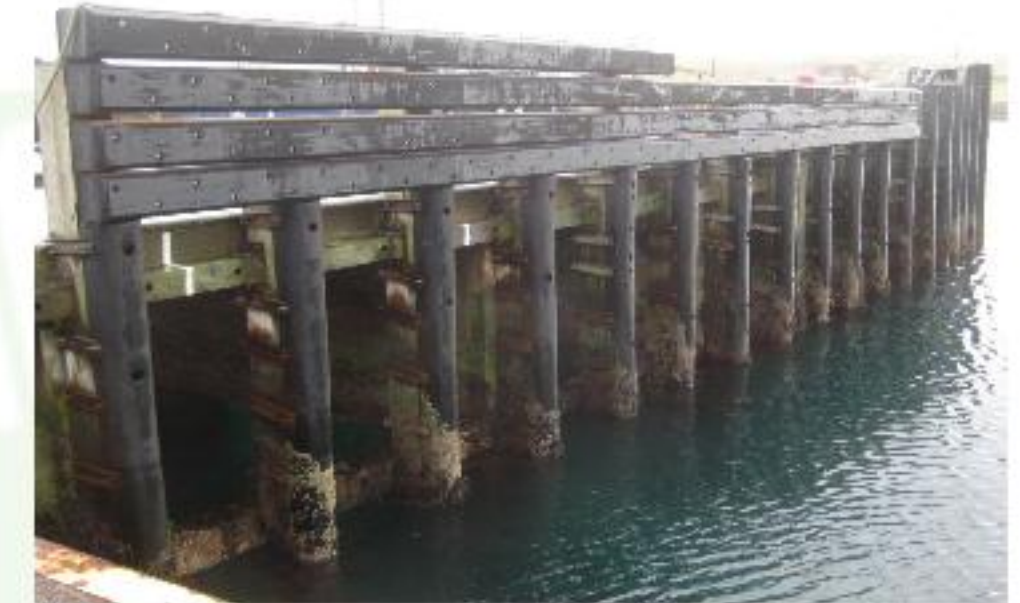
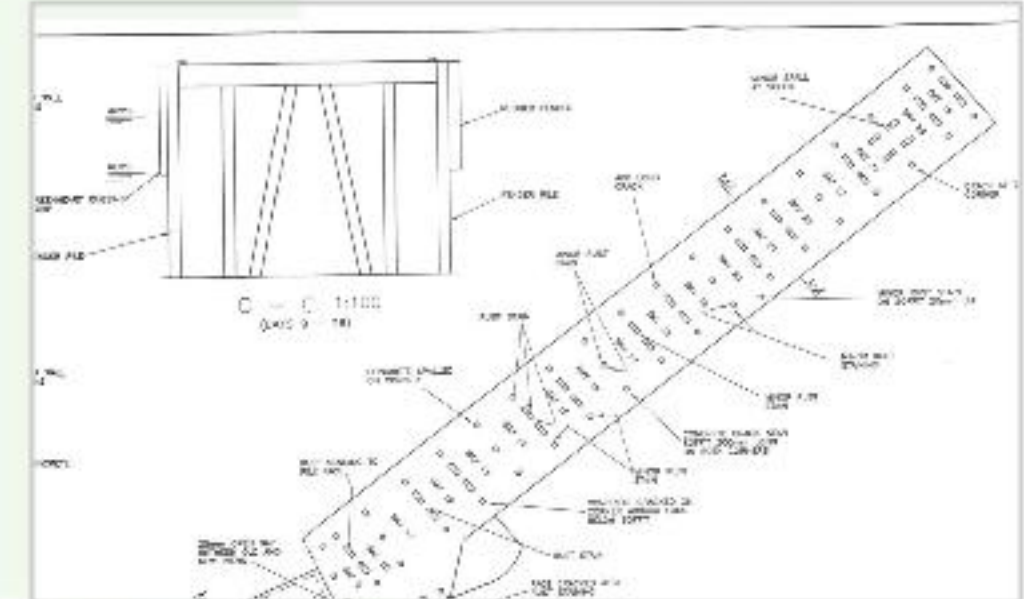
Symbister

This terminal was not visited but the 34m long by 9.4m beam ferry "HENDRA" and the 36m long by 10.8m beam ferry "LINGA" were observed on the route. About 125 lane metres of parking is provided for vehicle waiting for the ferry which is adequate for 1 vessel.

It is understood that the terminal is in serviceable condition.

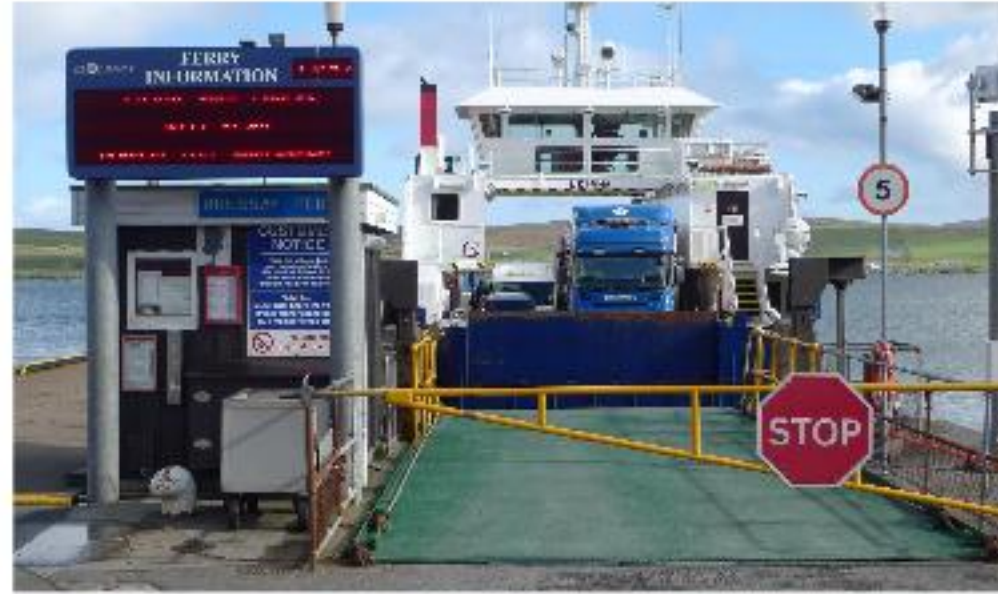
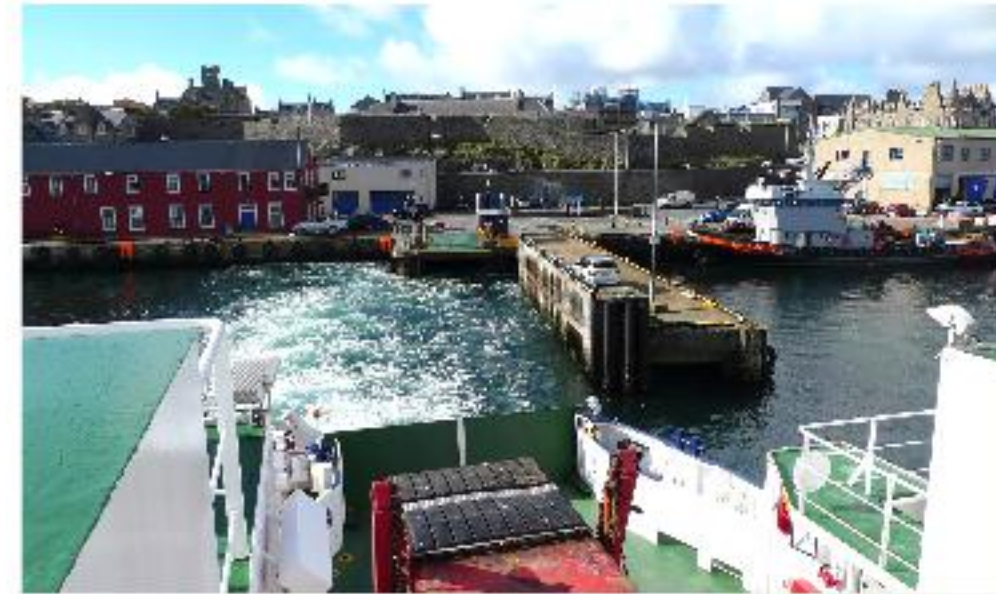
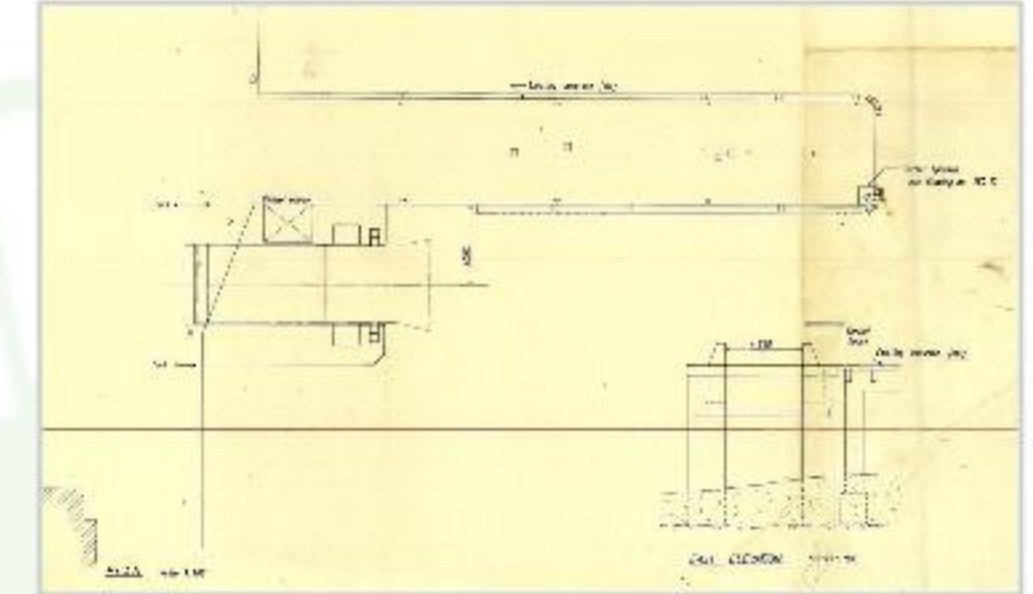
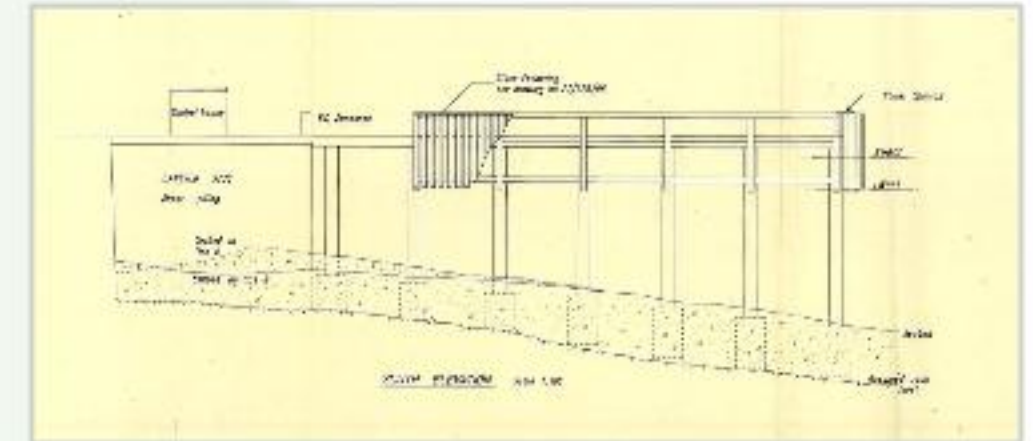
The 32m long by 10.7m beam ferry "LEIRNA" was observed on the berth. About 80 lane metres of parking is provided for vehicle waiting for the ferry which is adequate for 1 vessel.

The terminal was found to be in serviceable condition.

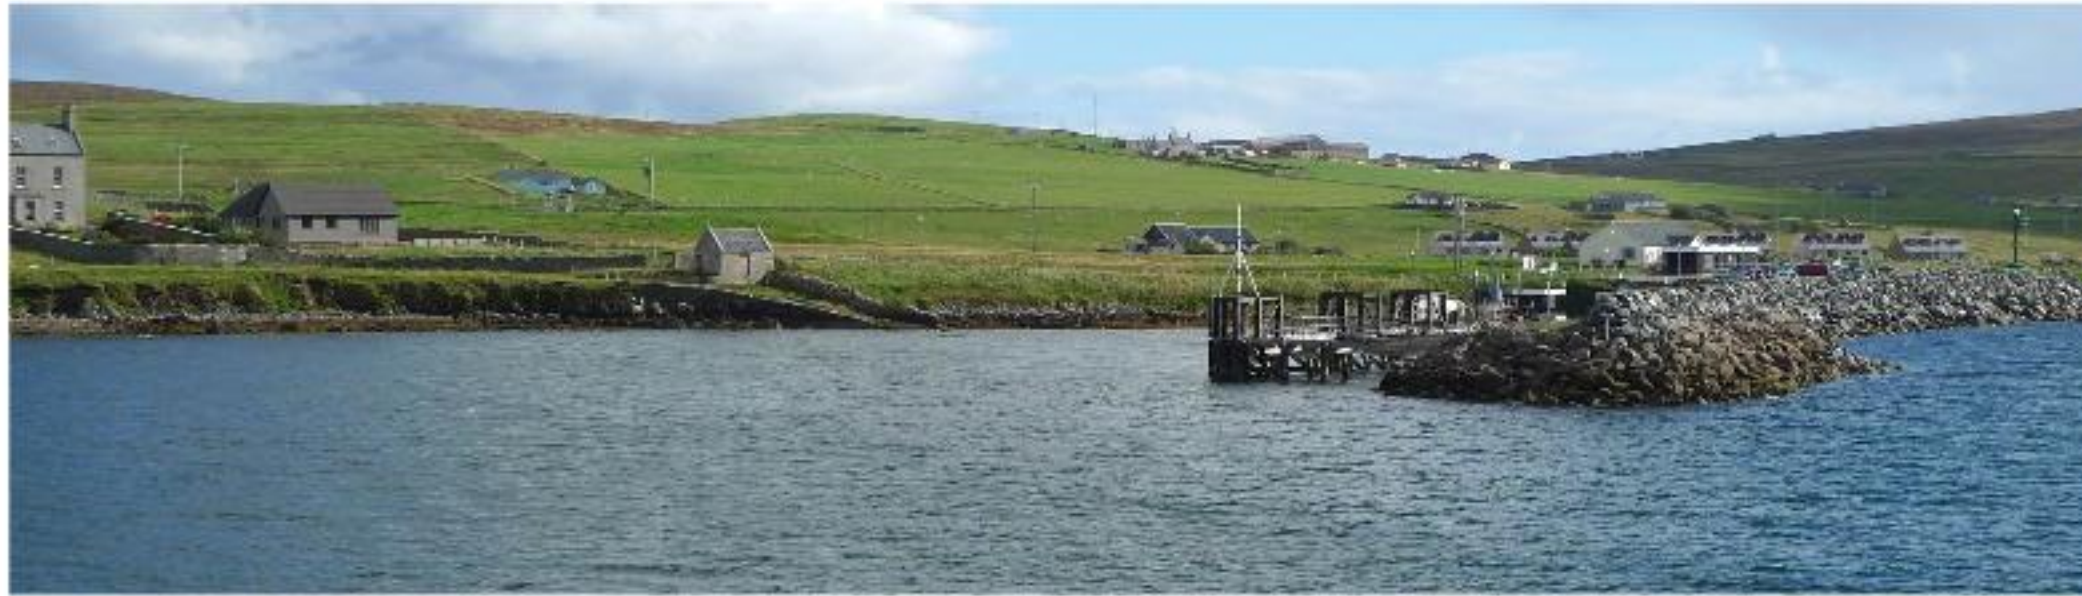
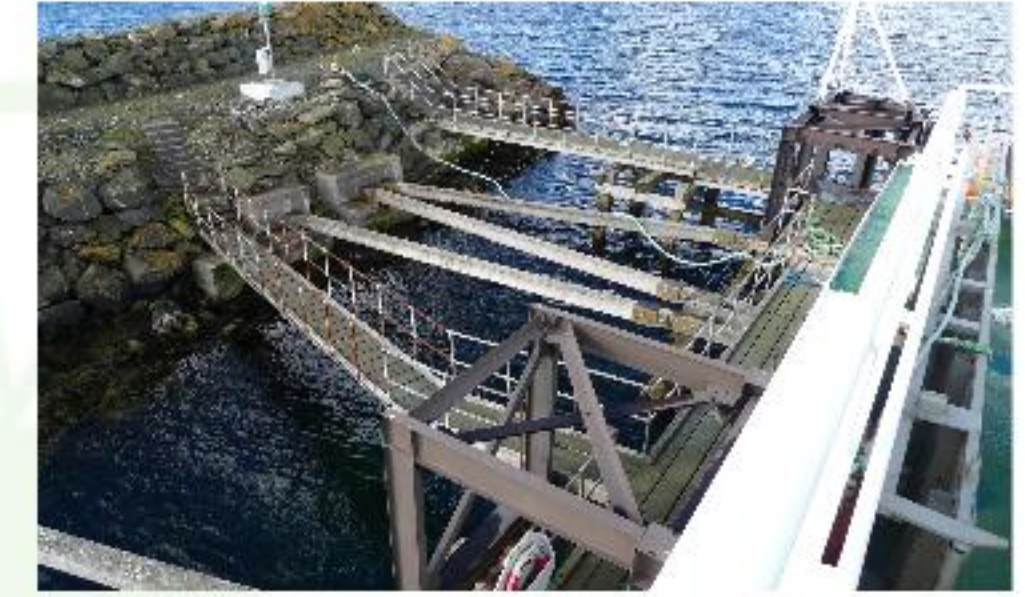
Bressay

Vessels berth against a row of 5 dolphins on the lee side of the rubble mound breakwater and extend 38m from the end of the linkspan. These timber dolphins are supported against the breakwater by a series of horizontal diagonal timber struts founded on concrete blocks and are faced with vertical rubber D fenders supported in steel H sections.

The 32m long by 10.7m beam ferry "LEIRNA" was observed on the berth. About 120 lane metres of parking is provided for vehicle waiting for the ferry which is more than adequate for 1 vessel.

The terminal was found to be in serviceable condition.

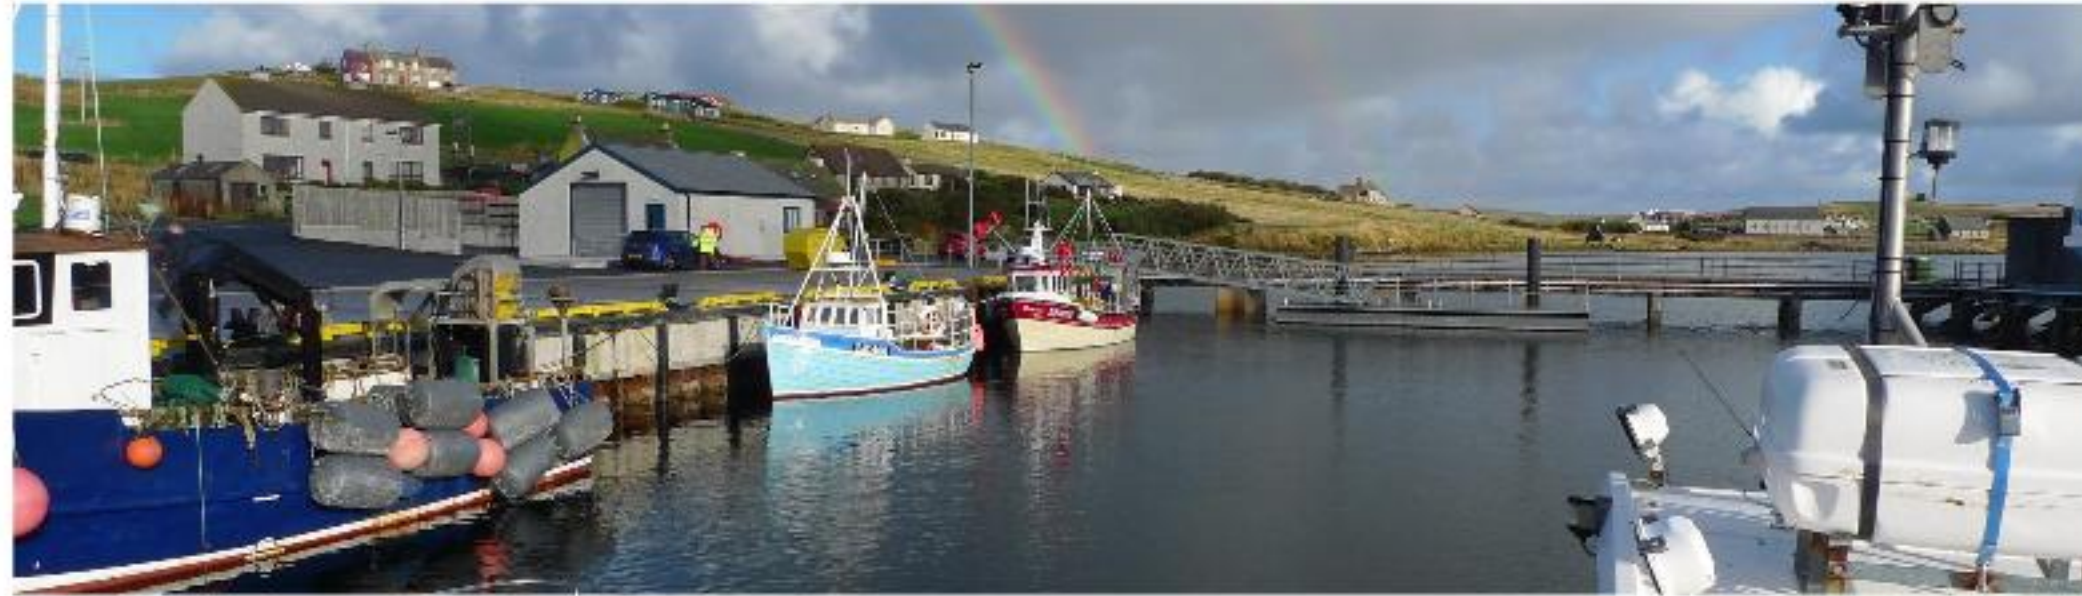
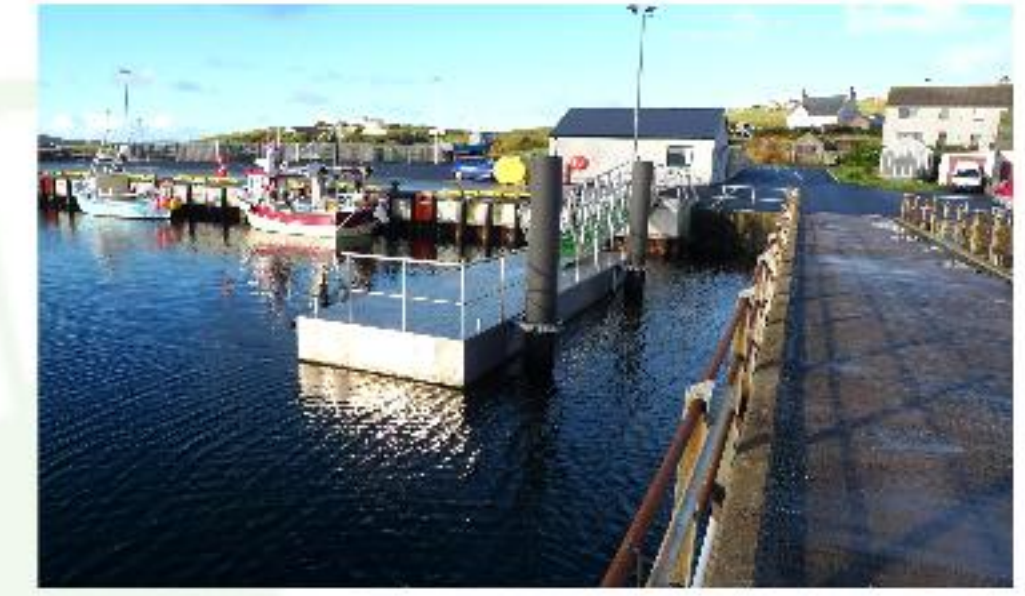
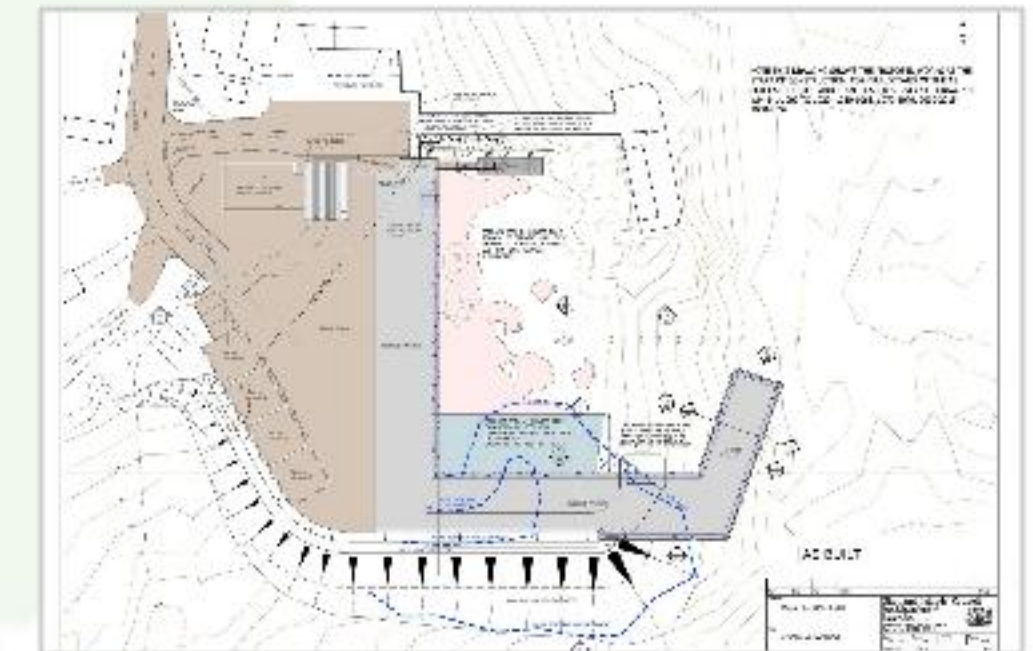
Walls

No ferry was observed on the berth.

The terminal was found to be in serviceable condition.
