SHETLAND ISLAND COUNCIL

Shetland Inter-Island Transport Study

Piers and Harbours - Existing Assets

WORKING PAPER

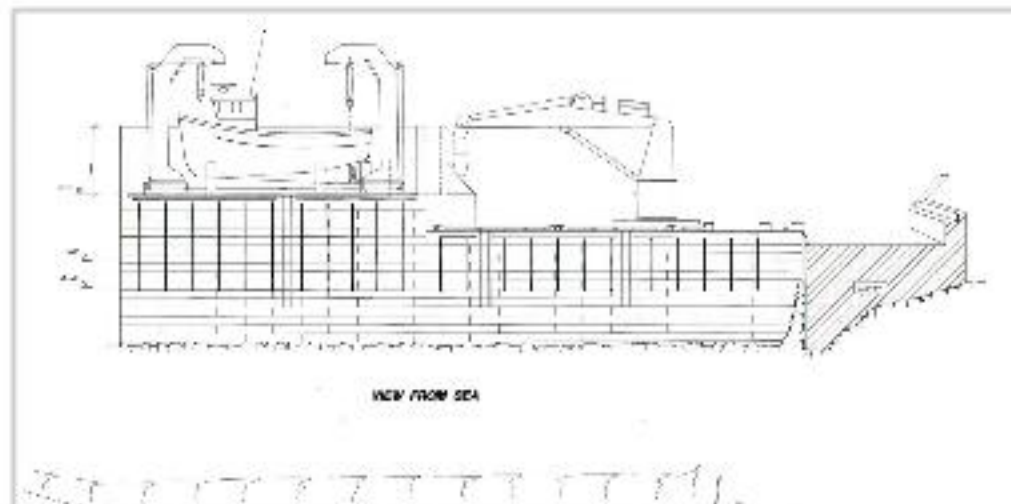
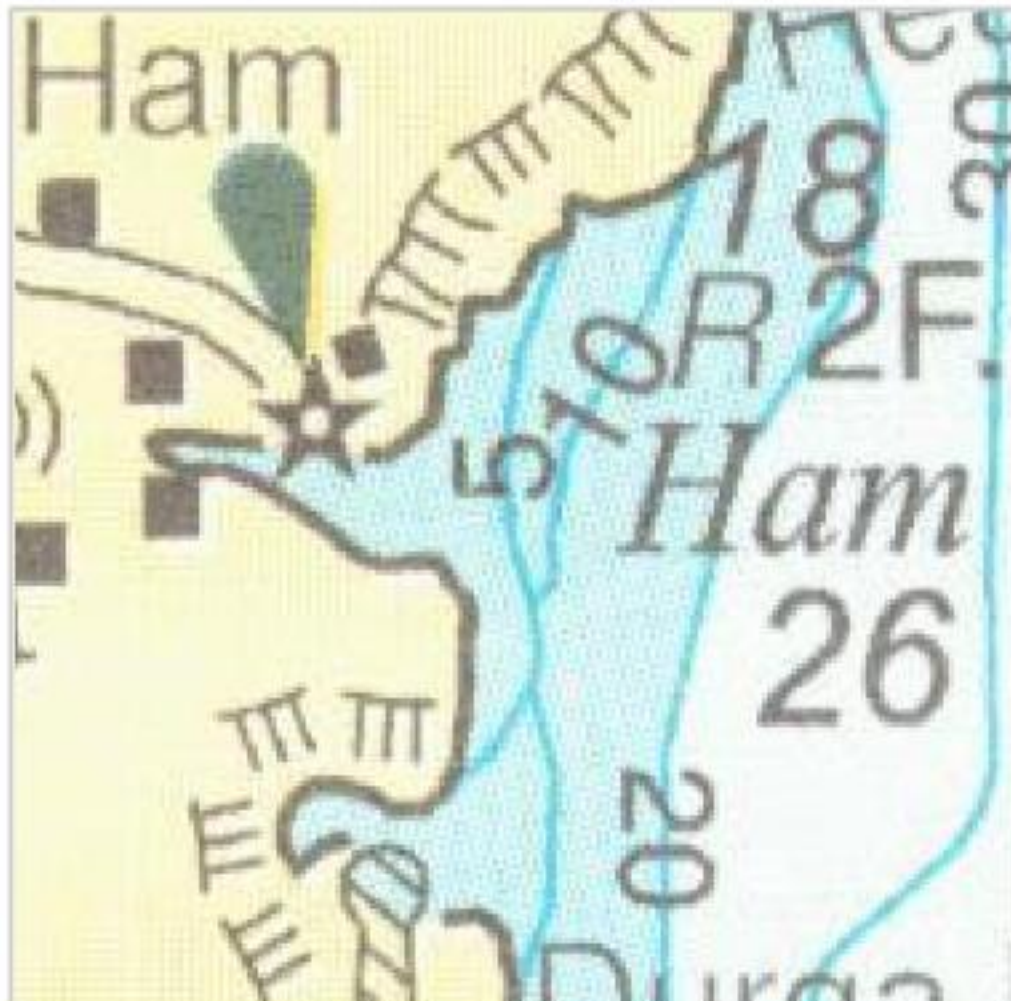
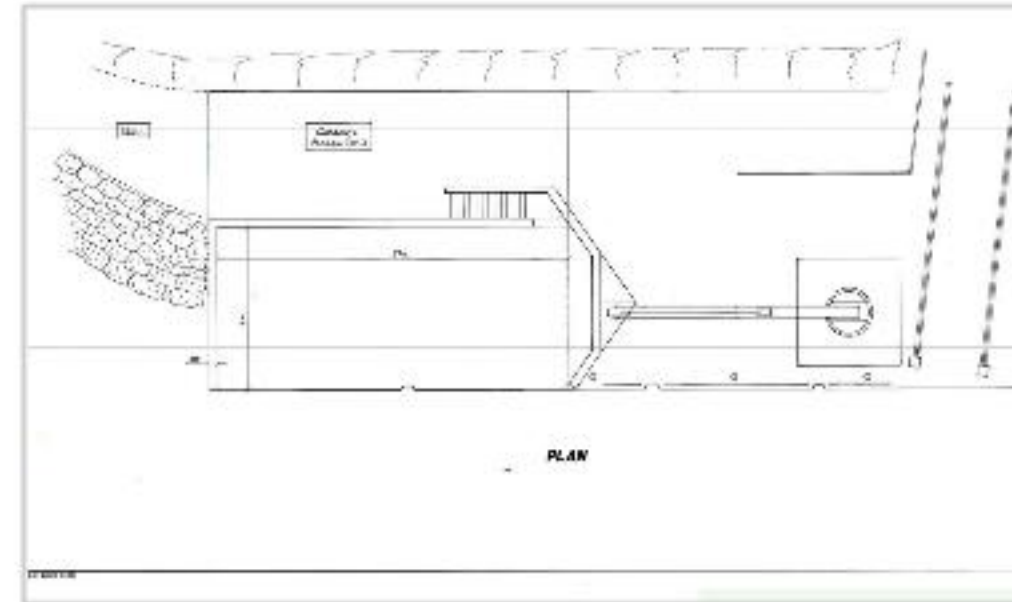
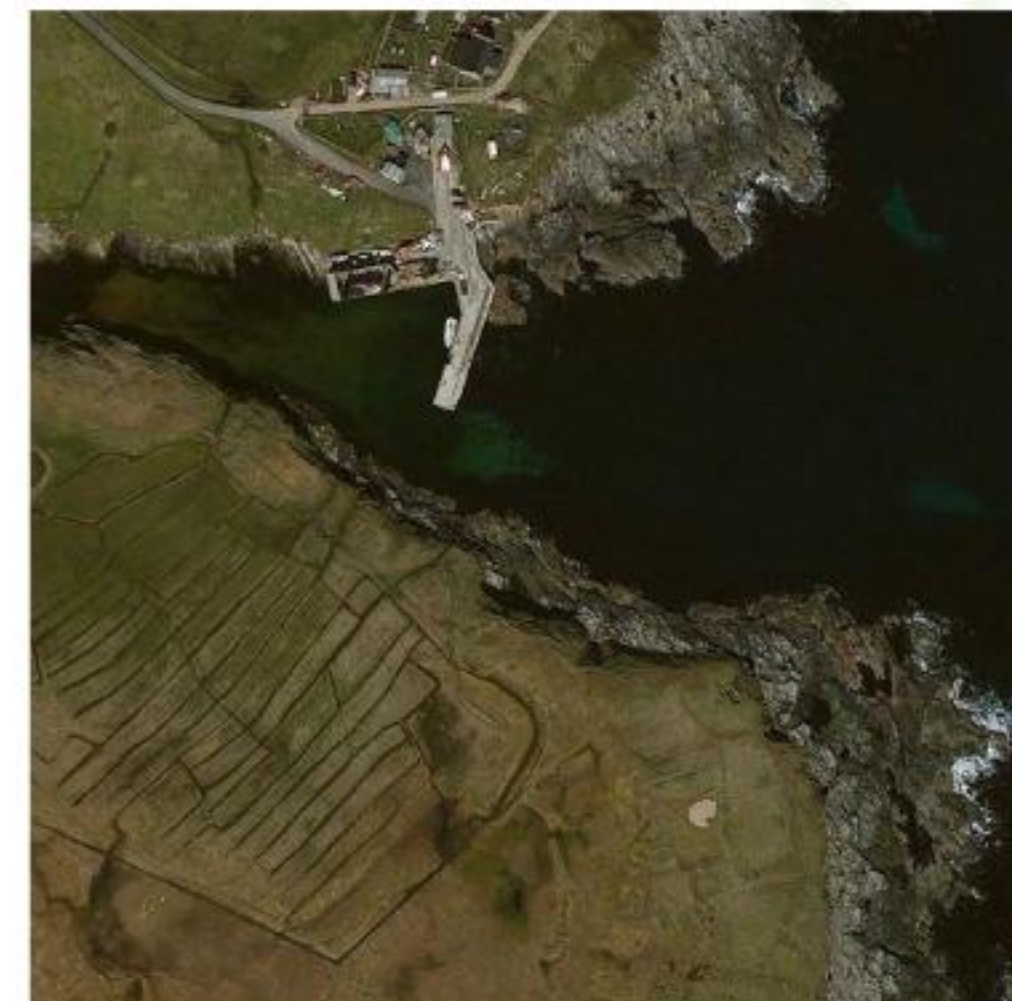
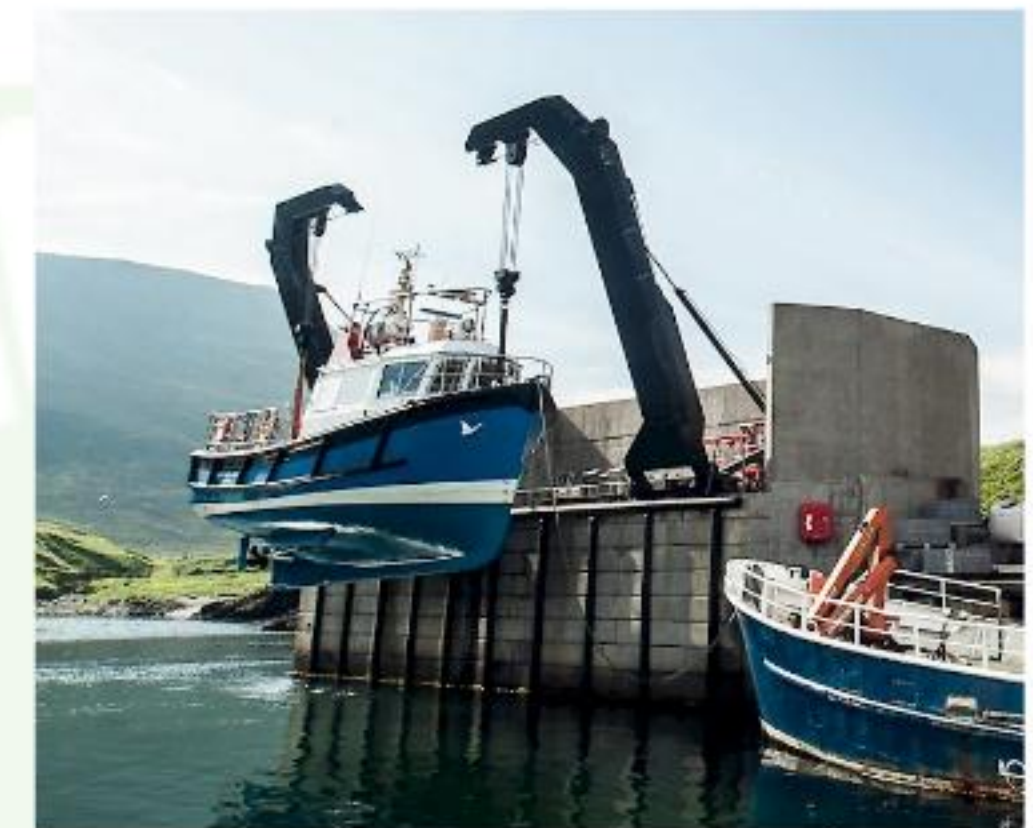
Foula

The ferry berths against a concrete quay and is lifted out of the water on davits on the northern side of the inlet in times of rough weather. The existing ferry vessels can therefore overnight here safely.

It is understood that the terminal is in serviceable condition.

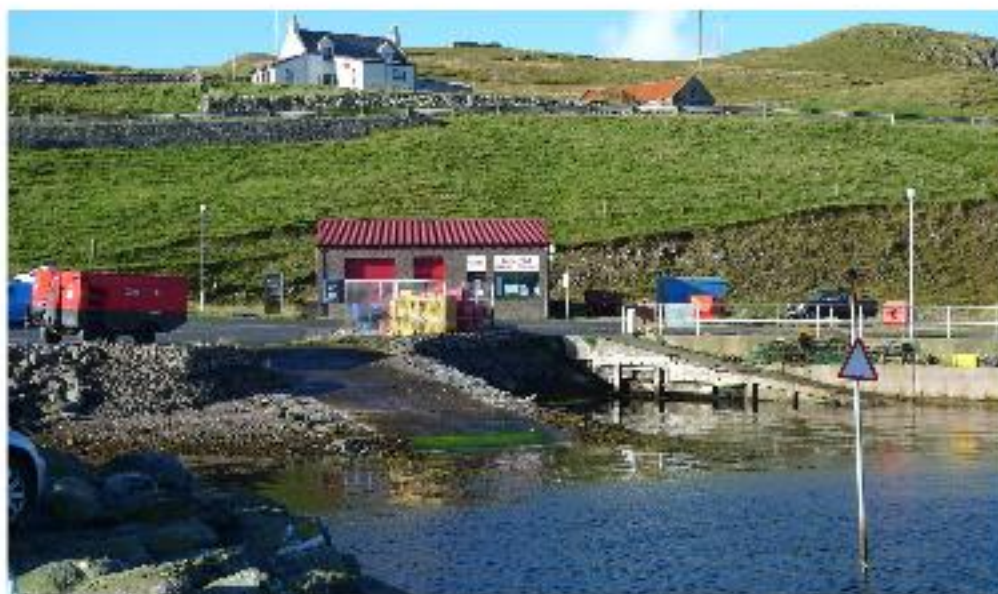
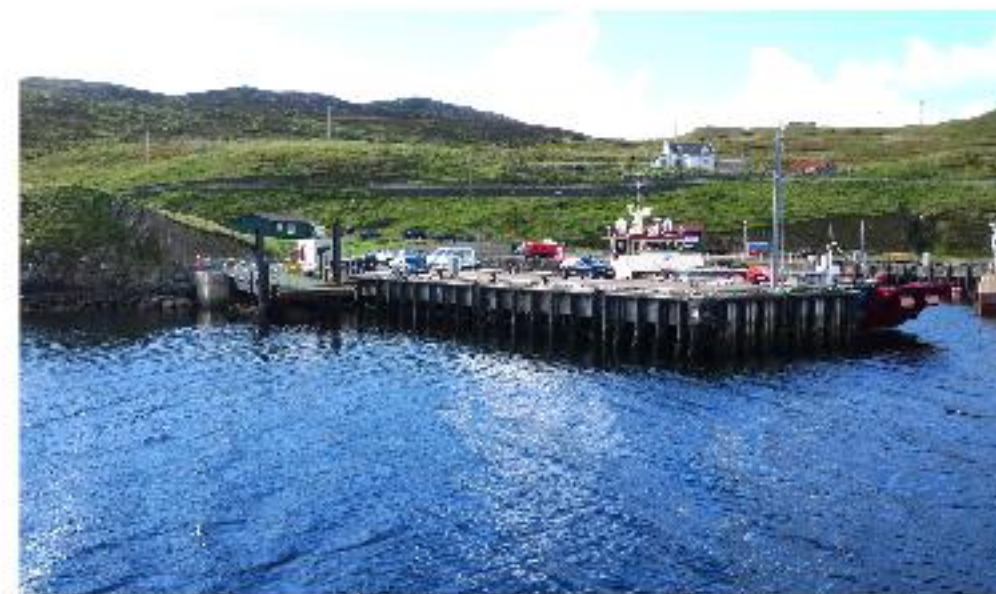
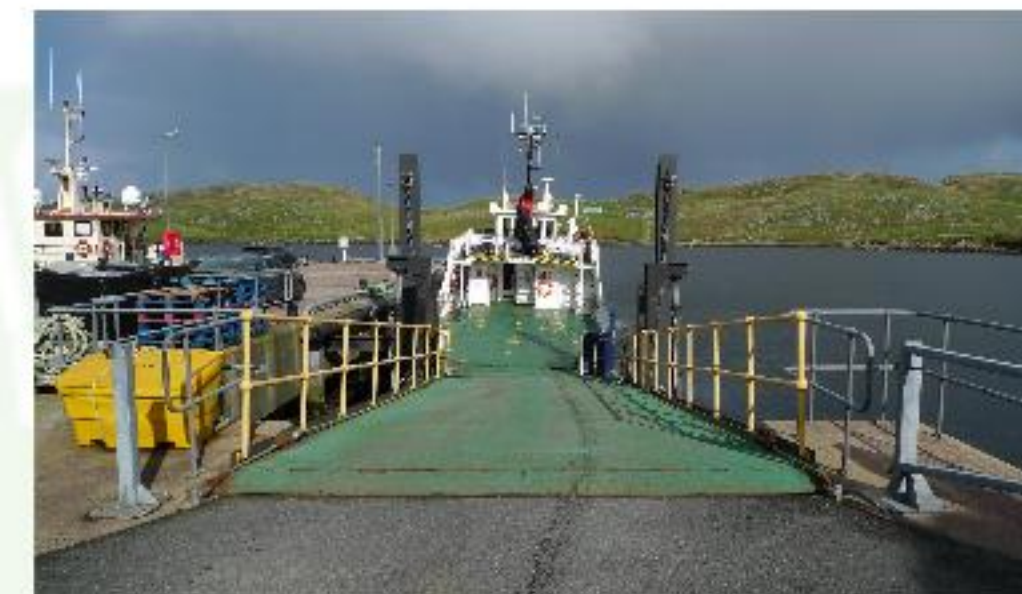
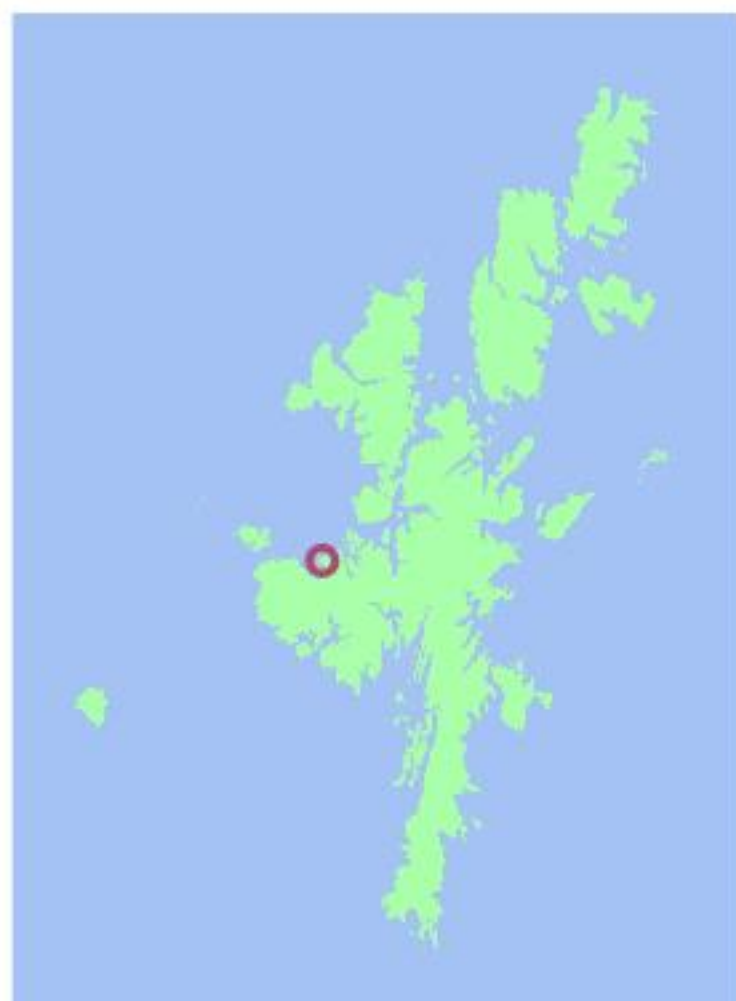
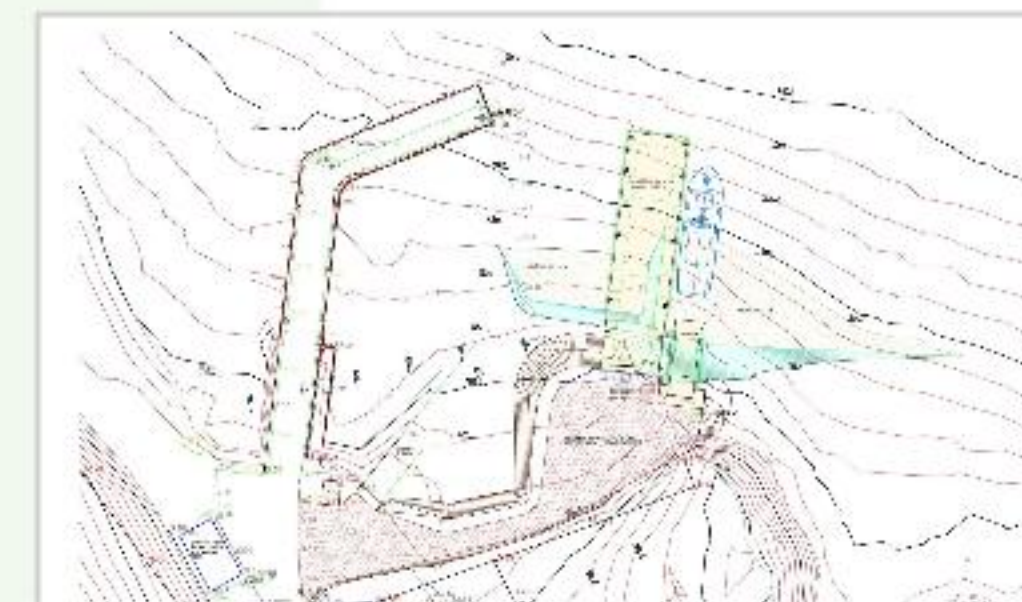
West Burrafirth

Vessels berth against the inside of a concrete piled jetty that extends 35m from the end of the linkspan. The jetty is fronted with vertical and horizontal D section rubber fenders and is also used for other activities.

The terminal was found to be in serviceable condition.

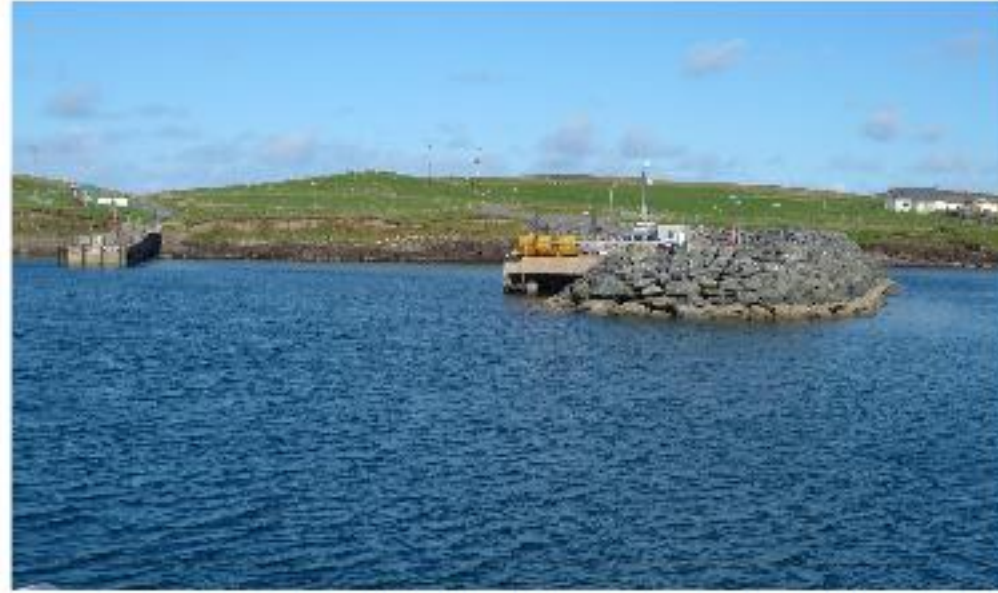
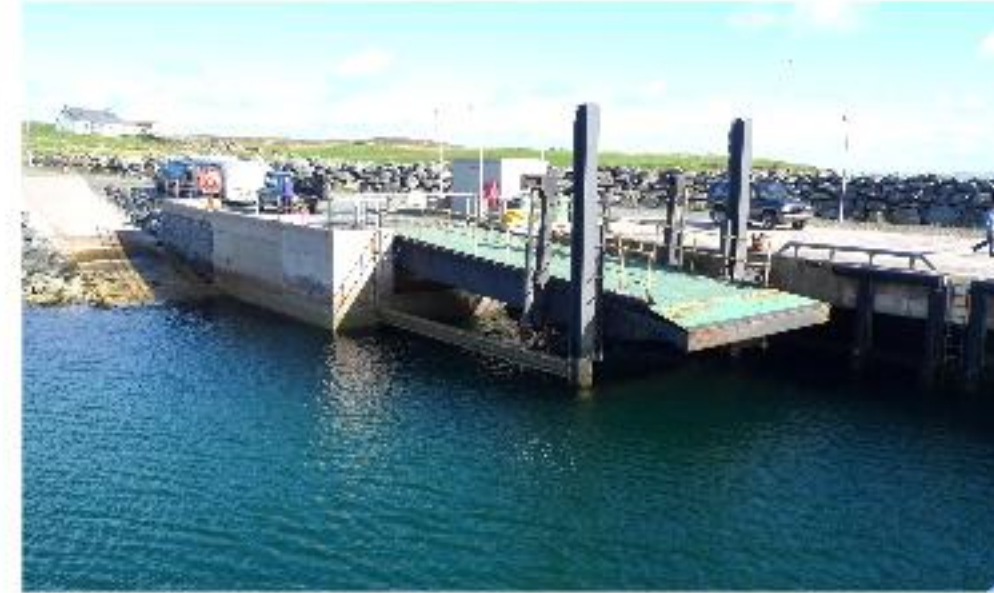
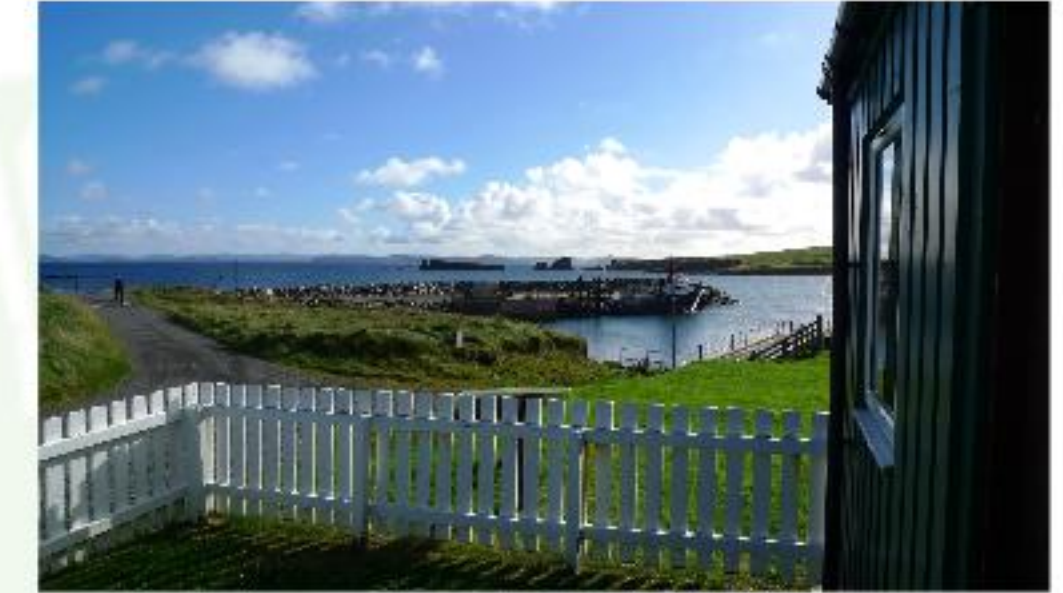
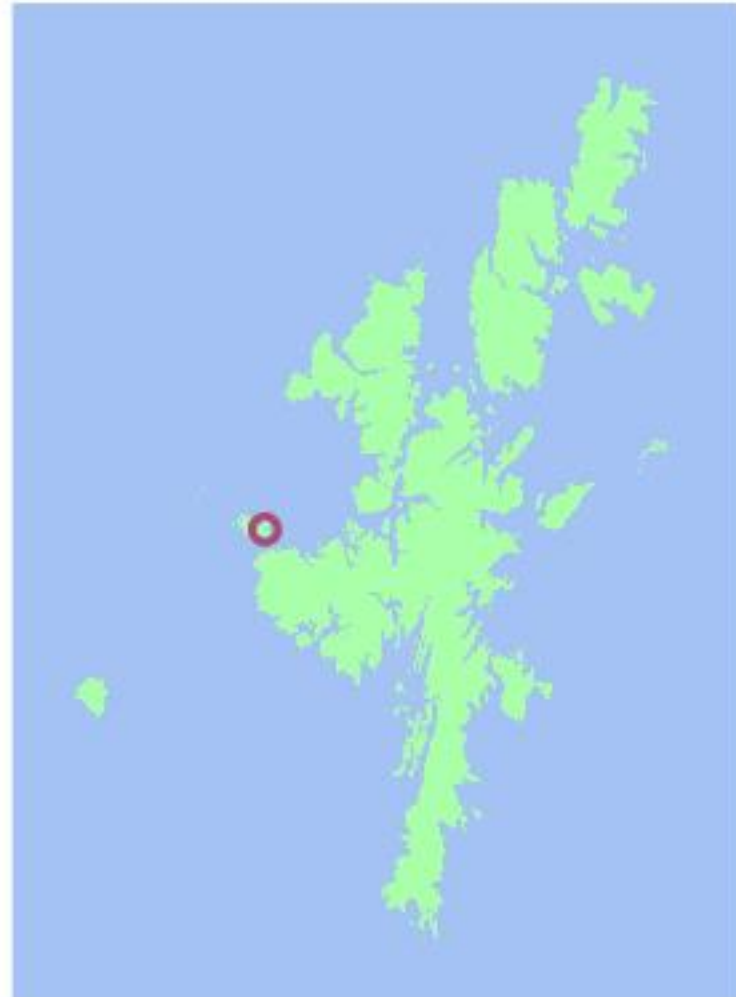
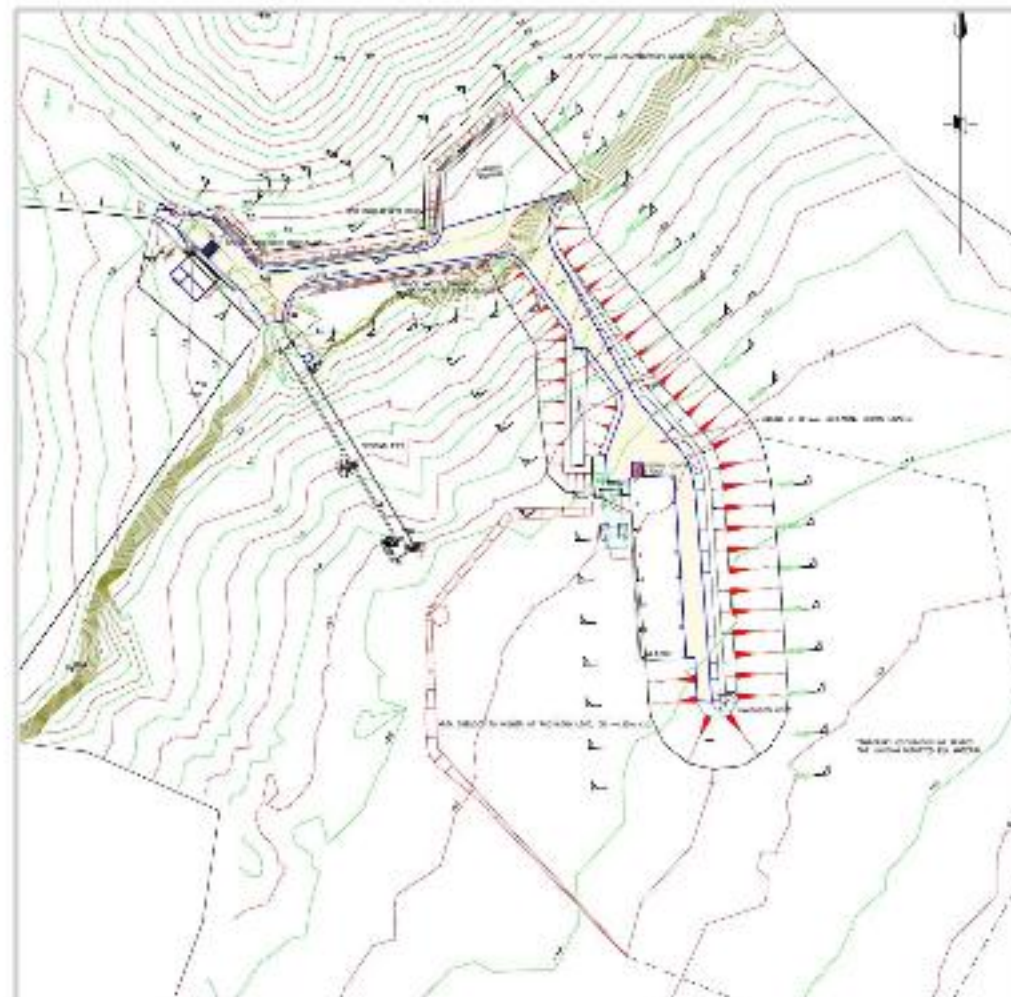
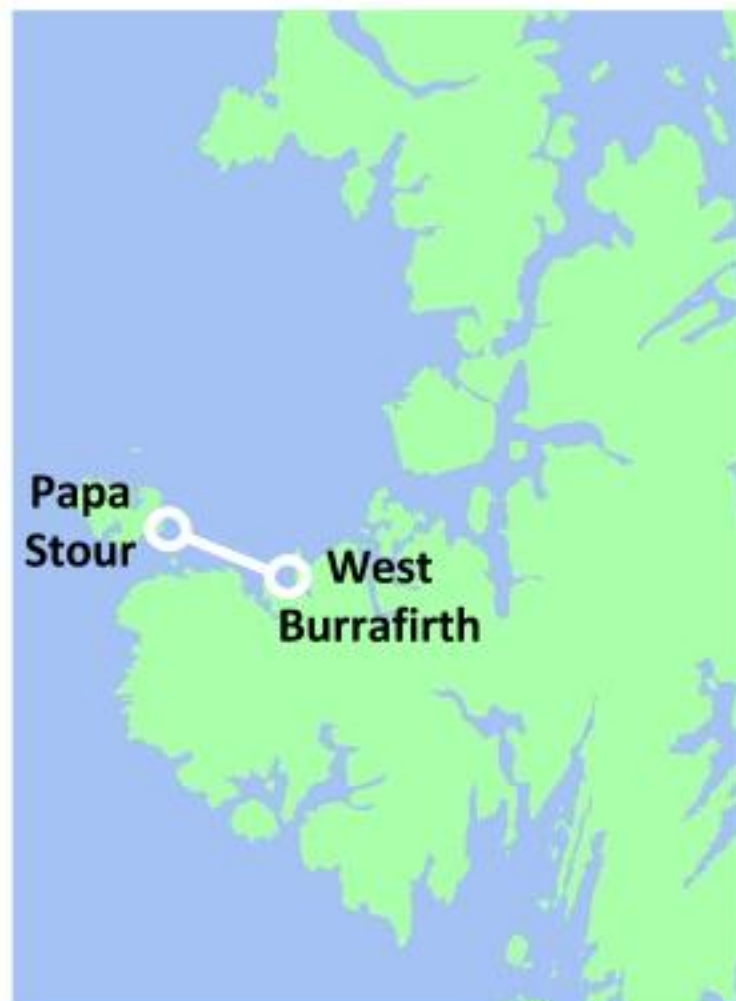
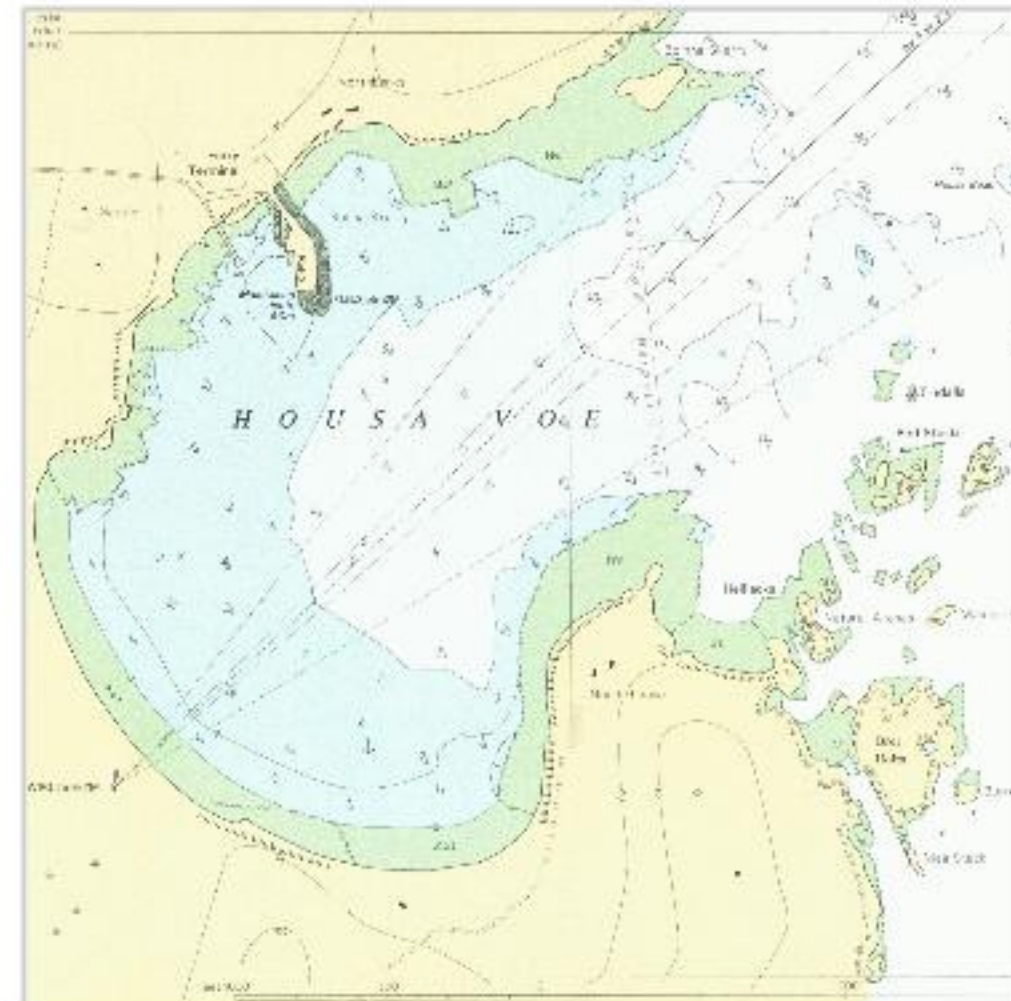
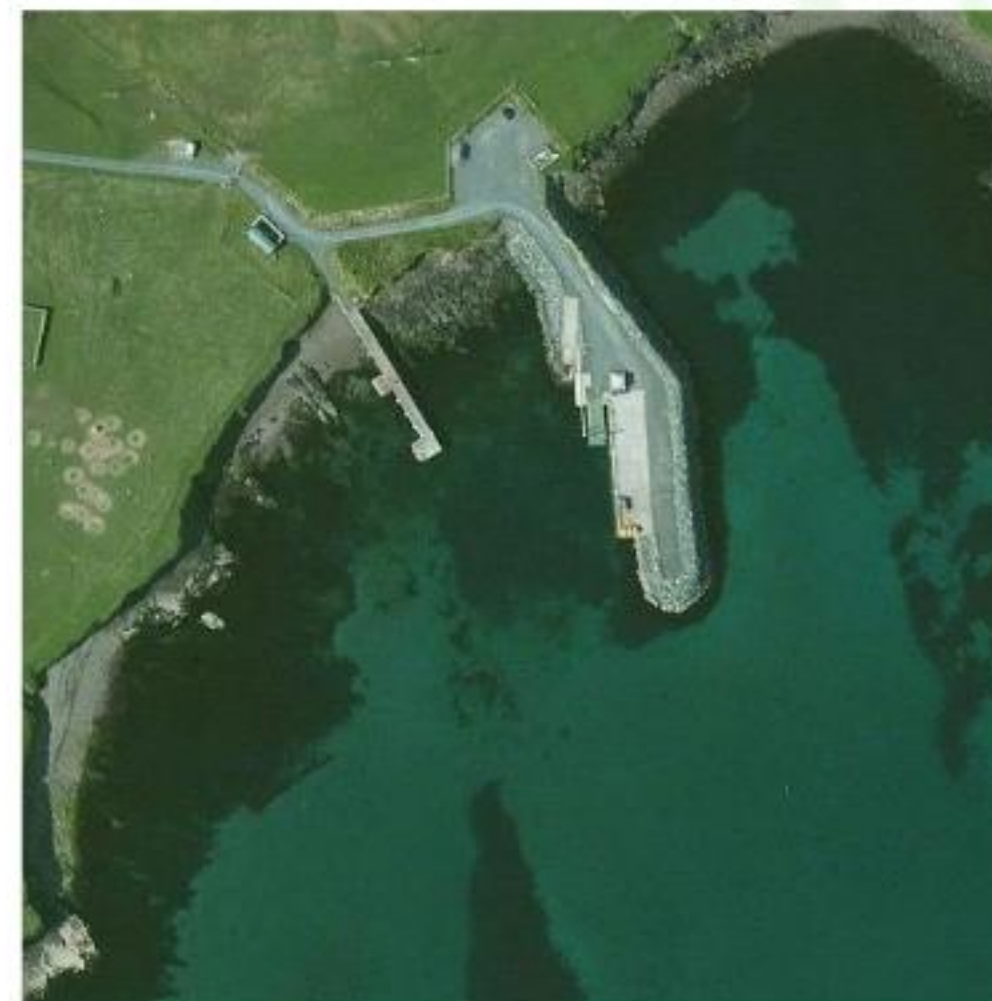
Papa Stour

The terminal was found to be in serviceable condition.

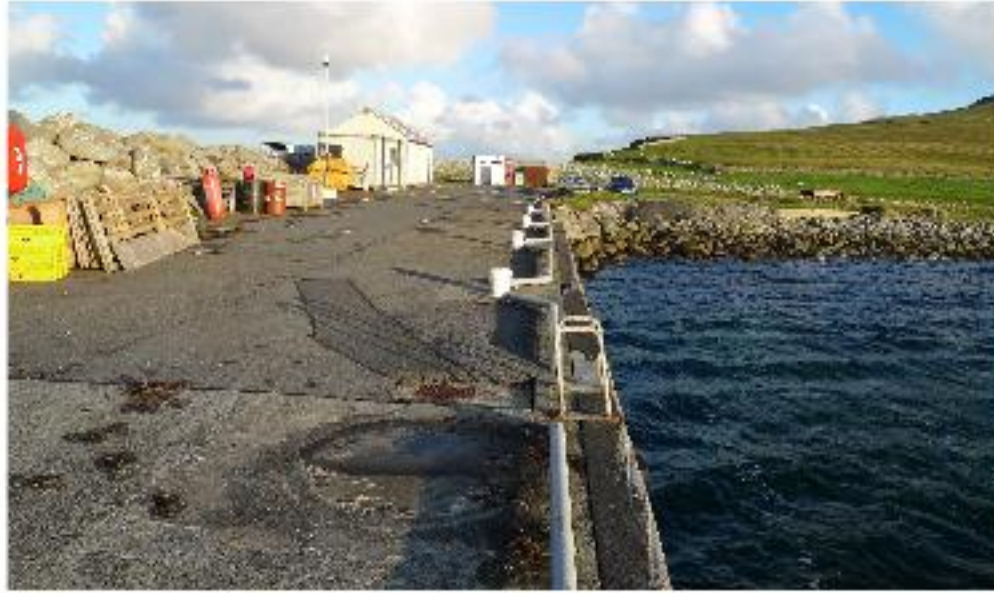
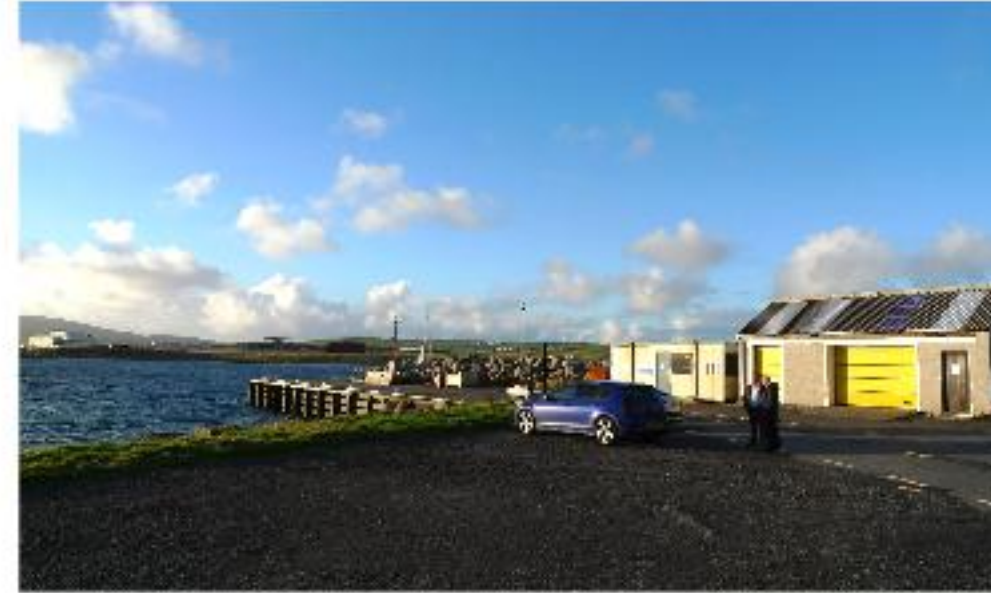
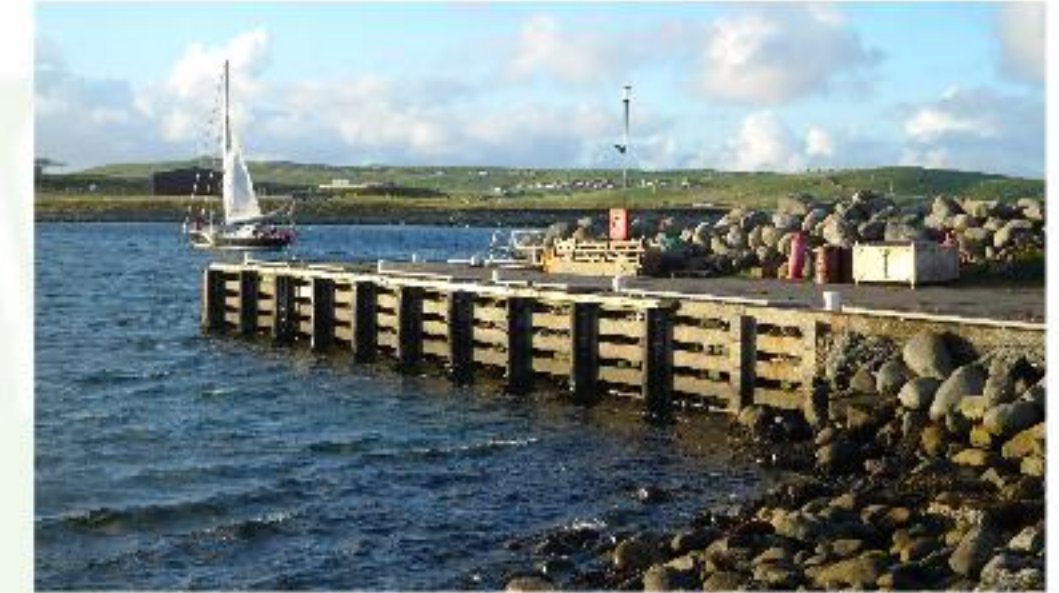
Grutness

No vessel was observed on the berth.

The terminal was found to be in serviceable condition.

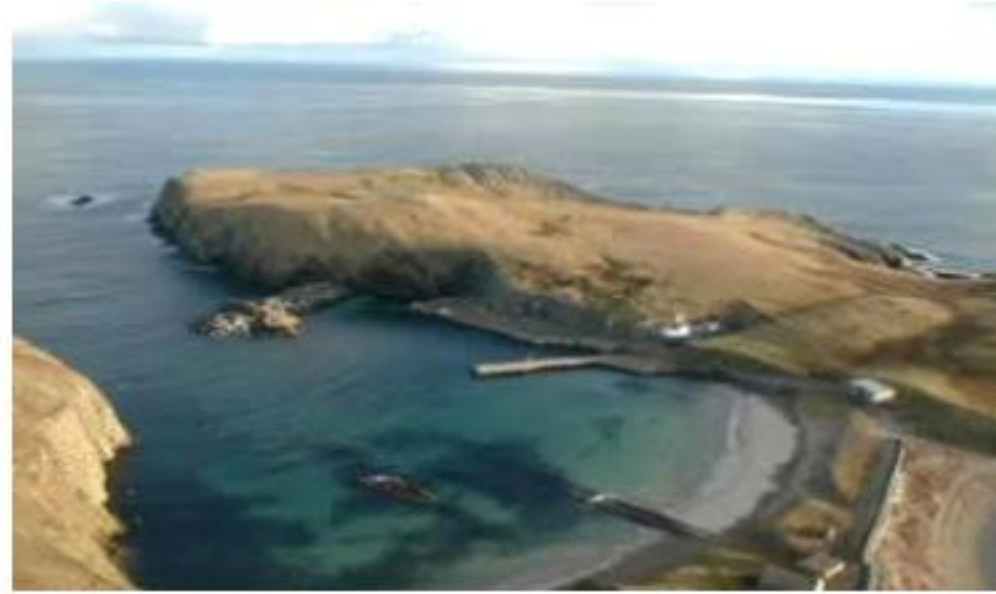
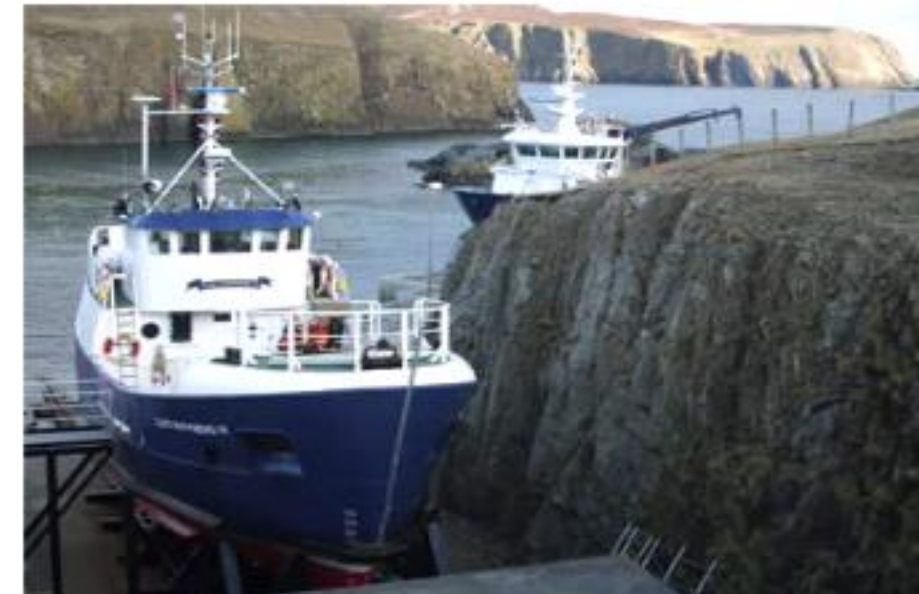
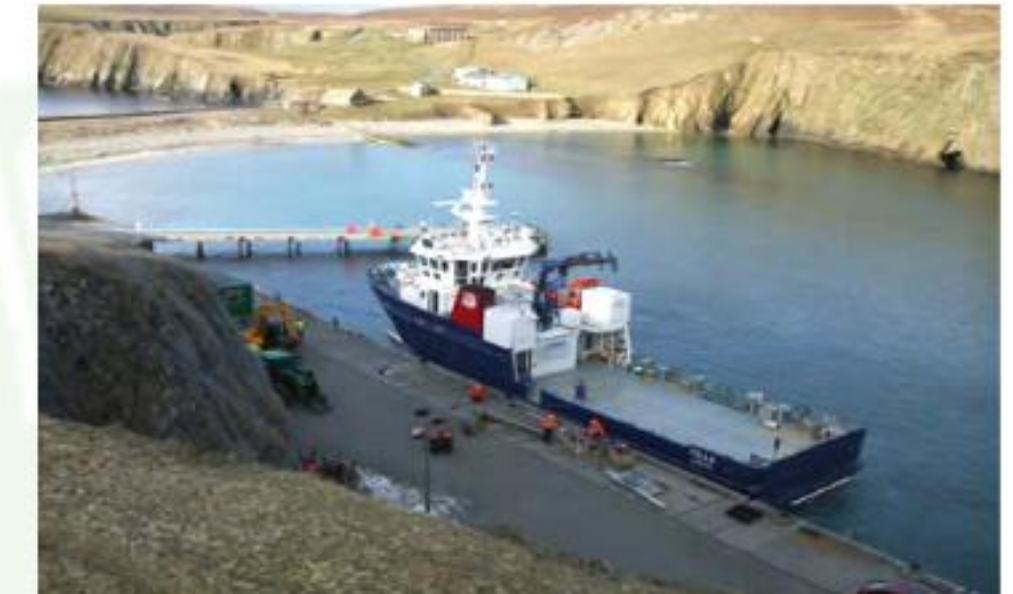
Fair Isle

No vessel was observed on the berth.

It is understood that the terminal is in serviceable condition.
